Research Paper

Geotechnical extreme-event reconnaissance (GEER) investigation to the 2016 M_w 6.0, M_w 6.2 and M_w 7.0 Kumamoto Japan Earthquakes

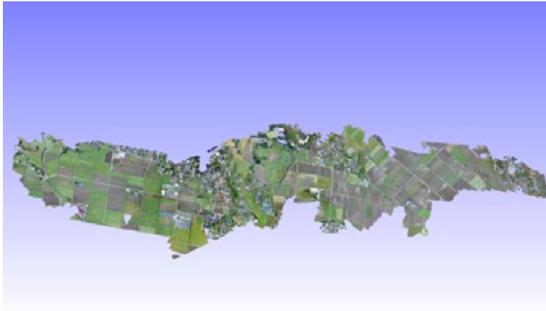
Fig. 3. Overall 3D model of the depression zone generated from UAV data (Kayen et al. 2016).

In the Aso Caldera, an approximately 10 km long “zone of depression” resulted from the Kumamoto earthquake mainshock. The zone of depression was typically 30 m to 110 m wide with roughly vertical offsets on each side of the depression zone of about 0.5 m to 2.5 m with a minor strike-slip component. The cause of the zone of depression is of interest. Potential causes include liquefaction, earth compaction, lateral spreading, and fault rupture (**Fig. 6**).

The GEER team made extensive UAV flights over approximately 4 km of the depression zone to create a large, unique three-dimensional (3D) model of the ground deformations. Extensive terrestrial LiDAR data was also acquired over a large portion of the depression zone where a bridge crossed the depression. Extensive photographing and manual mapping of the deformation was also completed by GEER. A composite overview of the entire

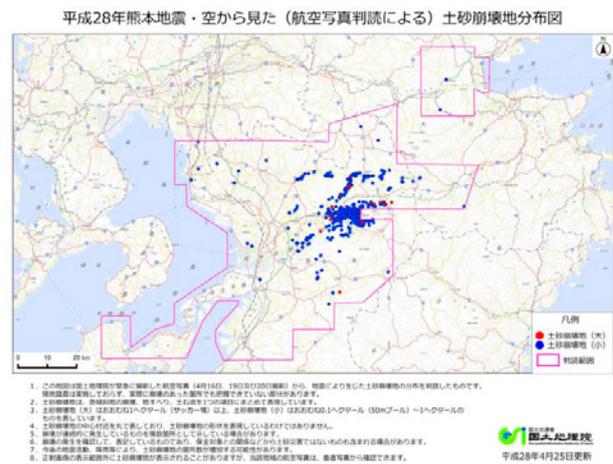
Fig. 4. Overview of landslides from the Kumamoto Earthquakes produced by the Geospatial Information Authority of Japan (GSI).

Widespread landsliding was caused by the Kumamoto Earthquakes in the steep volcanic geology of the region. Several hundred landslides are believed to have occurred based on satellite imagery interpretation conducted by the Geospatial Information Authority of Japan (Fig. 4). The GEER reconnaissance team observed numerous landslides while driving through the region. The native slopes in the area are composed of various types of volcanic deposits. These deposits, in general, are very susceptible to weathering and subsequent landsliding. Landslides in these formations are common around the region, and throughout Japan, and have been triggered by both intense rain and seismic events (Wang et al. 2006, Jitousono et al. 2008, Sidle and Chigira 2004, Yamao et al. 2016).

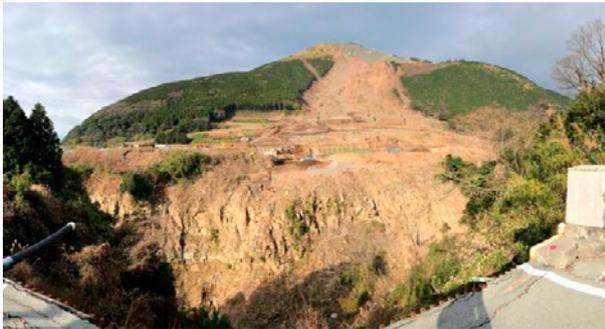
Fig. 5. Wide-angle view of the Great Aso Landslide that destroyed the bridge, whose remnant abutment is visible in the foreground of the photo (Kayen et al. 2016).

The Great Aso Landslide was likely the largest landslide that occurred as a result of the Kumamoto Earthquakes. The head scarp of the landslide was approximately 350 m higher in elevation than a canyon that ran directly beneath the landslide area. The horizontal distance from the head scarp to the canyon was approximately 700 m (Fig. 5). A bridge previously crossed the canyon directly beneath the landslide, but was destroyed in the earthquake, presumably by this landslide. The remnant of one of the abutments is visible. There was also significant slope failure of the canyon wall slopes throughout this area, independent of the overlying Great Aso Landslide. The Great Aso Landslide source area is mapped as Pyroxene Andesite Lava, lava flow and dike (Pa) in a 1:50,000 “Geological Map of Aso Volcano”.

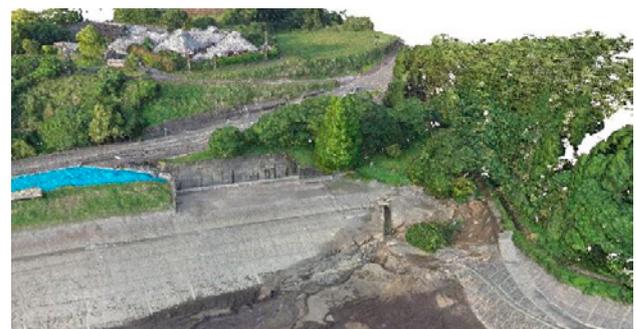
Fig. 6. Three-dimensional (3D) model of the spillway generated by UAV data (Kayen et al. 2016).

The Futagawa fault ruptured through an approximately 0.5 km long by 0.25 km wide water reservoir. The fault rupture passed through the western flank of the reservoir and through the main spillway. No catastrophic release of water occurred. However, the reservoir experienced significant damage, both as a result of the surface fault rupture and as a result of the strong ground motions. This presents a valuable case history of the response of dams to surface fault rupture.

GEER is currently working on developing three-dimensional models of the reservoir, dam, and spillway to fully document the condition of the reservoir after the earthquake. A preliminary view of the spillway from the UAV-generated 3D model is provided in Fig. 6. Preliminary, interactive 3D models are available at: <http://prismweb.groups.et.byu.net/JD/App/>.

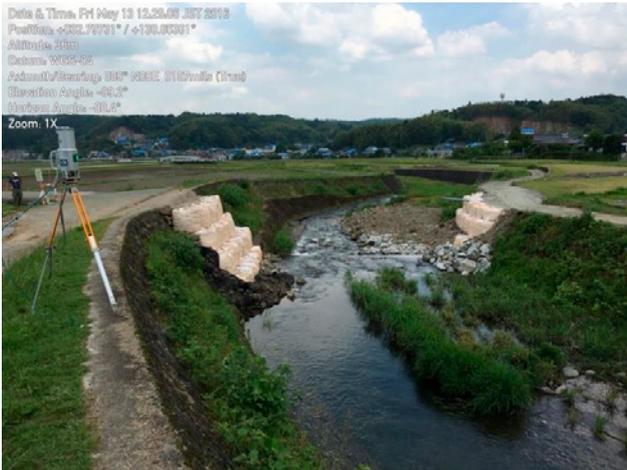
Fig. 7. The terrestrial LiDAR setup and damage to the canal embankments. The main fault crossing is at the location of the repairs visible in the photograph.

Since this represents a relatively unique dataset for analyzing ground deformation resulting from surface fault rupture, GEER visited a number of sites in the aerial LiDAR coverage zone. Of particular interest was a location where the Futagawa fault crossed a canal embankment. The response of the embankment to underlying fault rupture might be useful for studies on the performance of levees, dams, and other earth structures subjected to surface fault rupture. GEER therefore conducted a

Although the canal was not full of water at the time of the earthquake, the damage observed by GEER was relatively minor, despite measured fault displacements of about 57 cm horizontal and 28 cm vertical. A second, conjugate fault, with opposite direction strike-slip motion, also happened to cross the canal embankment at roughly the same location, making the deformation field relatively complex. The estimated displacement on this fault was about 29 cm horizontal and 13 cm vertical.

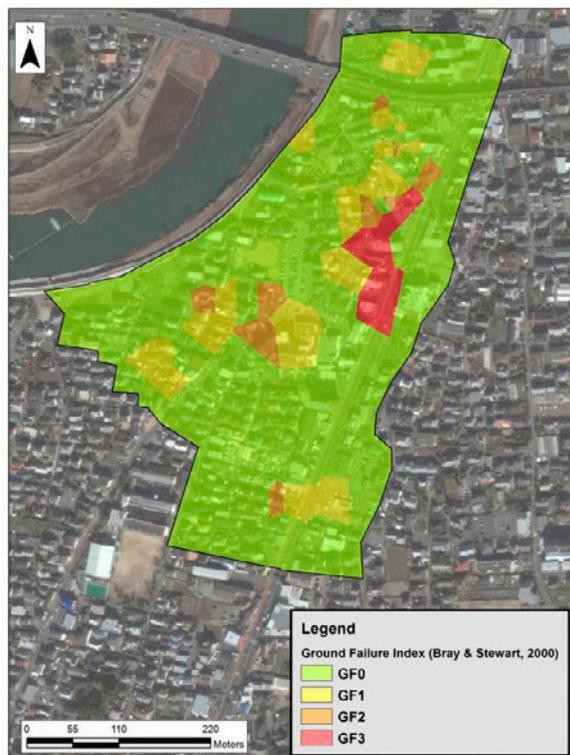
Fig. 8. Maps produced by GEER of observed liquefaction and related Ground Failure Index in the Kumamoto region.

One of the striking features of this earthquake was the relatively low number of liquefaction sites observed given the extremely strong ground motions recorded throughout the Kumamoto region and the large areas mapped as young alluvial deposits. GEER did visit a number of sites where liquefaction was observed, and other reconnaissance teams also observed a number of areas of liquefaction (shown in **Fig. 8**). However, more liquefaction-induced damage was expected based on the team's experience documenting liquefaction after earthquakes of such intensity. A detailed map of liquefaction-related damage to building structures observed by GEER is provided in **Fig. 8** in addition to a picture of one example building affected by liquefaction.

It is of interest to determine the specific reasons why more liquefaction did not occur or why surficial evidence of liquefaction and its effects on structures was limited. Given the high intensity of shaking, the relatively high ground water levels, and the abundant presence of loose granular soils with low SPT blow counts as evident in a number of Geotechnical reports in the area, reasons for limited evidence of liquefaction may be attributed to the presence of plastic (non-susceptible) soils within or between layers of loose sand, age of the soil deposit, and volcanic

geologic origin of the sediments. The GEER team expects that the soil plasticity, resulting from the volcanic origin of the sediments, is the most likely cause. The authors recommend that further studies (e.g., soil borings, laboratory testing, and extensive in-situ testing) be conducted at liquefaction and particularly non-liquefaction sites, where liquefaction would otherwise have been expected, to determine the causes of limited liquefaction evidence and effects resulting from the Kumamoto Earthquakes.

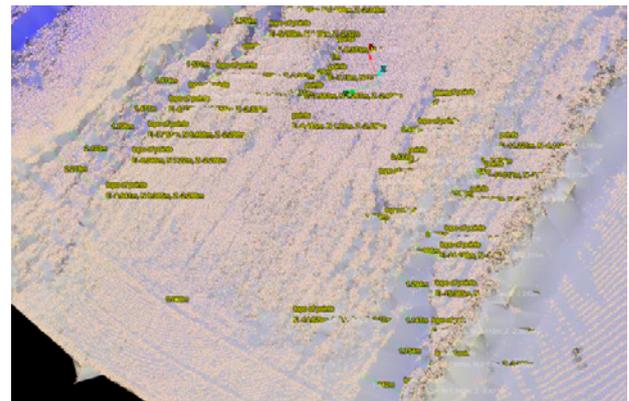
Fig. 9. Measurements of lateral spread elevations and fissure locations from LIDAR data at Mashiki town (Kayen et al. 2016).

In addition to liquefaction effects on structures, the team was interested in identifying cases where lateral spreading occurred and cases where lateral spreading was expected but did not occur. Remarkably, only one significant liquefaction-related lateral spread was encountered by the GEER team during the Kumamoto reconnaissance mission. This lateral spread was located in Akisumachi Nuyamazu, adjacent to a pipeline bridge and traffic bridge along route 232 crossing a tributary of the Midorikawa River at the east of Kumamoto City limits (32.77369° N 130.78384° E). A least seven repairs to water distribution pipelines in the immediate area were required, including three ruptures of the 800-mm-diameter steel transmission main crossing the river.

A LIDAR scan was taken at the north side of field exhibiting largest ground cracking (**Fig. 9**). This area was boarded by a concrete lined drainage canal to the north, and the river to the south. Based on observations, including limited damage to the drainage canal at the north, the team believes the majority of movement was south toward the river. In the residential area north of the small canal, several extension features were observed in sidewalk blocks and around buildings, indicating a slight movement of this area toward the river.

West of the LIDAR scan extension cracks propagated through a one-story concrete block structure resulting in greater than 0.5 m of relative wall displacement. Evidence of surface cracking was observed in the field to the west of this structure, generally oriented parallel to the river. Large road patches were also observed to the west along the river frontage road, likely repairs of lateral spreading. The extent of observable ground cracking to the west was within 100 m of the LIDAR scan.
