# Earthquake Damages and Disaster Prevention of Aboveground Storage Tanks

Shoichi Yoshida<sup>a,\*</sup>

<sup>a</sup>High Pressure Institute of Japan, Tokyo, Japan. Email:k3syoshidas@tea.odn.ne.jp

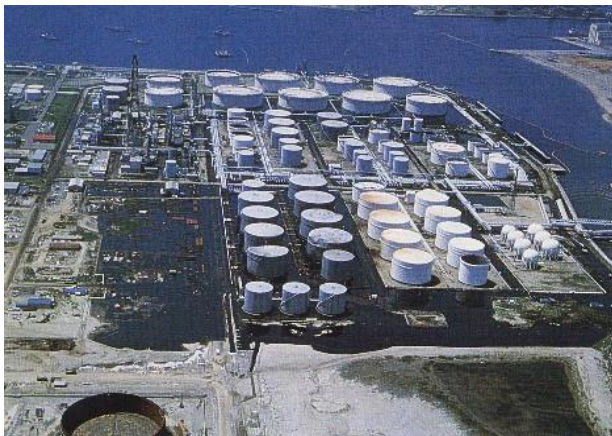
A refinery of Tohoku Oil, Inc. was located near Sendai. An uplifting occurred at the sidewall-to-bottom joints in three large fixed roof tanks due to the high frequency earthquake in this refinery. Two of them had the same size and stored heavy fuel oil. Their diameter was 43.6 m, the height was 21.9 m, the nominal capacity was 31,500 m<sup>3</sup>, the sidewall thickness of the lowest course was 19 mm and the annular plate thickness was 9 mm. The other tank stored diesel oil and the diameter was 37.8 m, the height was 21.9 m, the nominal capacity was 23,700 m<sup>3</sup>, the sidewall thickness of the lowest course was 16 mm and the annular plate thickness was 8 mm.

The uplifting caused large plastic strain in the sidewall-to-bottom fillet weld. The fracture started at the toe of the fillet weld, and it led to catastrophic tank failure. The three tanks lost their contents which then spilled over a dike, inundated much of the refinery area and spilled into the port. Black area in Fig. 9 shows the spilled oil. Fortunately, no fire broke out.

Figure 9. Spilled oil inundated a refinery area in Sendai at the 1978 Miyagi Earthquake (Courtesy of Kahoku Simpo Publishing Co.)

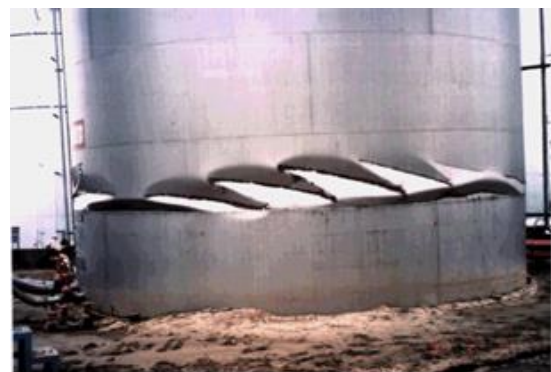
The high Frequency earthquake was predominant in Kobe, because the epicenter was near. The buckling of sidewalls in small ASTs occurred due to the rocking motion in Kobe. Figure 10 shows the diamond-shape buckle, and Figure 11 shows the elephant foot bulge of the sidewall in ASTs. The soil liquefaction also occurred everywhere in Kobe. Small ASTs were inclined by the soil liquefaction as shown in Fig. 12. Although a leak occurred in a water storage tank and many resident houses were burned, no oil leak and no fire occurred in ASTs.

Figure 10. Diamond-shape buckle of a sidewall in a small AST in Kobe at the 1995 Kobe Earthquake (Courtesy of National Research Institute of Fire and Disaster, Japan)

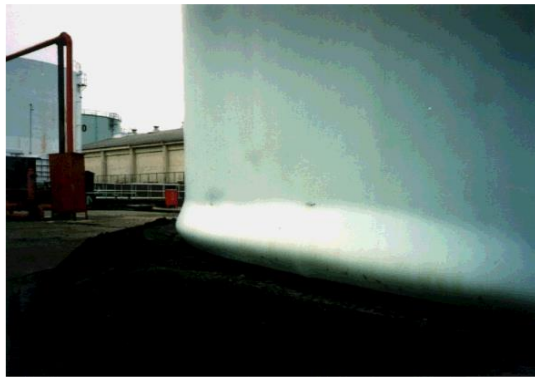
Figure 11. Elephant foot bulge of a sidewall in a small AST in Kobe at the 1995 Kobe Earthquake (Courtesy of National Research Institute of Fire and Disaster, Japan)

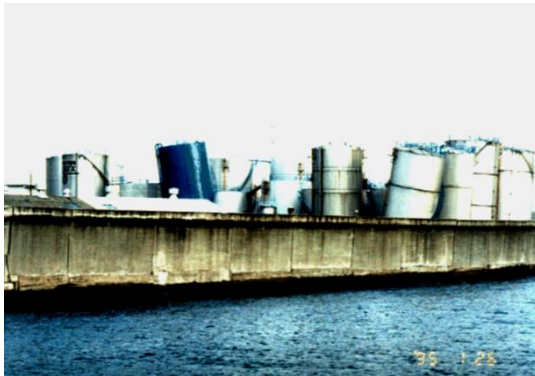
Figure 12. Inclination of small ASTs due to the soil liquefaction in Kobe at the 1995 Kobe Earthquake (Courtesy of National Research Institute of Fire and Disaster, Japan)

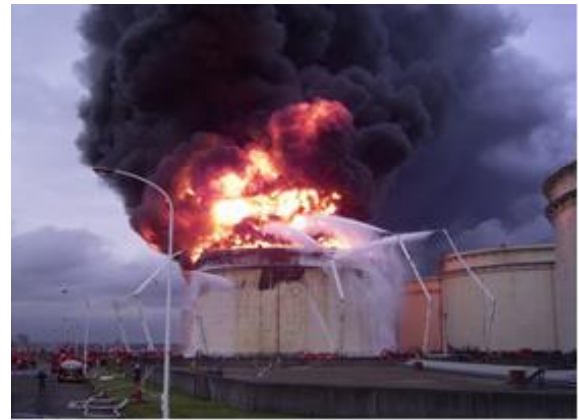
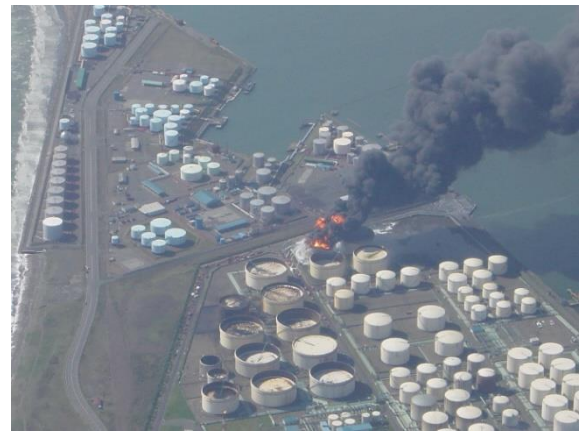
There was another external single-deck floating roof tank with 30,000 m<sup>3</sup> naphtha storage near the crude oil tank at the same site. The tank size was the same as the crude oil tank. The floating roof was ruptured due to the sloshing, and it sank into oil completely one day after the earthquake. A full surface fire broke out in this tank two days after the

Figure 13. Full surface fire in a 30,000m<sup>3</sup> naphtha storage tank in Tomakomai at the 2003 Hokkaido Earthquake (Courtesy of National Research Institute of Fire and Disaster, Japan)

Figure 14. Aerial photo of full surface fire in a 30,000m<sup>3</sup> naphtha storage tank in Tomakomai at the 2003 Hokkaido Earthquake (Courtesy of National Research Institute of Fire and Disaster, Japan)

earthquake, and continued 44 hours [1]. The fire was extinguished when naphtha burned out. The cause of ignition was unknown. Both Figure 13 and Figure 14 show this full surface fire.

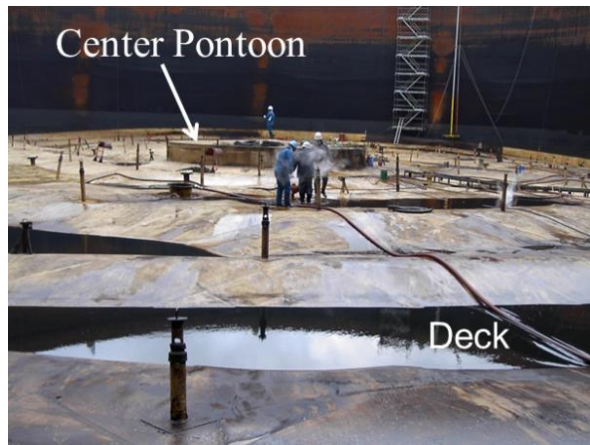
Other 6 ASTs had experienced sinking failures of single-deck floating roofs in this refinery. The pontoons and the deck plates were ruptured, and the floating roofs lost buoyancy due to the sloshing. The roofs sank into oil slowly taking several days. Figure 15 and Figure 16 show the sunken floating roof of an AST with 100,000 m<sup>3</sup> crude oil storage. These photos were taken several months after the earthquake when the oil was drained from the floating roof and the tank was cleaned. The large deformation and failure of the floating roof is presumed to be caused during the sinking process. This roof remained afloat without collapse for 1.5 days after the earthquake according to aerial photos.

Figure 15. Deck plate of a sunk single-deck floating roof of a 100,000 m<sup>3</sup> crude oil storage tank at the 2003 Hokkaido Earthquake

Though floating roofs had been designed under the load of rain water, snow and buoyancy, the earthquake sloshing had not been taken into consideration. This full surface fire and the sinking failures led to an establishment of the seismic design method of floating roofs. The regulation for

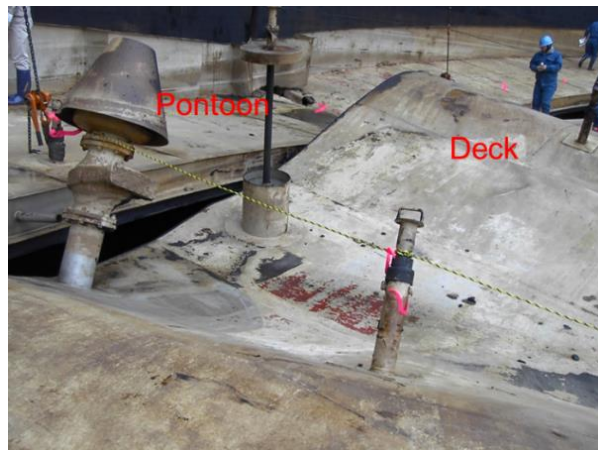
Figure 16. Deck plate and pontoon of a sunk single-deck floating roof of a 100,000 m<sup>3</sup> crude oil storage tank at the 2003 Hokkaido Earthquake

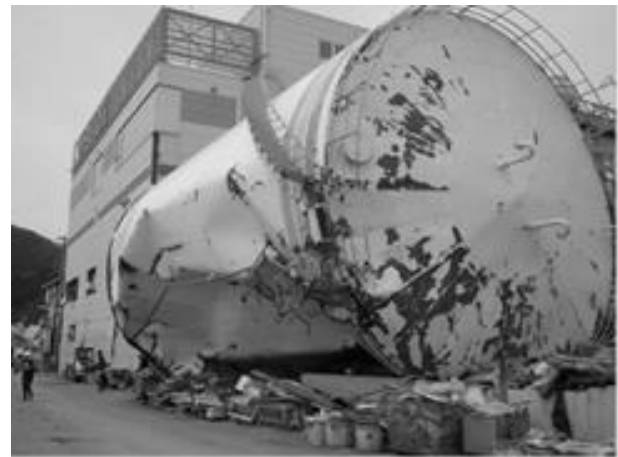
There are many fishing ports along the coastline of northeast Honshu Island. Several small ASTs were installed at the fishing ports. The ASTs had stored the fuel for fishing boats. Tsunami moved the tanks and overturned them. Some of them sank to sea. Leaked oil from ASTs made massive

Figure 17. AST moved to higher ground and overturned by the tsunami at the 2011 Great East Japan Earthquake (Courtesy of National Research Institute of Fire and Disaster, Japan)

fire. Figure 17 shows an AST moved to higher ground and overturned by the tsunami.

From the Great East Japan Earthquake, countermeasures against tsunami in ASTs also became an important issue. It is not realistic to make individual ASTs resistant to tsunamis. If possible, it is desirable to transfer ASTs to a high place not subject to the tsunami or a place far from the coast. However, when it cannot be done, it is necessary to think in the framework of disaster prevention measures for the entire local area or the AST base.
