Role of Flow Simulation as A Tool for Failure Analysis Induced By Sulfate-Reducing Bacteria

Abstract

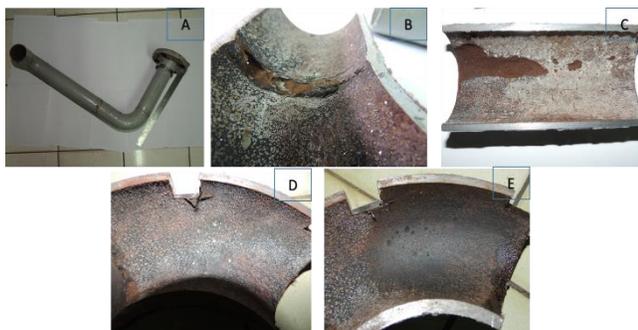
Figure 1. (a) Visual condition of the corroded tubing, (b) section of failed tubing, (c) corrosion at the weldment and straight pipe, (d) condition of the elbow pipe before cleaning, and (e) pit revealed after cleaning

The first step in the examination is a visual examination. As the received sample is a part of tubing pipe that consists of tee pipe, straight pipe, and elbow pipe. (Fig. 2A) The leakage is found near welding area. After internal observation, the leakage was initiated from internal of the pipe (Fig. 2B). It propagated at HAZ area through the welding area. In the internal tubing, a white layer covered the tubing. (Fig. 2C) The denser white layer area is always found together with the corrosion attack at the adjacent area. The exciting findings are the pitting that is found precisely below the white layer. It is revealed after the removing of the white layer (Figs. 1D and 1E). Moreover, if we make a comparison between the elbow and straight pipe, it is found that the elbow had less density of white scale if compared with straight pipe (Figs. 1C and D).

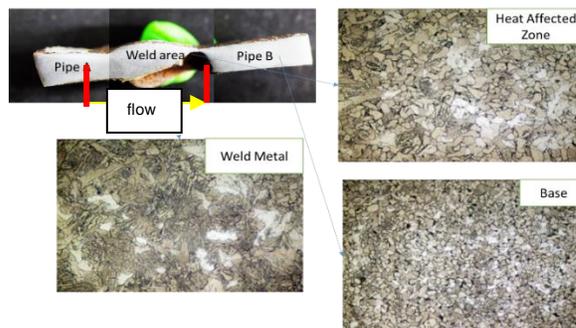
The microstructure of base metal consists of pearlite and ferrite. Based on Fig. 2, corrosion propagated from weld and Heat Affected Zone (HAZ) area. Fig 2. showed leak located at the HAZ 1 while HAZ 2 is in normal condition. It showed the area after the welding cap is a “dead zone area.” At this area, the velocity will lower than the other area. This phenomena is the effect of vortex zone area. The leak formed a shallow pit which is indication effect of flow.

Figure 2. Microstructure of weld area that was attacked by SRB corrosion

However, our result showed the different result with Sreekumari et al. We found that the microstructure of weldment did not give a significant effect on microbial induced corrosion as shown in Fig. 3. We concluded that the microbial induced corrosion was more affected by the flow pattern in the weldment than the microstructure.

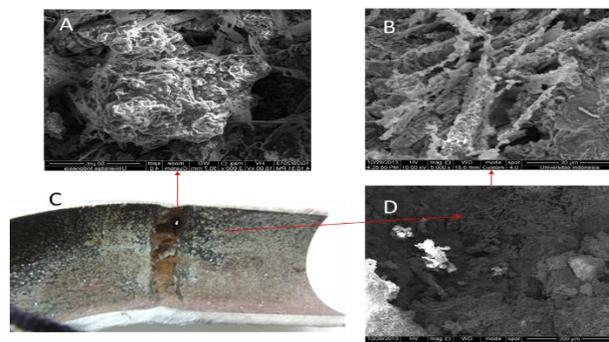
Scanning Electron Microscope (SEM) examination was performed at leak area. The results showed microbial activities, indicated by the presence of tubercle and extra polymeric substance (EPS). EPS could accelerate corrosion by binding with metal ions or accelerate iron oxidizing [11]. This EPS will be easier to form in the low velocity area. Fig. 1C showed that the white area consisted of EPS and the colony. The white area covered area around the pit area.

Energy dispersive spectroscopy (EDS) was performed to analyze chemical composition of the Extra Polymeric Substance (EPS). Based on the result, the EPS consisted of Sulphur, carbon, oxygen, and iron. It indicated the activity of bacterial. Calcium and Natrium are not detected in this area. It conforms that the white layer is not a salt precipitation or carbonate scale. On the other hand, the black scale area consists of carbon, oxygen, and iron with small percentage of Sulphur. It showed the black area is an oxide area which did not have any bacterial growth.

Figure 3. Scanning electron microscope (SEM) analysis at leak position (C) showed Extra Polymeric Substance threads with (B and D) that bind the colony (A)

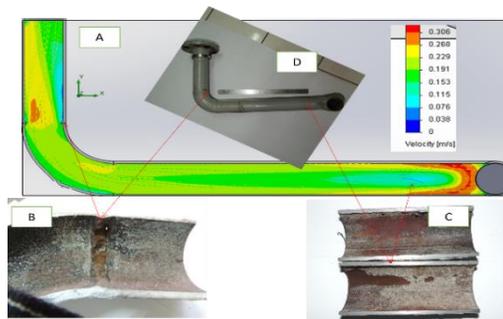
Based on the simulation result, it can be seen that the Sulphate Reducing Bacterial (SRB) spread widely around the areas that affected by the vortices especially at the center of the vortices, where the velocity is very low.

The reason of occurrence of such mechanisms is the stability of the Sulphate Reducing Bacterial growth rate. The Simulation results also showed that both of these areas had a flow rate below 0.5 m/s. The value is quite ideal for the growth of bacteria.

Figure 4. Simulation result showed similar result with the failure area
