Research Paper

Uplift of very sensitive soft clay due to pile driving

W. Teeparaksa¹ and J. Teeparaksa²

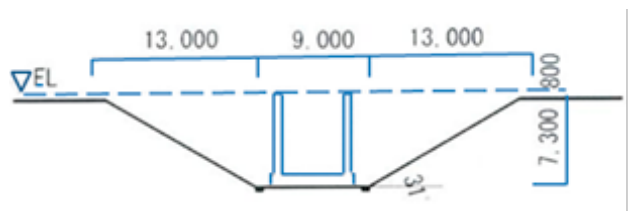
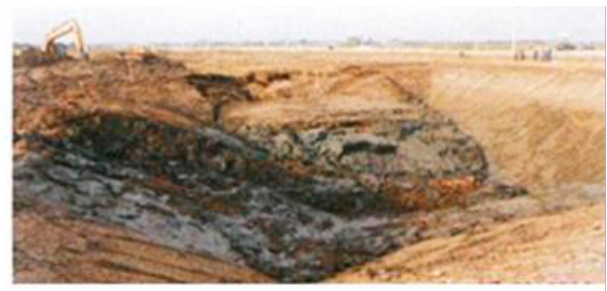
Fig. 2. Trial excavation work.

The building of this factory project was designed by using I-shape driven pre-stressed concrete piles as a pile foundation to support the columns, floor slabs and press pits structures. The pile capacity and layout was designed based on soil investigation. There were many driven piles in the project. Since the soil conditions consists of thick very sensitive soft clay of about 12 m, before starting the construction of press pit, the trail open excavation was carried out on April 2014 to verify the possibility of open excavation as shown in Fig. 2. There was no ground water during excavation. The result of excavation showed the collapse of excavation slope and the soil was flow as also shown in Fig 2.

Due to the collapse during open excavation as shown in **Fig. 2**, it can be seen that the trial open excavation was very dangerous to construct the press pit. Therefore, in order to avoid any possible risks, the sheet pile braced excavation method was preferred as a soil protection system instead of open excavation method. Generally, during excavation by sheet pile braced cut system in the very soft sensitive clay, the pile deviation and pile crack normally occur both inside and outside of the pit. Thus, the contractor proposed the excavation method by sheet pile bracing system without pile installation outside of the sheet pile wall as shown in **Fig 3 and 4**. There were, in total three steel bracing layers at the level of -2.0 m., -3.45 m. and -5.05 m. from the ground surface level. Sheet pile was 18 m. long. In addition, the contractor proposed the pile driven sequence into 3 phases as well as construction of press pit as shown in **Fig. 5** with detailed as follows:

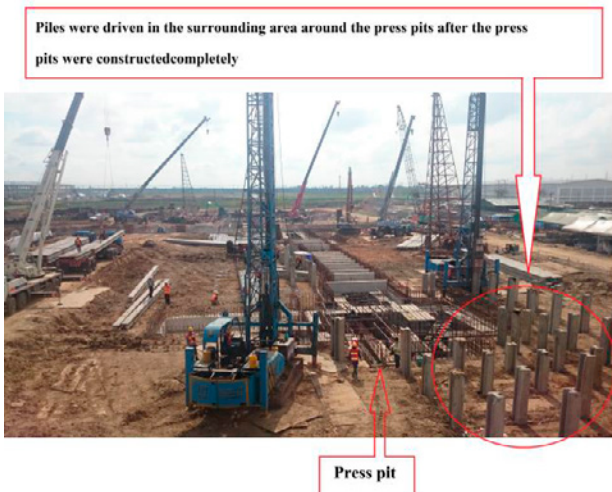
Fig. 6. Piles driven in the surrounding area of the press pit.

Zone3: After completion of press pit structure and piling in zone 1, the piles surrounding the press pits were driven as shown in **Fig. 6**. The piling in zone3 was carried out between November to December 2014. After completion of piling in zone3, the uplifts of press pits were observed. The uplift of the press pit is the unforeseen behavior.

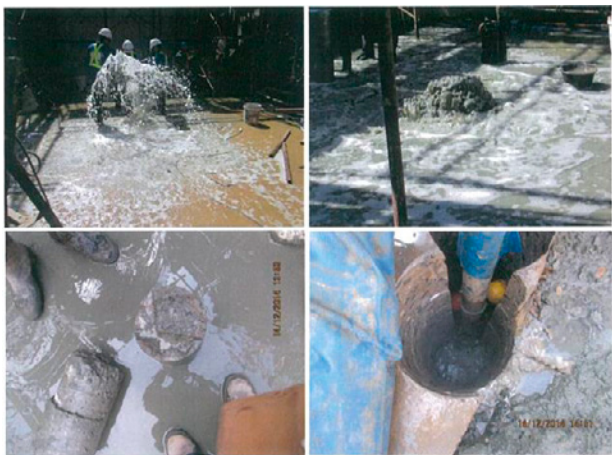
Fig. 7. Concrete coring at location 1.

At location1: After coring of base slab, water flow up was found and pile head was separated from base slab. The water flow was stopped after 30 minutes as shown in **Fig 7**.

The water flow up at location 1 was strong and had high pressure because it was the first coring hole and uplift pressure beneath the base slab was still very high. For location 2, the water flow was less than location 1 because the uplift pressure was already partly relieved. At location 3, the coring was about 3 days later from execution at location 1 and location 2. There was no uplift water pressure

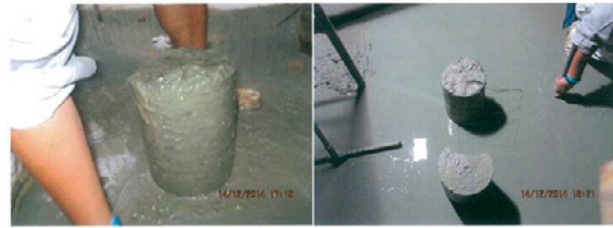
Fig. 8 . Concrete coring at location 2.

At location2: The concrete coring was pushed up to about 30 cm. by the uplift pressure and the flowing of water was stopped after 10 minutes. The pile head was not separated from base slab as shown in **Fig. 8**.

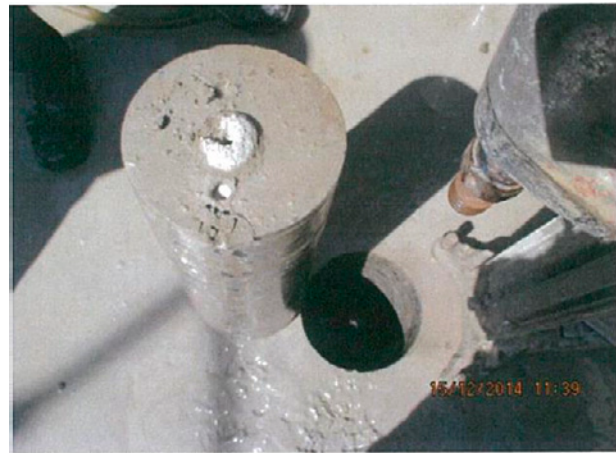
Fig. 9. Concrete coring at location 3.

At location 3: After coring concrete of base slab, no water flow was found and pile head was not separated from base slab as shown in **Fig. 9**.

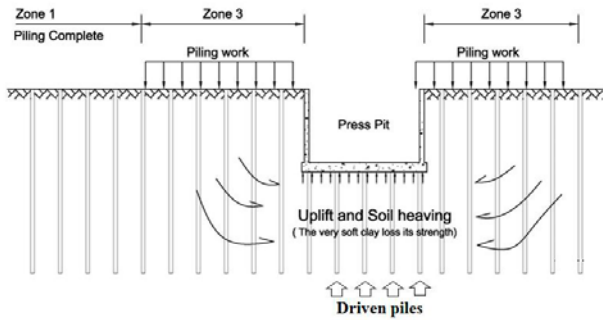
Fig. 10. The uplift and soil heaving at press pit area.

The piling work induces the excess pore pressure in the very soft clay layer. The 12 m. thick very soft clay in this project is very sensitive clay with very high water content of 109-158%. Driving of pile would strongly compress soil, and would lead to a buildup of excess pore water pressure. The soil pressure from piling work also induced soil heaving. As the very soft clay located at the first layer (0-12 m.) was the very sensitive clay, the vibration due to pile driving in surrounding area of press pit (zone 3) created disturbance to very soft clay and led to a reduction or loss of the shear strength of the very soft clay. This also promoted reduction in pile capacity. Decrease in friction capacity induced by soil disturbance was well observed and studied; for example, Bozozuk et al. (1978). This decrease would recover with time (Broms, 1981). In addition, the detail regarding the vibration due to pile driving can be learnt more in Design of Structures and Foundation for Vibration Machine by Arya et al. (1979). The excess pore pressure, loss of shear strength as well as soil heaving created uplift at the press pit area because the overburden pressure at press pit area was lower than the surrounding area as presented in **Fig. 10**.
