## GEOTECHNICAL ASPECTS OF THE DESIGN AND BEHAVIOUR OF THE HIGHWAY BRIDGE OVER DRADER RIVER IN MAROCCO

**ABSTRACT:** The motorway bridge on the Drader River suffered from severe floods, which occurred during its construction in 1995-1996. At this site, 8 m thick compressible soft clays layers were found during the site investigations and piled abutments were designed. During the flood, due to erosion of the riverbed under the bridge, the piled abutments were displaced and came in contact with the bridge deck. The access embankments were taken away and a new project was established for the abutments and embankments. L-shaped retaining walls prevent any contact between the fill and the abutments and hollow concrete tubes were placed in the fill in order to reduce the load applied to the ground surface.

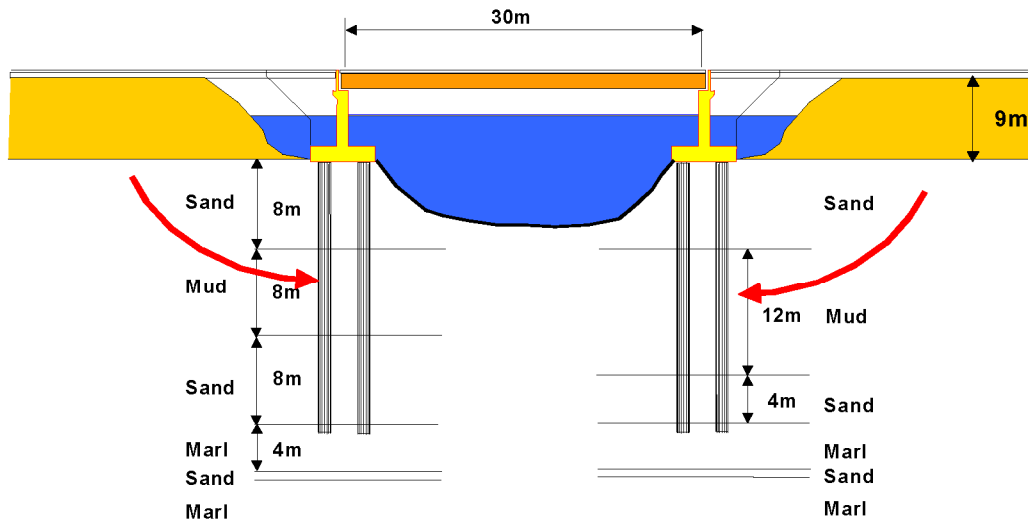
During the floods of January 1996, the estimated flow under the bridge was about 175 m<sup>3</sup>/s, which corresponds to a mean water level of 3.82 m NGM under the bridge and a mean speed of water of 1.89 m/s. The maximum water speed could reach 2.3 m/s, with a mean deepening of the unprotected river bed by at least 4 m.

- horizontal movement of the abutment towards the river : 2 to 5 cm;
- fissuration of the abutment walls;
- distortion of the bearings by about 40 mm;
- residual deepening of the riverbed of about 4 m, due to scour;
- erosion and failure of the access embankments next to the abutments.

Fig. 6 Longitudinal section of the bridge after the flood and river bed scouring

The best and maybe only way of controlling the horizontal movements of the existing abutments consisted in limiting the pressures on the retaining wall (front wall) and on the piles. This was obtained by two measures:

- the construction of an additional retaining wall behind the abutment, which will suppress any contact between the embankment and the abutment;
- the replacement of the standard fill material by a lighter one.

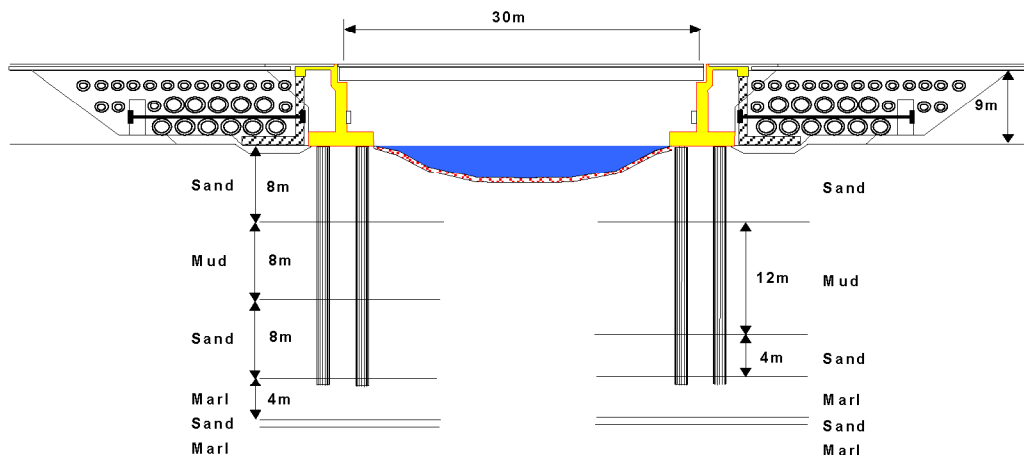
Fig. 7 Longitudinal section of the bridge over the Drader river after the repair works

Since the construction works had been interrupted and the completion of the motorway had to be achieved as soon as possible, it was felt that the availability of concrete pipes made this solution the most adequate one. Two types of pipes, 1.6 m and 1.0 m in diameter, were selected and placed in three layers on both sides of each bridge (Fig. 7). The mean weight density of the embankments was thus decreased by 22%. The lower pipes were kept

open, in order to facilitate the flow of water during the floods, whereas the pipes of the upper two layers were closed by means of concrete plugs. Two views of the completed embankment are presented in Figs. 8 and 9.

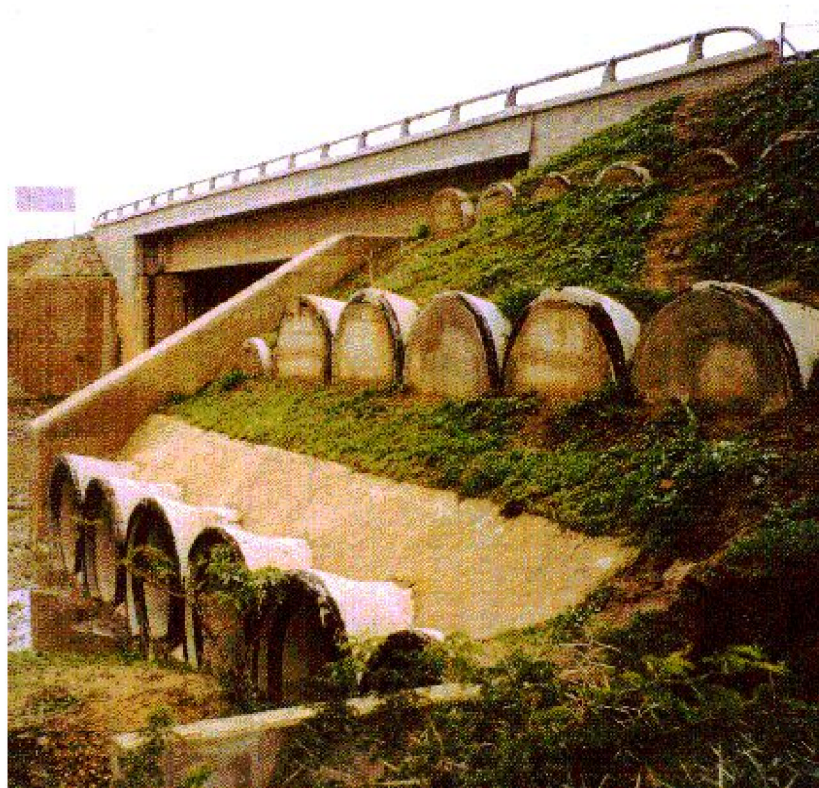
Fig. 9 View of the three rows of concrete pipes aimed at decreasing the weight of the access embankments of the bridge over the Drader river

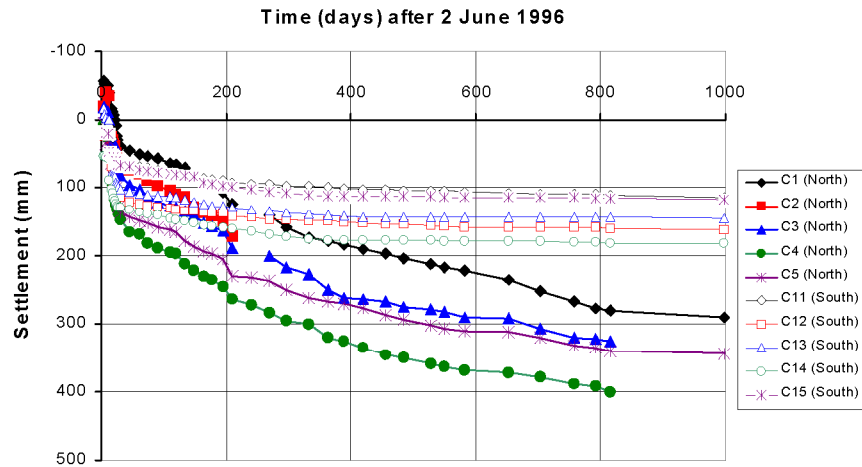
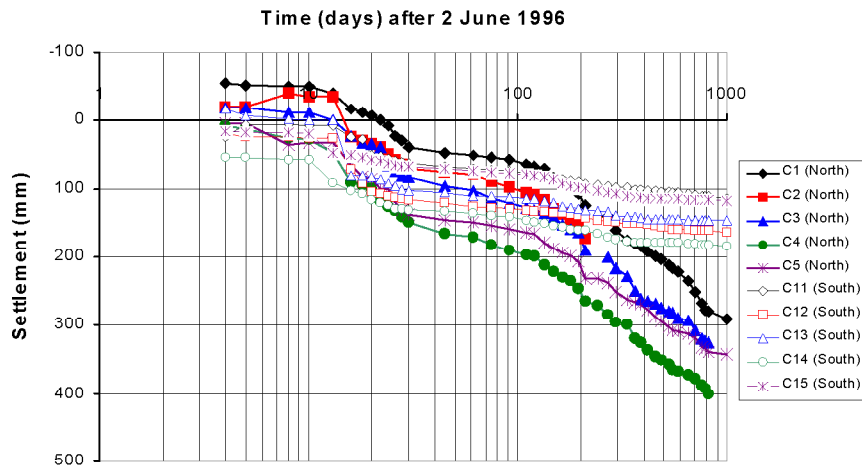
The settlements measured at the natural ground surface under the embankments are presented in Figs. 11 (linear time scale) and 12 (logarithmic time scale). The settlements of the left bank embankments (C11-C15) are clearly lower than those of the right bank (C1-C5) and the consolidation period was much shorter, too. The quasi stabilisation of settlements on the left bank agreed with the data obtained from the site investigations (less compressible soils). Therefore the settlements of the left bank access embankments did not receive further attention.

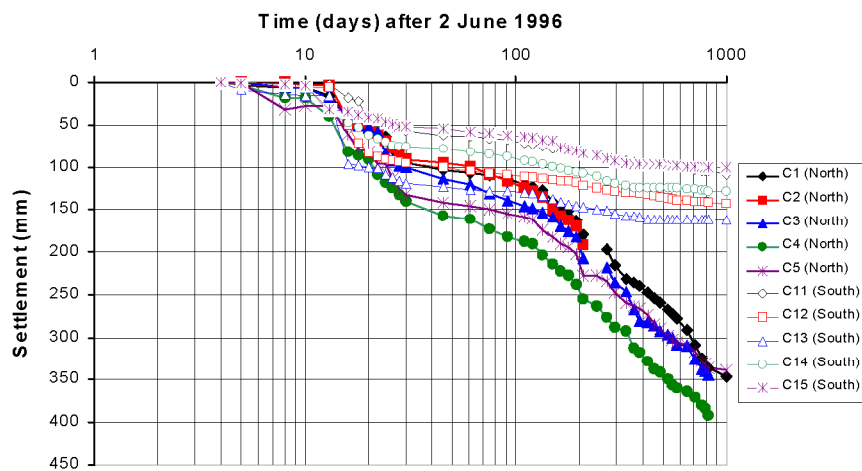
Fig. 13 Settlement versus logarithm of time (corrected values, all equal to zero for  $t=4d$ )

showed some scatter, which might come from the installation of the pipes and of the fill next to the settlement probes. In Fig. 13, the curves are referred to a common initial state (zero settlement) on the 6<sup>th</sup> of June (the pavement was completed three weeks later). The linearity of the curves shows that primary consolidation still did not come to its end. Besides, the settlements observed in the zone where more pipes were placed (between the L-shaped wall and the deadman wall) are lower than in the intermediate zone (C4, C5).

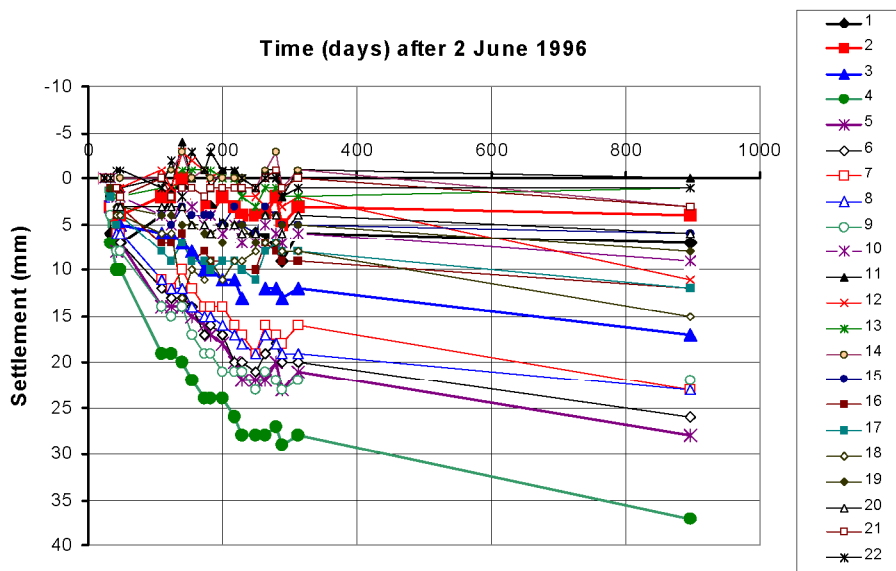
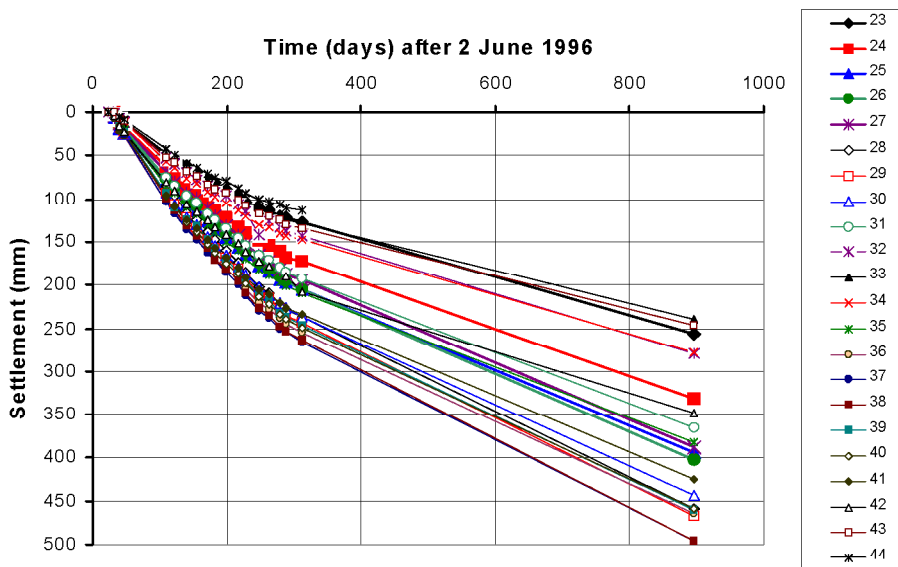
The surface settlements of the motorway are clearly different from one side of the river to the other. On the left (Southern) bank, they are all less than 4 cm. This confirms the conclusions drawn from settlement probes installed under the embankments (Figs. 11 to 13).

On the right (Northern) side of the river, the settlements vary from 25 to 50 cm and are still not stabilised. The large scatter of the curves of Figure 15 can be further analysed if the position of the points is taken into account. This was done in Figs. 16 to 18:

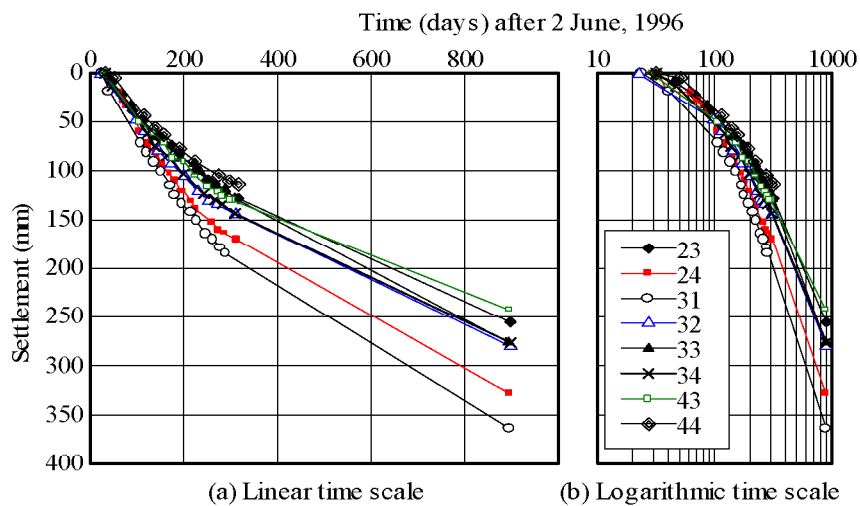
- next to the abutments, in the zone with the lowest loading (Fig. 16), the settlements vary from 25 to 35 cm and are similar to those of Fig. 13;
- behind the deadman wall, in the transition zone from the lighter embankment to the normal one, the settlements range from 35 to 45 cm (Fig. 17);
- away from the bridge, they vary from 40 to 50 cm (Fig. 18).

Fig. 16 Settlements measured in the zone of lowest loading (Right/Northern bank)

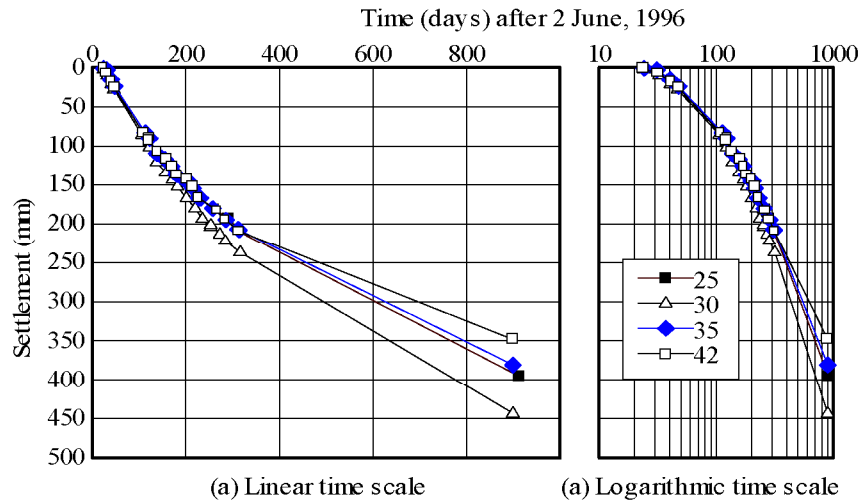
Fig. 17 Settlements measured in the zone of intermediate loading (Right/Northern bank)

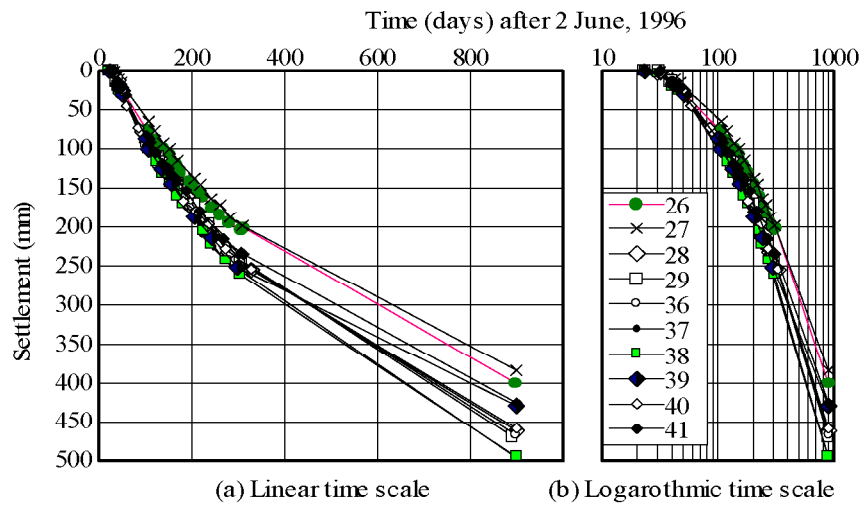
Fig. 18 Settlements measured under the initial embankment (no pipes) (Right/Northern bank)

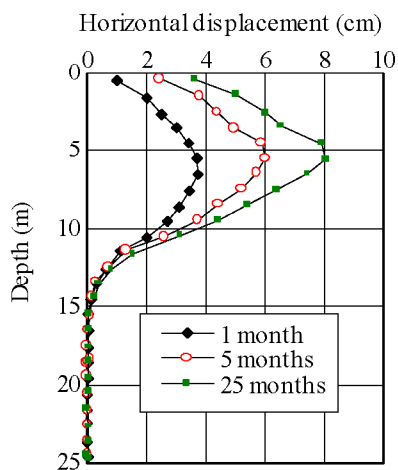
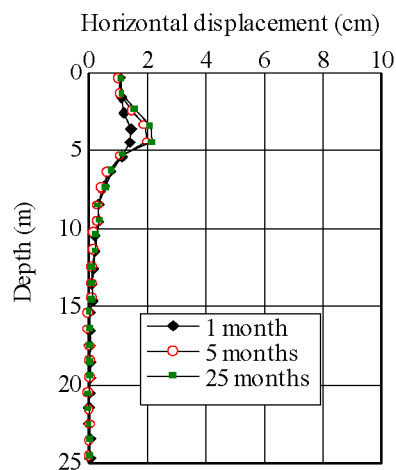
The horizontal movements of the ground on both sides of the river, as measured in the two inclinometric tubes TI1 (Left/Southern bank) and TI2 (Right/Northern bank), are shown in Figs. 19 and 20. The movements are not parallel to the bridge but perpendicular to the riverside (Fig. 10). The maximum horizontal movement was observed at a depth of 5.5 m on the right bank (8 cm) and 4 m on the left bank (2.2 cm). Much of the movement occurred during the construction period (3.5 cm and 1.5 cm, respectively). During the next four months, the horizontal displacement amounted to 2.5 cm (0.5 cm), whereas the corresponding settlement of the embankment was in the range 7-10 cm (1-1.5 cm) (Figs. 15 and 14, respectively). The ratio of the horizontal to the vertical displacements was thus close to 30% during that four months period. During the following 21 months (until August 1998),

the maximum horizontal displacement was equal to 2 cm (0.2 cm) and the settlement to 20 cm (3 cm). The ratio of horizontal to vertical displacements was therefore lower (10% or even less for the left side of the river). Over the 1000 days elapsed from the beginning of the construction period, this ratio is close to 20%. For embankments built on soft soils (Leroueil et al., 1990), the ratio of horizontal to vertical movements is usually close to 17% but the present layering slightly differs from the usual one because of the existence of a thick layer of sand below the ground surface, on top of the soft soils. Besides, the erosion of the riverbed during the floods may have influenced the state of the foundation soils next to it.

Another important information obtained from the inclinometric measurements is the depth of the lower limit of the more compressible soils: 12-15 m on the right bank and 7-8 m on the left bank. This confirms the conclusions of the geotechnical site investigations.
