Research Paper

Geomorphic approach of controlling mass movements on Tama Koshi road in Central Nepal

M.R. Dhital

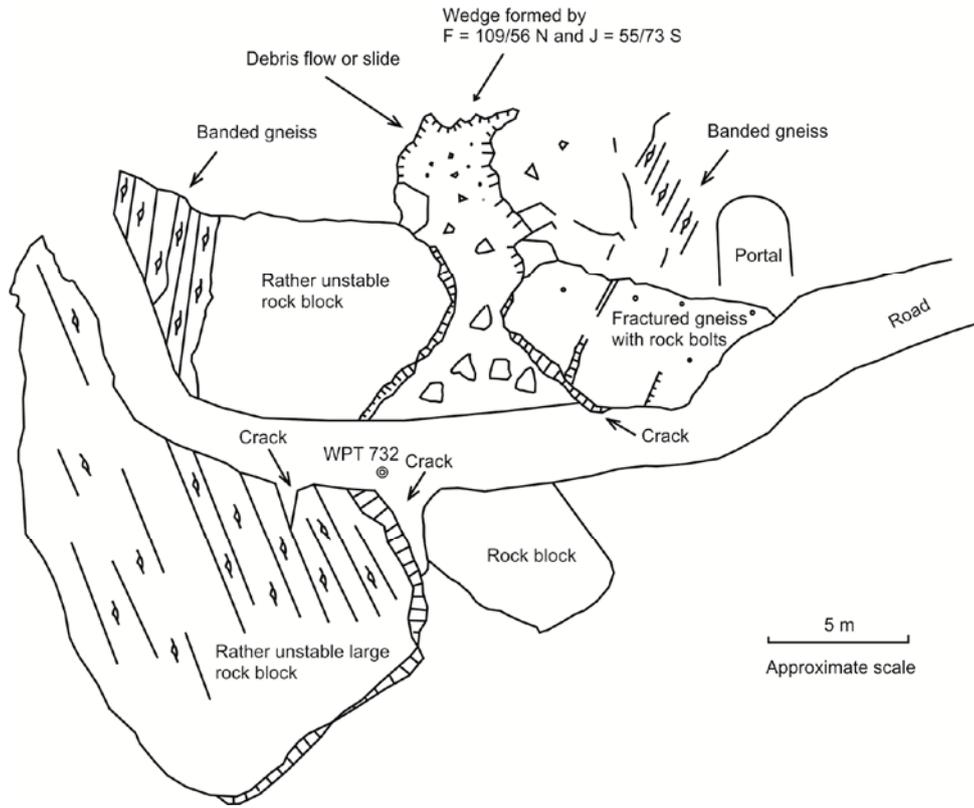
The wedge slide lies about 10 m south of the tunnel portal of the Upper Tama Koshi Hydroelectric Project, at an altitude of about 1960 m. It begins about 30 m above the road and continues for about 100 m below the road. The bedrock is represented by grey kyanite-garnet gneiss. It is moderately to highly weathered and the joint surfaces are wide open. The foliation and joints have formed a number of wedges. Debris slide and flow took place along a large wedge formed by the foliation (F: strike/dip = 109/56 N) and a joint set (J = 55/73 S). **Figure 2** gives the main features of the failure whereas **Fig. 3** depicts a general view of the slide. The wedge slide, cracks, and debris are shown in **Figs. 3 and 4**. At the crown of the portal, grey banded gneiss with pink garnets and kyanite is exposed. The orientation of foliation (F) = 123 (strike)/64 (angle of dip) N (dip

Fig. 2. Sketch of the wedge slide No. 1. Main cracks, large blocks, and wedges are shown.

Since the tunnel portal is located close to the wedge slide, a complete control of the instability and protection of the area surrounding the portal was needed. Similarly, as there is a sharp turn of the road just after the box cut towards the portal and the road is narrow, some widening was needed. For this purpose the following measures were recommended: removal of loose and unstable blocks lying above the road, sealing of cracks with grout or shotcrete, construction of a toe wall and drainage, and widening the road towards the downhill side by making a RCC retaining wall near WPT 732. Also, a seismic survey was also proposed to assess the depth of fractured rock mass.

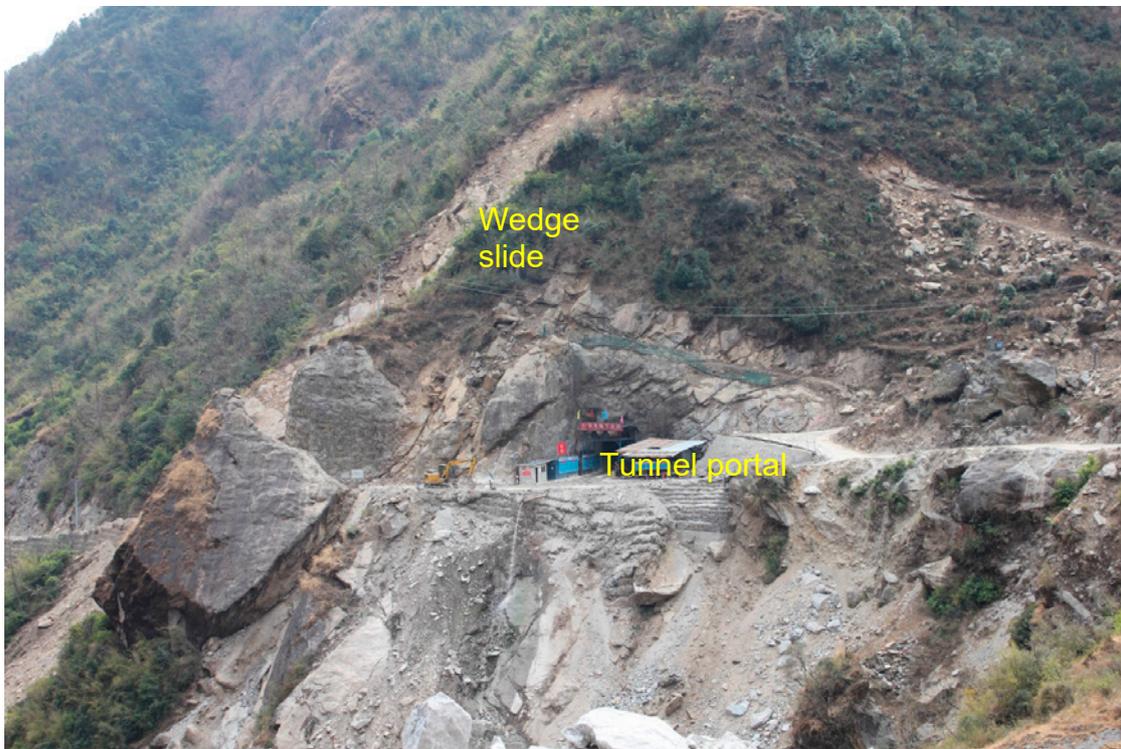
Fig. 3. Wedge failure south of portal at Landslide No. 1. Note a precarious rock block through which the road is constructed by making a box cut. View to SW.

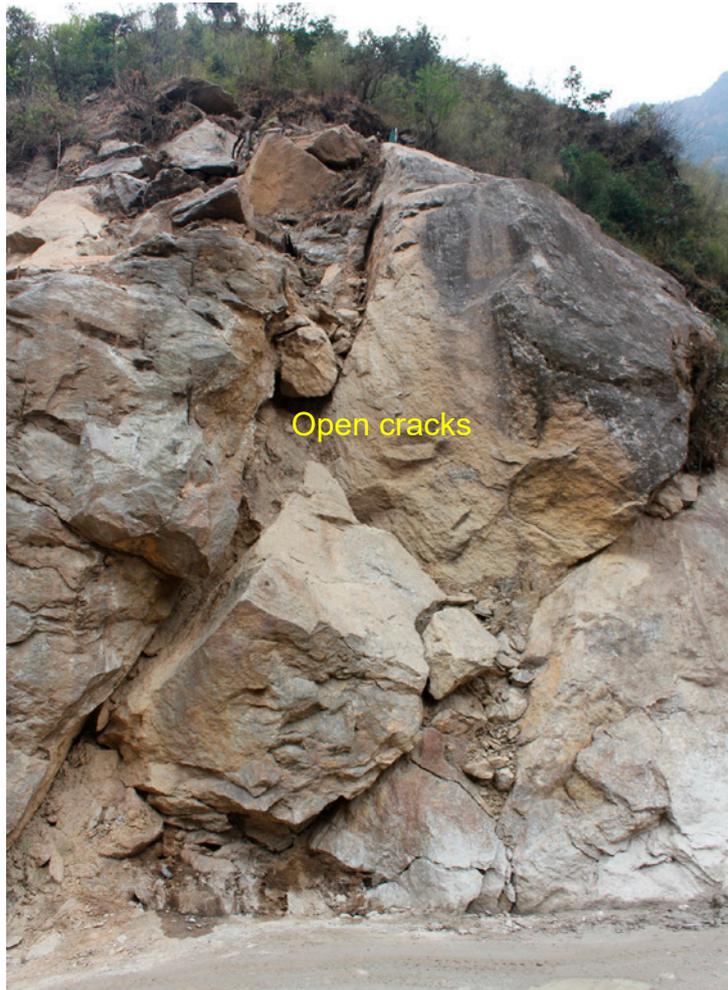
Fig. 4. Open joints forming wedges near tunnel portal.

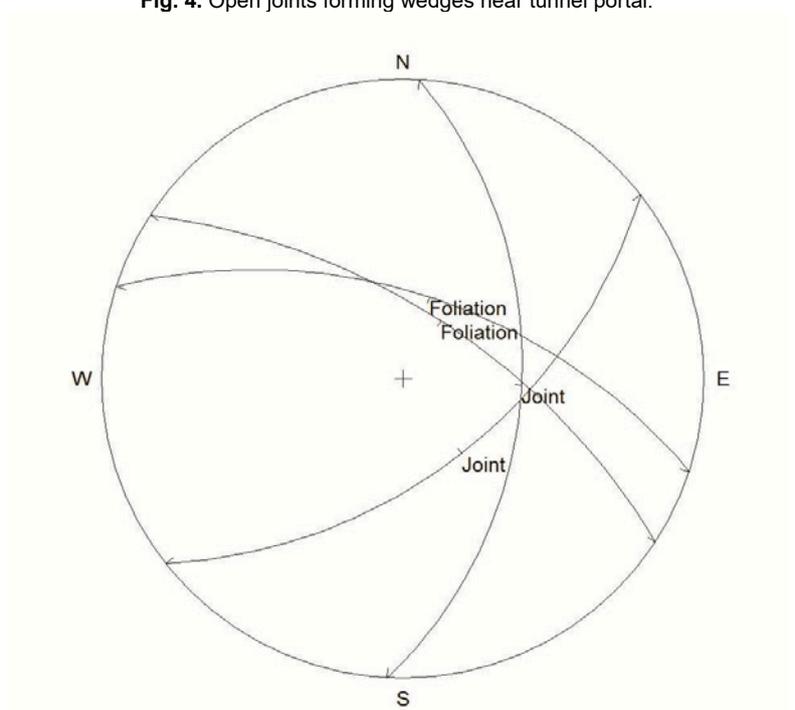
Fig. 5. Stereographic plot of discontinuities near tunnel portal. Lower hemispherical projection.

direction), 108/58 N; Joint (J1) = 52/55 SE, Joint (J2) = 3/47 SE. The stereographic projection of foliation and discontinuities also indicates a wedge failure (**Fig. 5**).

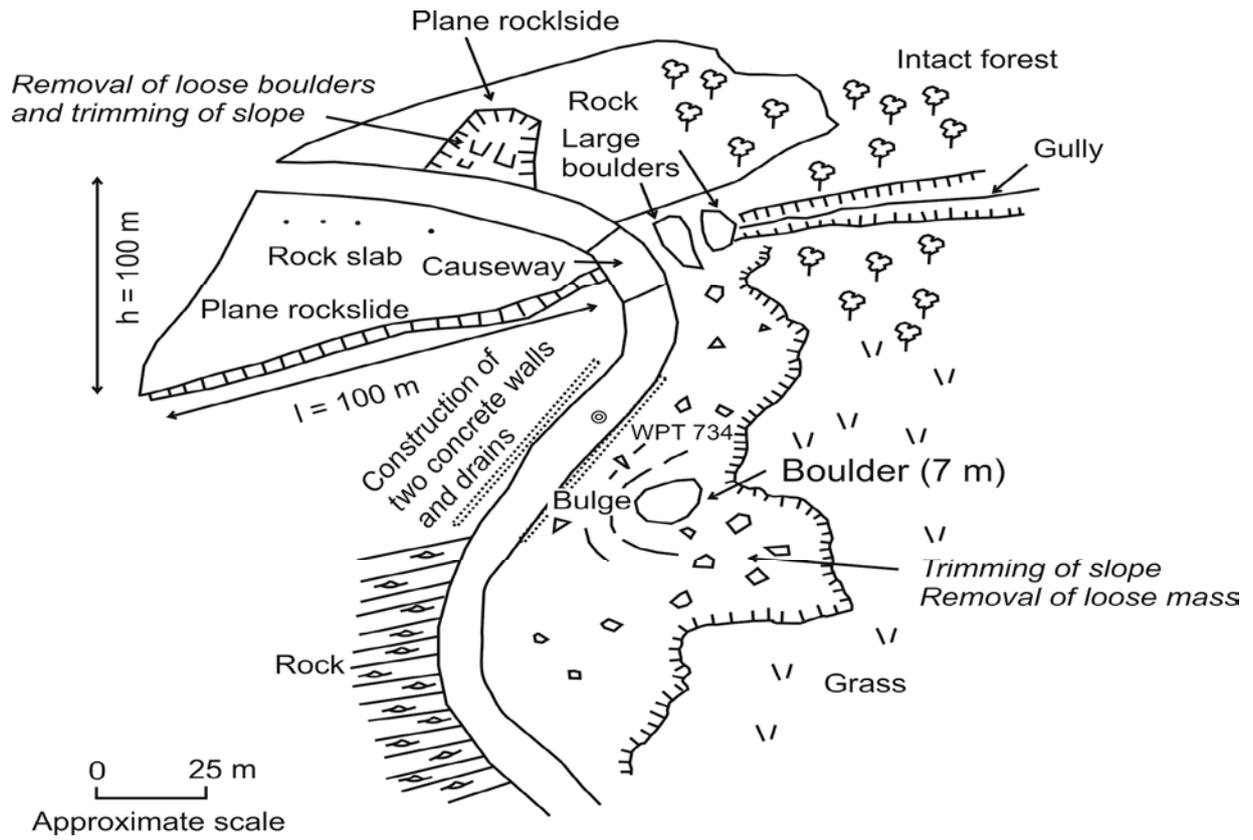
The road crosses a problematic concave bend at Km 58+200 m. This slide occurs at an altitude of about 1850 m, and it blocked frequently the access to Lamabagar during the rainy season. The area is covered by colluvial debris that extends for about 100 m in height and about 75 m in width. The toe of the soil slide is one the road. There is a gully to the south, at the rock and soil interface. **Figures 6 and 7** show the main landslide and unstable boulders in a gully, respectively. Many large gneiss boulders are creeping and partly blocking the gully. The colluvial soil is from 10 m to 15 m deep and resting on rock. The colluvial mass is bulging and contains boulders at the base of the bulge (**Fig. 6**). The trees above the crown are intact. The rock is represented by grey banded gneiss and it is moderately dipping due N ($F = 92/38$ N). To the south end of the concave bend, another minor plane rockslide is noticed.

Fig. 6. The colluvial soil bulge and unstable round around Km 58+200 m.

- Trimming of the slope, removing loose boulders lying above the road on the uphill side.
- Construction of a side drain and careful management of water while diverting below the road.
- Construction of a causeway at the gully crossing.
- Construction of concrete walls below and above the road. The wall height should be about 3 m to 4 m above the road and 5 m to 7 m below the road. The walls should be carefully constructed and they should be founded on rock or a stable ground.
- Partly shifting of the road towards the downhill side on the fill behind the existing concrete wall where there is rock exposed in a few places.
- Removal of debris from the rockslide at the south end of the bend and trimming of the slope.

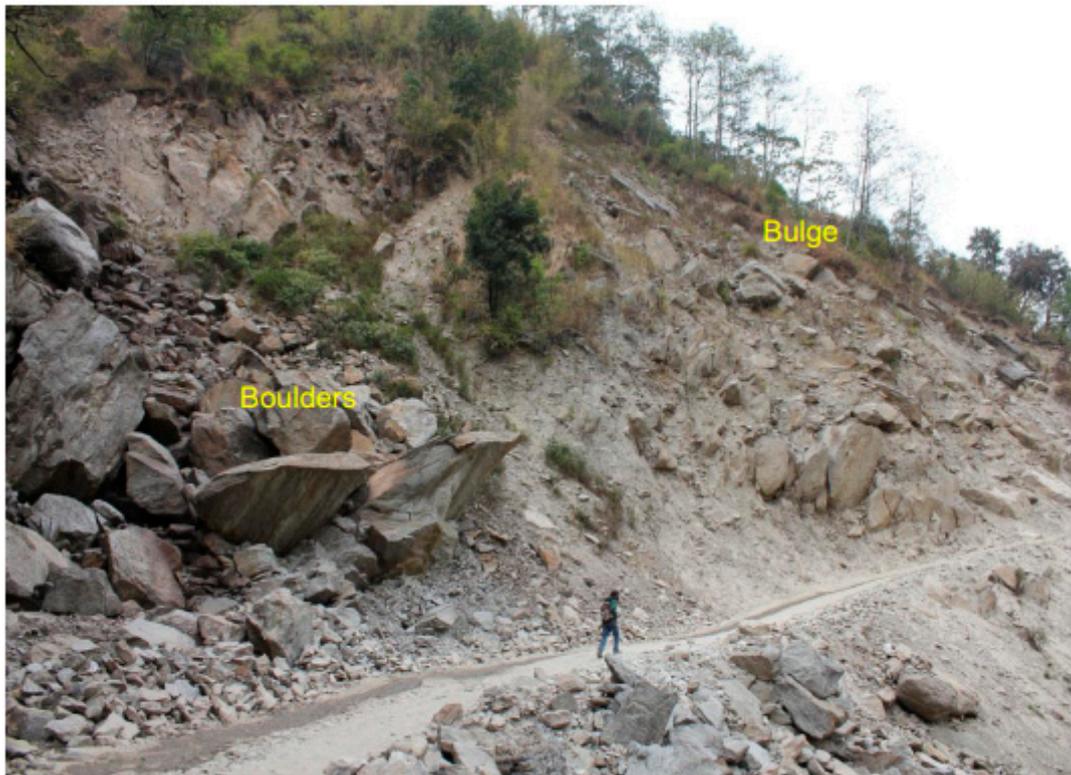
Fig. 7. Large boulders creeping towards the road at Km 58+200 m.

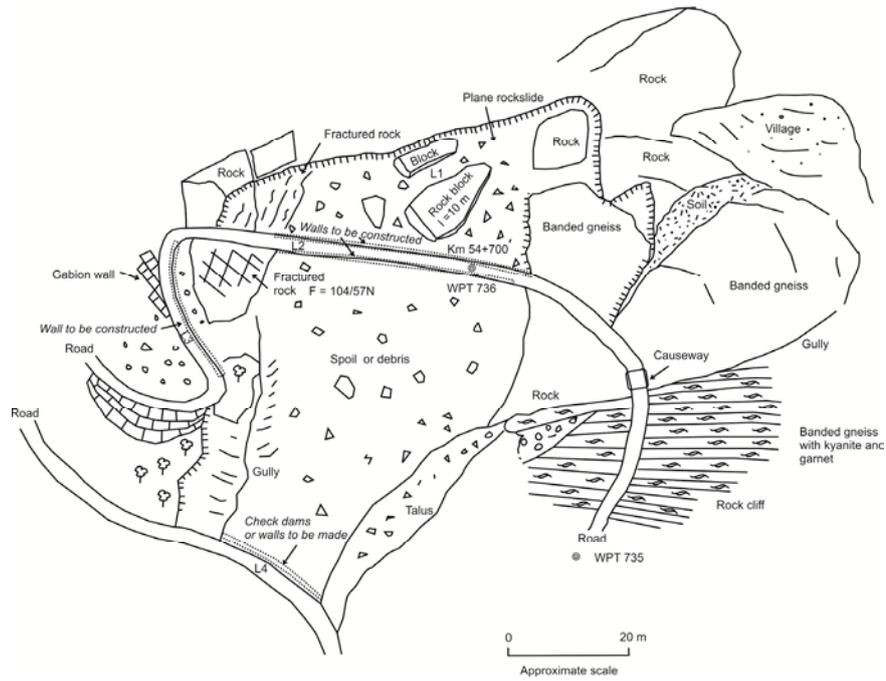
The rockslide in the vicinity of Km 55 is a very complex failure (**Fig. 8**). It obstructed the road from 3 July to 11 August 2012. There is a banded gneiss with kyanite and pink garnets. The rock is moderately to highly weathered and has many wide-open joints and foliation planes with the following attitude: $F = 112/68$ N.

It is a rather complex slide on weathered gneiss. Though most of it is a plane rockslide along the foliation, part of it is also toppled and some wedges are also developed.

Fig. 8. Rockslide in the vicinity of Km 55.

- Removal (if required, by blasting) of large hanging boulders resting above the road (at L1 in **Fig. 8**).
- Trimming the uneven slope above the road and removal of loose debris from there.
- Construction of a concrete retaining wall below the road (at L2 in **Fig. 8**).
- Construction of a side drain and a retaining wall above the road (L2).
- A retaining wall is also needed at the lower S-shaped bend (at L3).
- A few check dams or walls are needed at the end of the bend (at L4) to retain the debris above the road.

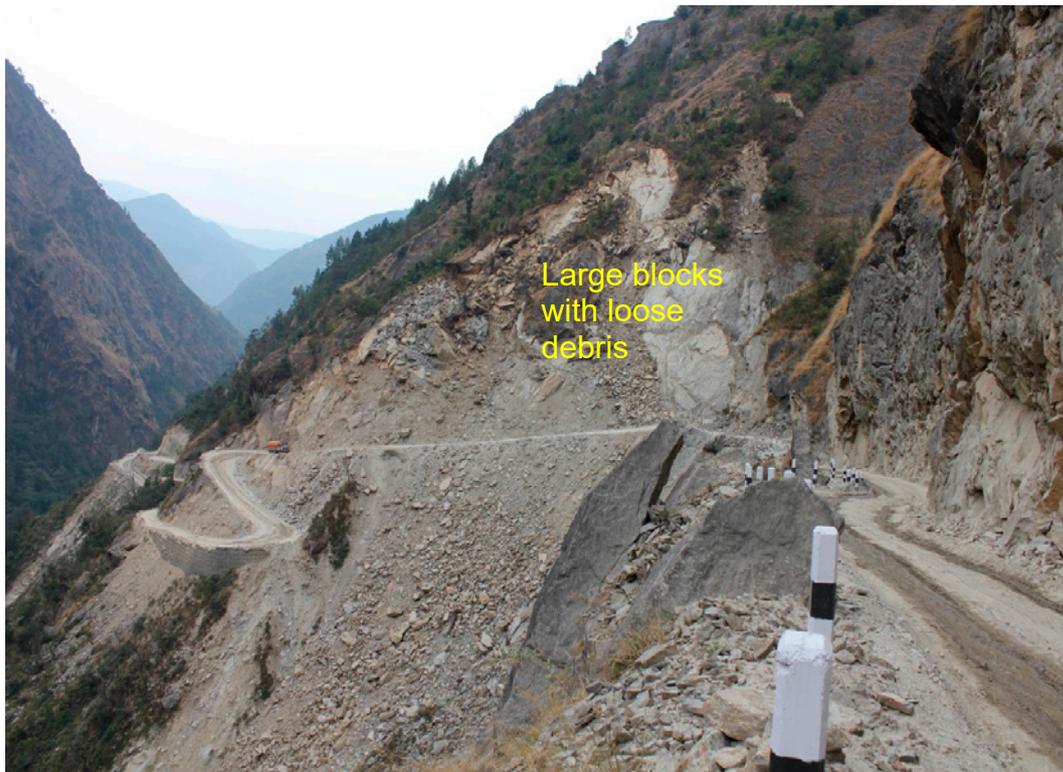
At the plane rockslide area (**Fig. 9**), the hanging boulders of gneiss range in size from 30 cm to 10 m. The debris resting on slopes is loose. Below the road is spoil where the estimated depth of disposal is about 3 m to 5 m. Presumably there is rock below the road where it is covered by the debris.

Fig. 9. View of the plane rockslide from north. Note unstable large blocks above the road and spoil and debris below the road.

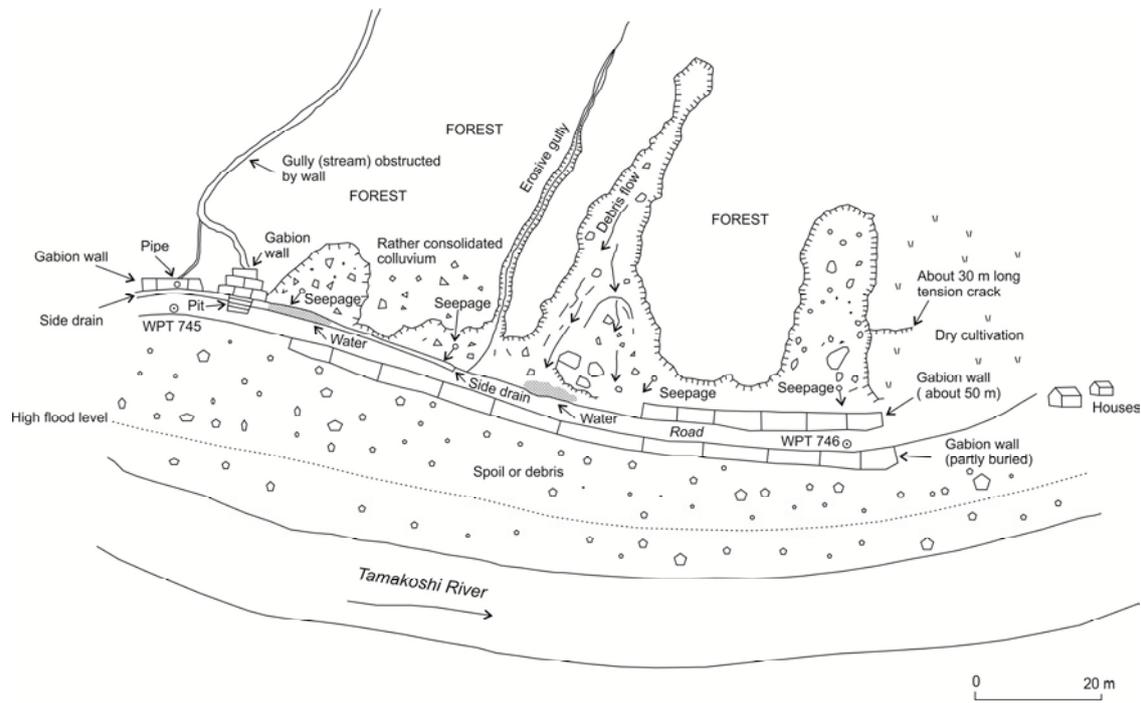
At this location, in the last rainy season, the road stretch of about 20 m length was destroyed. The road section was then filled with tunnel muck. It is mainly a debris flow and debris slide the toe of which is essentially on the road (**Figs. 10 and 11**). The instability was triggered by a high-intensity rain leading to the formation of many debris flows and slides. Presently, most of the road is saturated with water. Since the high flood level of the Bote Koshi River is below the landslide toe, the river has not contributed significantly in triggering the failure.

The debris flow disturbed the unsupported colluvium exposed by the road cut. The soil on the road is more than 10 m deep. It also contains many large (2 m to 5 m in diameter) boulders of laminated dark grey to black slate and siltstone. There are mainly three zones of failure (**Fig. 9**). Two of them are shallow slides and the central one is a debris flow. Presumably, the water from the central gully was obstructed and diverted in the central part, triggering the debris flow. The gully is more

Fig. 10. The debris flow and debris slide at Km 43+000 m.

- Safely draining water from all the three gullies. Removal of loose debris from their banks and trimming of slopes.
- Construction of a concrete side drain.
- Removal of the loose debris from the landslides and debris flow zones, trimming of the slope above the road.
- Construction of a strong retaining wall at least 4 m high throughout the unstable ground. The wall should be founded on rock or firm ground.
- Application of bioengineering (grasses) above and below the road.

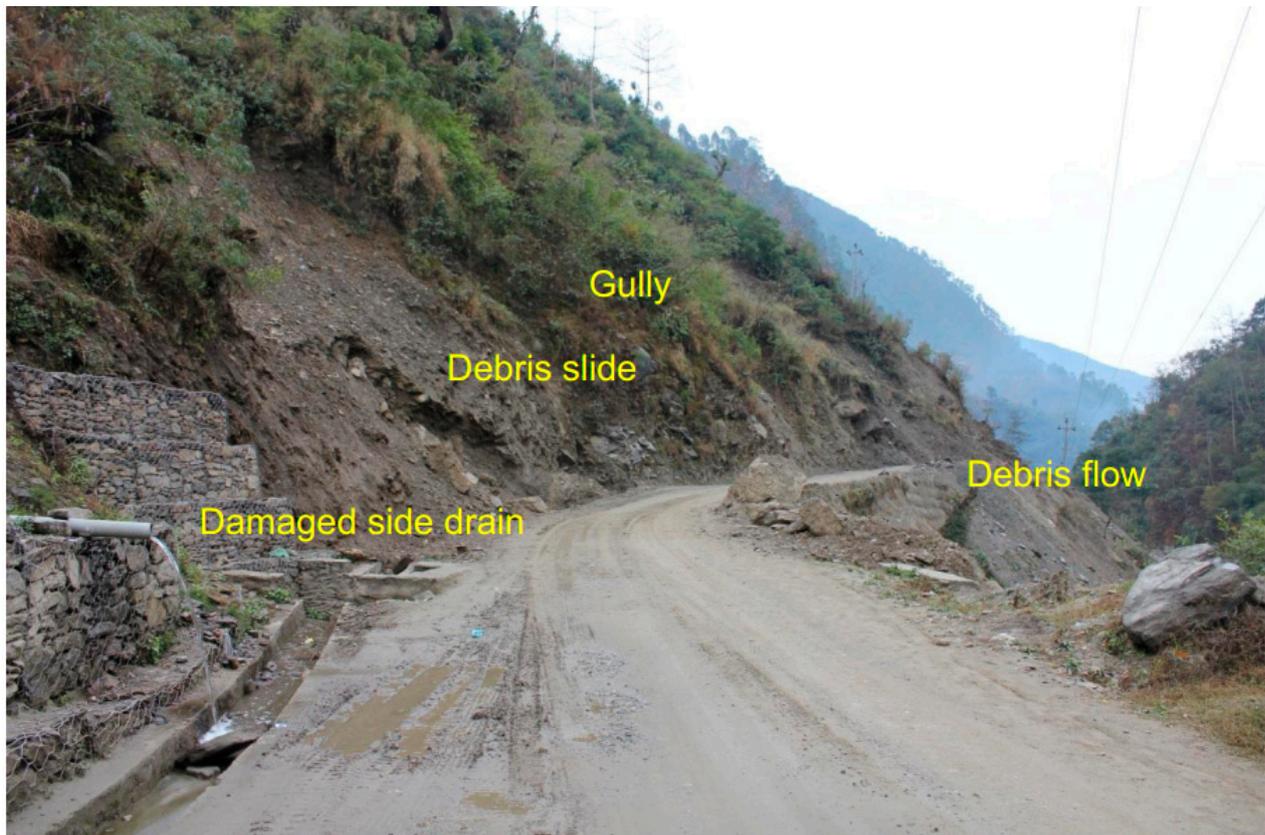
Fig. 11. View of the debris flow and debris slide at Km 43+000 m from north to south.

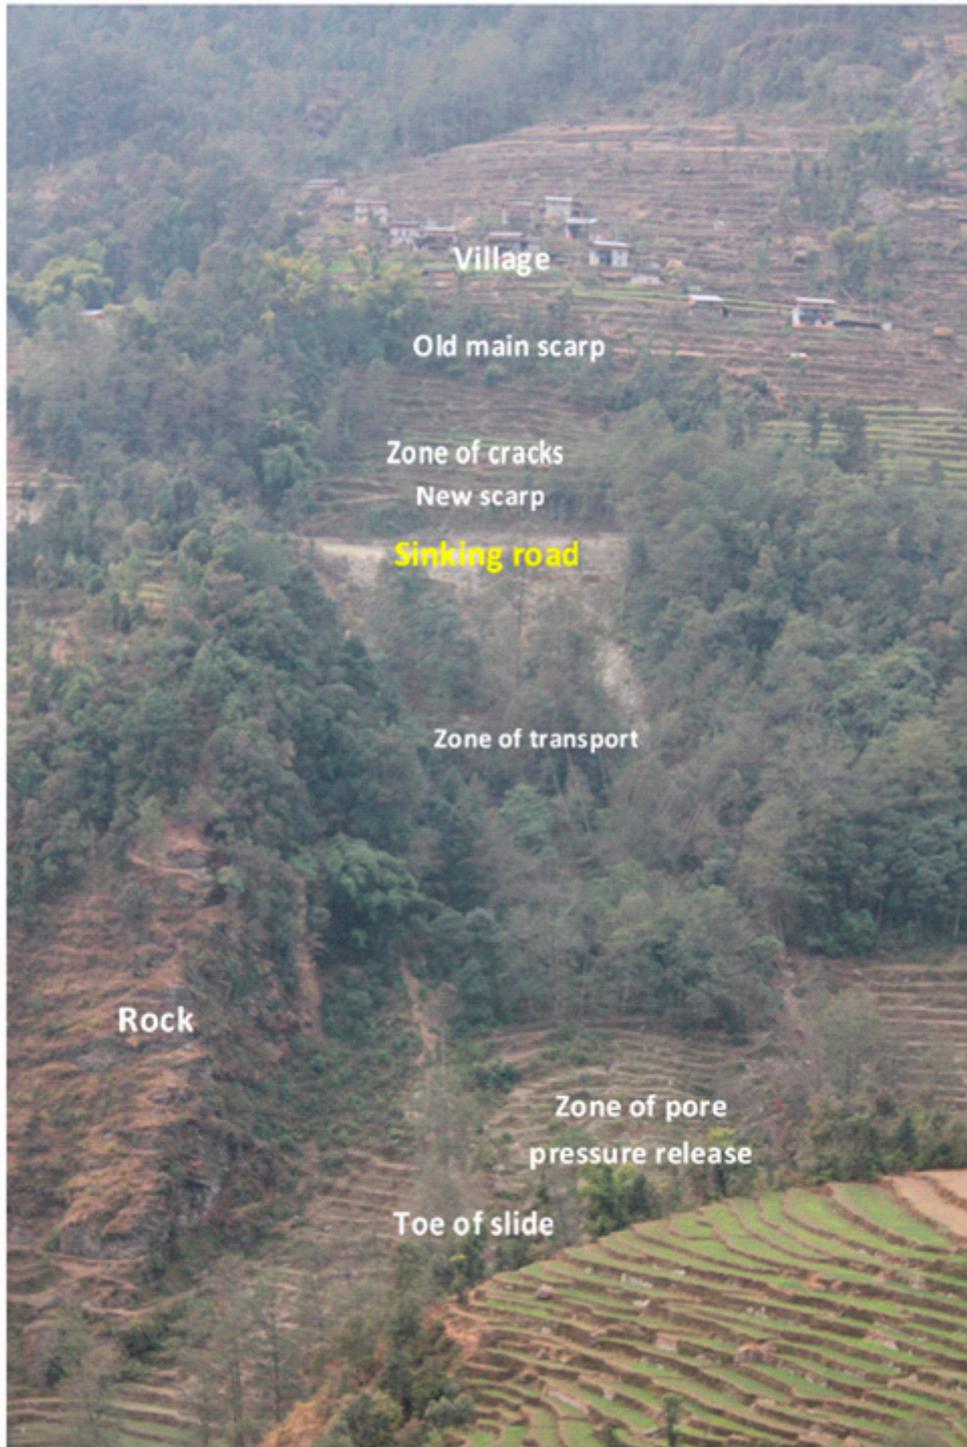
This is a reactivated large debris slide (**Figs. 12 and 13**). In this area, the road section of about 50 m length is sinking. It has settled for more than 5 m and shifted laterally for more than 12 m. The movement was severe in the rainy season and it is almost stable during the dry period. A weathered garnet schist is exposed on both ends of the soil slide.

The newly formed scarp (**Fig. 13**) runs through the upper part of the sinking road, where numerous springs and seeps are noticed in the rainy season. The pore

The toe of the slide rests on the streambed (**Fig. 13**). At the toe a number of secondary slides and bulges are developed. The stream is also partly pushed to the east, i.e., away from the slide. On the other hand, the stream is presently actively cutting the toe of the landslide.

Fig. 13. General view of the debris slide at Km 10+500 m.

- Detailed topographic mapping of the area. If required, geophysical investigation of the ground to locate the slip surface and the soil-saturated zone.
- Excavation of a temporary road towards the uphill side of the sinking ground.
- Investigation of the depth of groundwater under the sinking road.
- Removal of the subsurface water from the road and below it.
- Safe management of the irrigation canal and shifting from paddy cultivation to dry cultivation.
- Construction of retaining walls and other structures of the road.

- Construction of a long drainage structure with check dams from the road level down to the toe of the slide.
- Construction of chevron-shaped open drains in the landslide zone.
- Making of side drains and cross drains at the road level and safely discharging the water into the constructed drainage.
