Research Paper

Water supply damage caused by the 2016 Kumamoto Earthquake

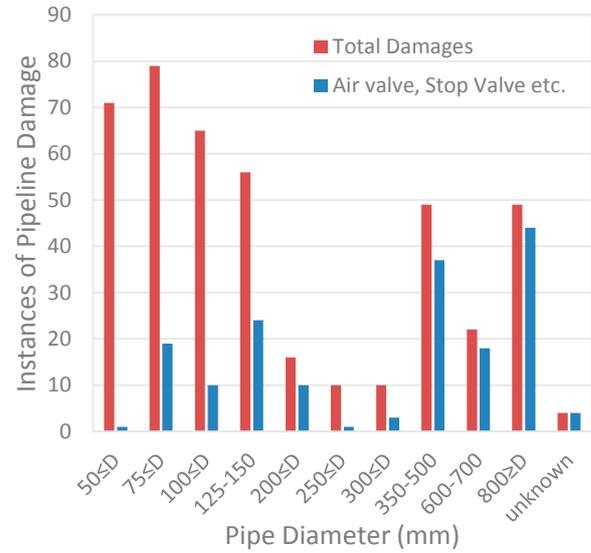
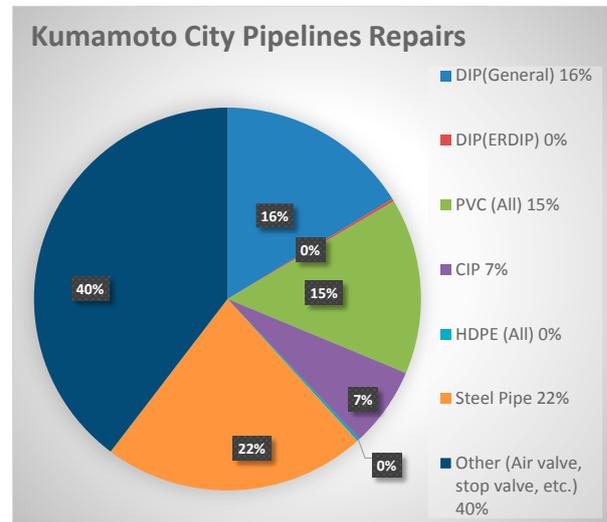
Fig. 7. Pipeline damage/repairs in Kumamoto City

Figure 7 summarizes the repair data for various diameters and materials. **Figure 7(a)** includes the total damage for each diameter range as well as the damage attributed to valves and other mechanisms necessary for system functionality. The figure shows that valves and other accessories account for the majority of damage repairs for larger diameter pipes (greater than 300 mm). This may be a function of additional mechanisms necessary to safely manage larger diameter pipes. **Figure 7(b)** shows the distribution of damages relative to pipe material. Valves account for the greatest percentage of the total damages, followed by steel pipe.

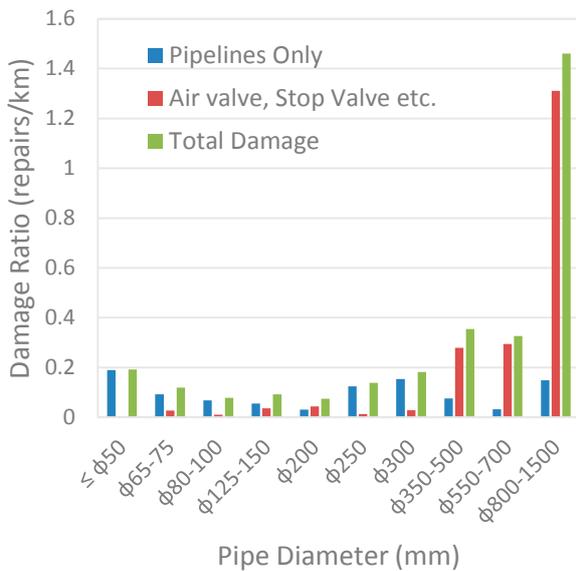
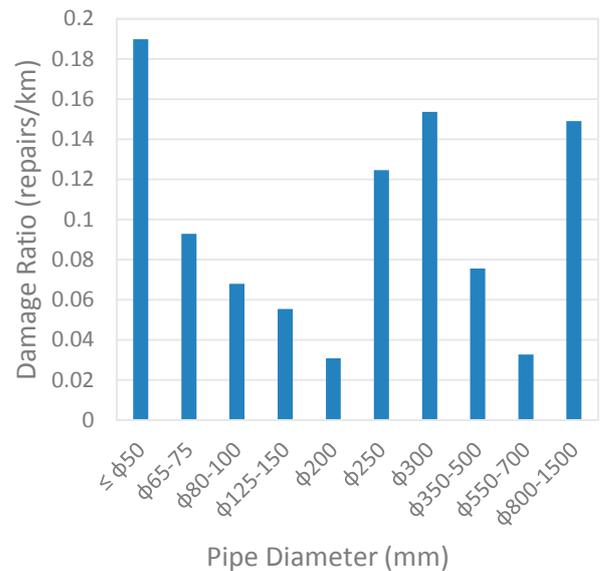
Fig. 8. Damage ratios for (a) all pipelines and system components and (b) pipelines excluding valves and other mechanisms.

diameters. **Figure 8(a)** suggests that larger diameter pipelines are more susceptible to damage, especially pipelines of 800 mm or greater. The significant damage ratio of large pipes is a direct result of necessary repairs to valves and other mechanical components of pipelines greater than 350 mm in diameter. **Figure 8(b)** provides a magnified look at damage ratios for pipelines only, excluding valves and other components. The figure suggests that, while smaller diameter pipes required the greatest number of repairs per pipeline length, damage ratio for pipelines alone is relatively independent of diameter.

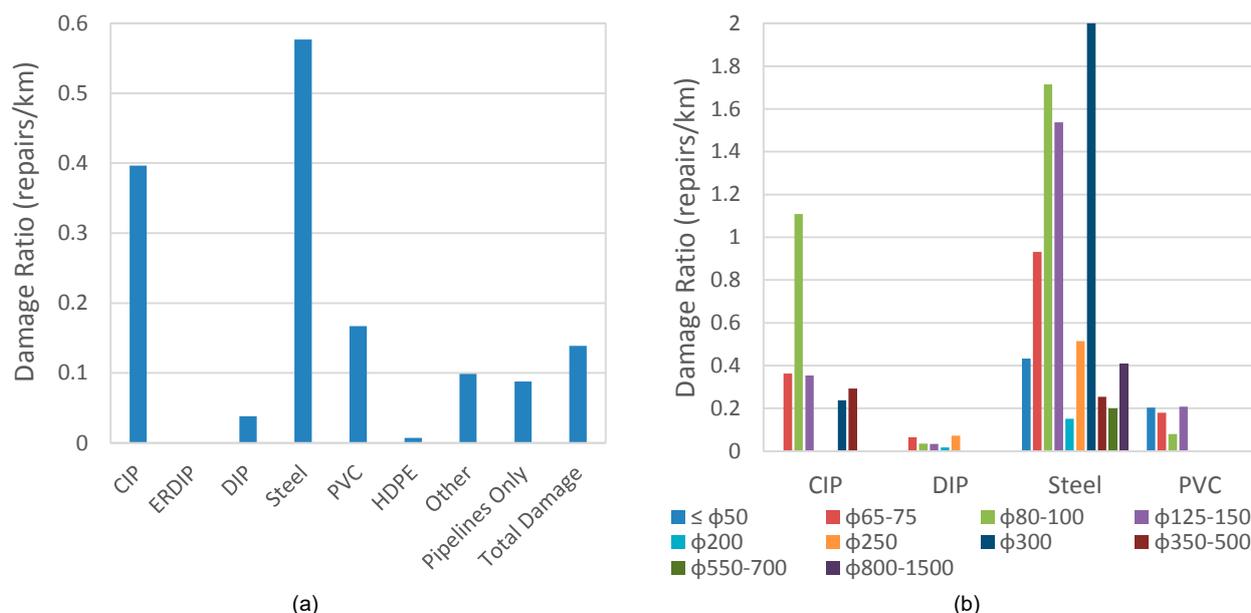
Fig. 9. Damage ratios for (a) all pipeline diameters and (b) select material and diameters in Kumamoto City (Note: not shown is $\phi 300$ mm steel with damage ratio=3.7).

Figure 9 provides damage metrics for various materials, as well as the overall damage ratio for Kumamoto City. The two right columns in **Fig. 9(a)** are normalized by the total pipeline length reported for Kumamoto City in 2014, 3,366 km. Steel is shown to have the largest damage ratio requiring greater than 0.5 repairs/km. As expected, brittle cast iron pipelines performed poorly relative to more ductile systems. Of the 578 km of Earthquake Resistant Ductile Iron Pipe (ERDIP), there were no reported breaks, and only a single repair required to address improper assembly. There was a single HDPE repair required for a small-diameter, mechanically-jointed line.

Figure 9 (b) shows a diameter breakdown for damage ratios of the mostly poorly performing materials. The steel pipe statistics, which included both screw and welded connections, show that various diameters performed poorly. The largest damage ratio, 3.7 repairs/km which is not shown on the plot for clarity purposes, occurred in 300 mm diameter steel pipe. Although specific data was not available, the authors hypothesize that the substantial

number of failures for this size and material may correlate with a specific pipe with poor construction quality, aggressive deterioration with age, or located in an area of significant ground deformation. The data suggest that, in general, steel and cast iron (CIP) pipelines performed poorly across many diameters.

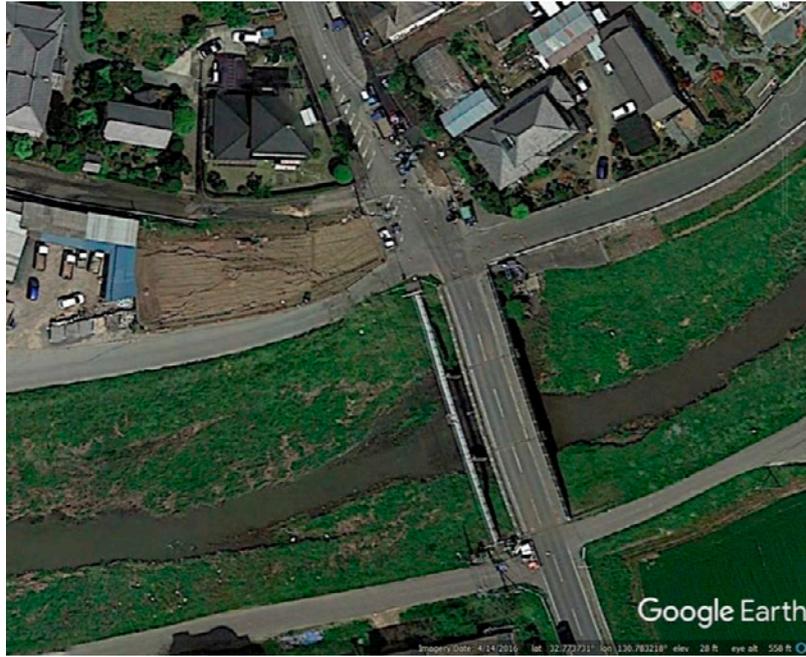
(a) Google Earth image of site

One site of particular interest is a lateral spread event located in Akisumachi Nuyamazu, adjacent to parallel pipeline and traffic bridges along Route 232 crossing a tributary of the Midorikawa River at the east Kumamoto City limits (identified in **Fig.1**). Site observations

(liquefaction, ground cracking) and data (e.g., LiDAR) collected at the site can be found in the GEER reconnaissance report (Kayen, et al., 2016). **Figure 10(a)** shows a Google Earth satellite image of the site dated April 14, 2016 (US date). Significant ground cracking can be seen in the field to the northwest of the bridges. **Figure 11(a)**, taken May 7, 2016, shows the lateral spread and pipeline bridge in the background. **Figure 10(b)** shows a survey map and **Table 2** provides a summary of pipeline breaks in the area as reported by KWSB (2016).

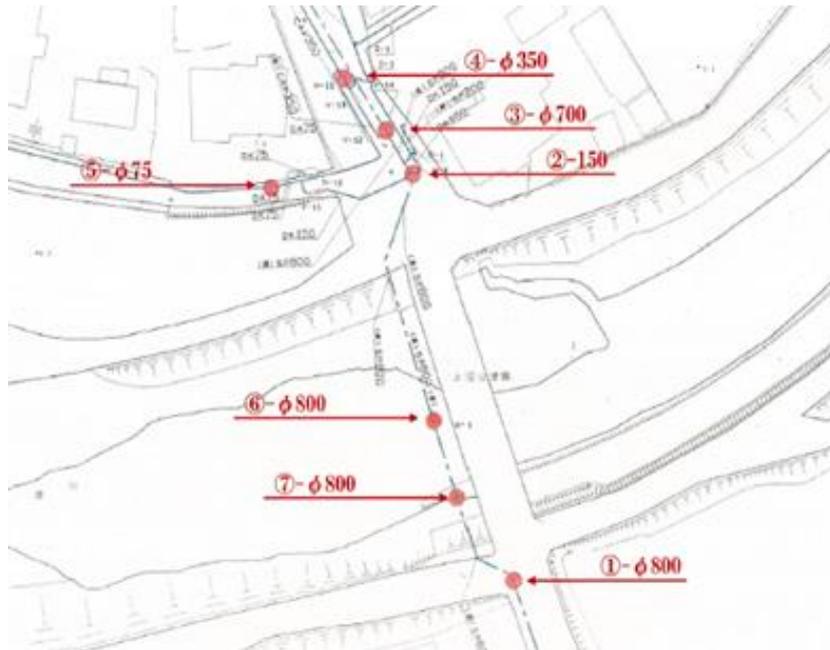
(b) Drawing of site and pipeline repairs (KWSB, 2016)

No.	Dia. (mm)	Material (description)
1	800	Steel (rupture near abutment)
2	150	DIP (K-type) Leakage at joint
3	700	Steel (fracture at gate valve flange)
4	350 x 75	CI or DI (rupture of Flange Tee, FT)
5	75	Ductile Iron (A-type) Leakage at joint
6	800	Steel (leakage at air valve)
7	800	Steel (rupture at expansion/contraction joint)

The 800-mm steel pipeline carries emergency water supply to 57,000 people from reservoir tanks located in the agricultural field to the south over the river to populated residential districts. The pipe is equipped with slip joints to account for expansion/contraction (typical range of ± 50 mm) near both the north and south abutments. During the April 14th event, leakage occurred at the slip joint close to the south abutment (**Figure 11(b)**, repair No.7). Observations suggest leakage occurred due to over insertion of the joint, an indication that the banks of the river displaced as a result of the April 14 foreshock. It is likely a component capable of larger compressive displacements, such as the seismically-resilient inclusions tested by Wham et al. (2017), would have survived the imposed deformation and continued uninterrupted conveyance of emergency water supply across the river.

A total of seven repairs were required in the vicinity of the pipeline bridge, including four repairs to valves and joints of the large diameter steel pipeline. Further investigation of this site is suggested owing to the general lack of liquefaction induced lateral spreading that occurred in the region as a result of the Kumamoto Earthquakes.

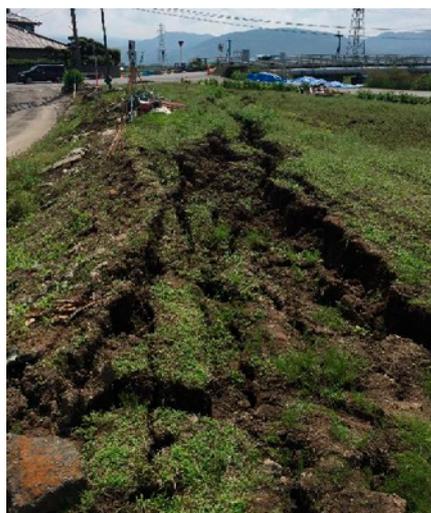
(a) Lateral spreading, pipeline bridge in distance (Kayen, et al. 2016)

Fig. 11. Location of significant lateral spread and pipeline repairs (32.77326, 130.78428).

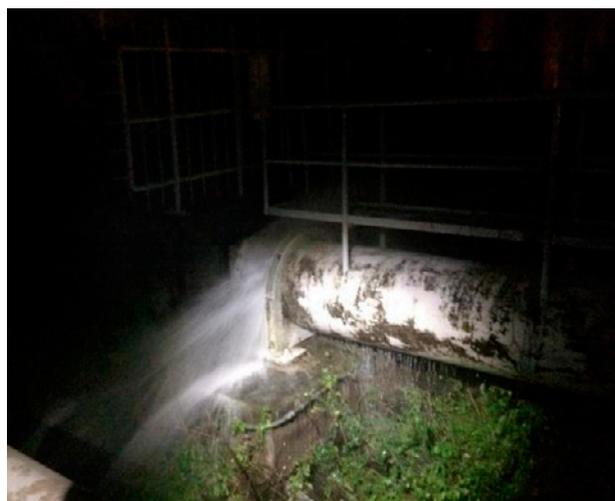
(b) Leakage of 800 mm diameter bridge pipeline at expansion joint (KWSB, 2016)
