Research Paper

Investigation on the damage to Kumamoto Castle stone wall related to the 2016 Kumamoto Earthquakes

T. Ohsumi

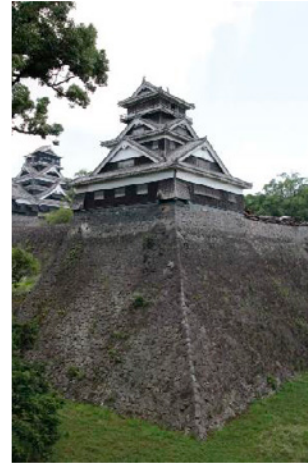
Fig. 5. Photograph of Uto Yagura, which is designated as an important cultural property. (photo by T. Ohsumi, taken August 11, 2016).

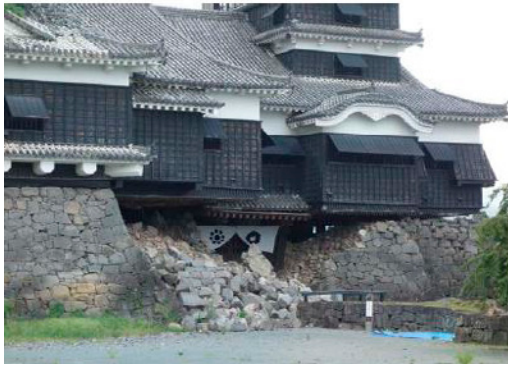
Fig. 12. Photograph of Shotenshu-dai from Hon-maru side. (courtesy of Prof. K. Meguro, taken Oct. 26, 2016).

lesser keep (Shotenshu) is 19 m tall, with two floors and four stories. The stone wall is the same height as Daitenshu. The keeps have connecting structures at the side of the entrance. The stone wall of Daitenshu has a shallow slope with a gentle curve, whereas that of Shotenshu is a steep slope. Daitenshu was attached to Shotenshu (Owada 2006). It is said that the lord Kato Tadahiro age (ranking 1611–1632) was built. Tiles were fallen from the roof of Daitenshu and Shotenshu following the earthquakes. **Fig. 11**, taken from Hon-maru side, shows that the stone wall foundation of Shotenshu subsided after the earthquakes, and part of the foundation, which is the Sangi-tsumi method, collapsed. **Fig. 12** and **Fig. 13** shows damage caused by subsidence of the foundation of Shotenshu (Shotenshu-dai). **Fig. 13** shows close-up photograph of Shotenshu-dai, which can see basement damage.

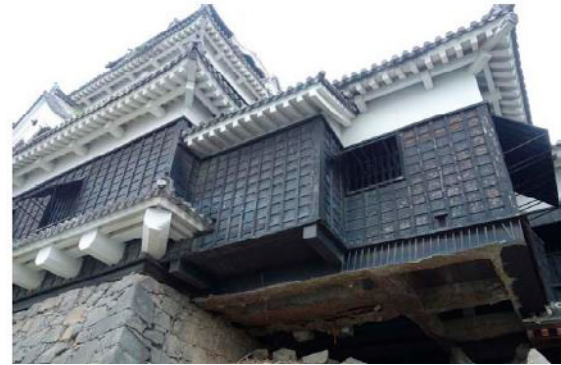
Fig. 13. Close-up photograph of Shotenshu-dai (courtesy of Prof. K. Meguro, taken Oct. 26, 2016).

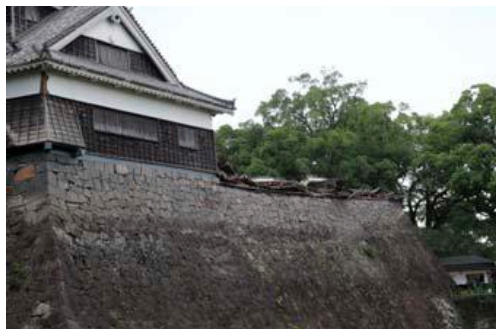
Fig. 14. Photograph of Tsuzuki Yagura taken from Kato Shrine. Unlike Uto Yagura, this turret was not reinforced to be earthquake resistant, and collapsed after the earthquakes (photo by T. Ohsumi, taken August 11, 2016).

height of 20.5 m. The turret has three floors and five stories below the foundation floor is a squirrel that continues from the north side to the west side and a renovation was performed in 1989. It has a corridor on the top floor. A 25-m-long section of Tsuzuki Yagura on the west side collapsed after the earthquakes. Uto Yagura was reinforced by a steel brace installed at the opening. This seismic reinforcement improves strength and stability. However, since it was not similarly reinforced, Tsuzuki Yagura collapsed (**Figs. 14, 15, 16**). **Fig. 17** shows Uto Yagura from Hohoate-gomon, which stone walls were heavily damage.

- 5) Uto Yagura is reinforced against seismic activity by a steel brace installed at the opening, which a renovation was performed in 1989. Unfortunately, Tsuzuki Yagura lacked such reinforcement and collapsed after the earthquake.

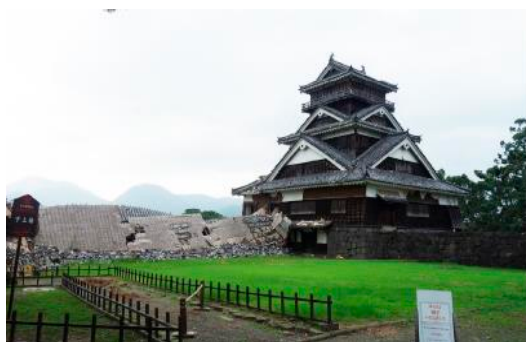
Fig. 16. Photograph of Uto Yagura (right) and Tsuzuki Yagura (left) (courtesy of Prof. K. Meguro, taken Oct. 26, 2016)

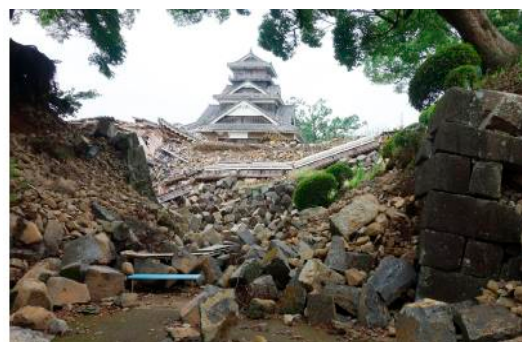
Fig. 17. Photograph of Uto Yagura inside of Hohoate-gomon (courtesy of Prof. K. Meguro, taken Oct. 26, 2016)

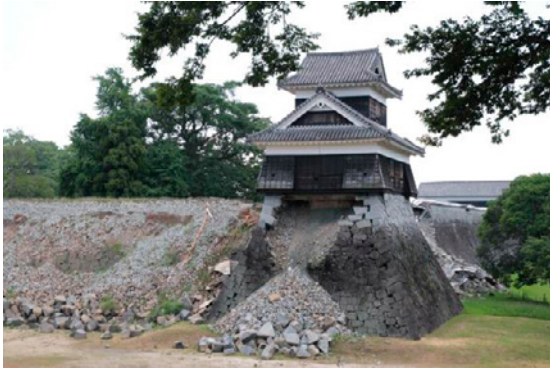
Fig. 18. Photograph of Inui Yagura (right: 2003 reconstruction), a wooden two-floor three-story turret that was rebuilt in 2003. Inui Yagura foundation was partial collapse in the middle of the stone wall. (photo by T. Ohsumi, taken July 20, 2016)

Inui Yagura is a wooden turret, reconstructed in 2003, with two floors and three stories. This turret was constructed at the northern end of the site to defend the north-northwest. **Fig. 18** shows the foundation of Inui Yagura, which partially collapsed on the north side.

The foundation of Inui Yagura was constructed using the above-mentioned Sangi-tsumi method. Even in this earthquake, the corner stones kept their shape for all stone walls. In contrast, the middle parts of some walls

partially collapsed, like in a landslide. It is a tower of restoration, and the foundation part of the collapsed turret is seen a steep structure. It is conceivable that the structure forming this impermeable layer induced the collapse of the stone wall in the middle part.

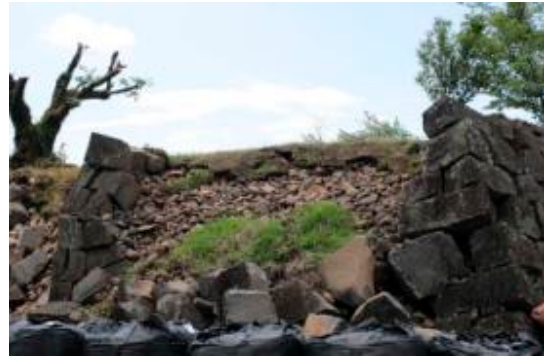
Fig. 19. Photograph of the stone wall of Kato Shrine (photo by T. Ohsumi, taken August 11, 2016)

Kato Shrine enshrines Kato Kiyomasa. This shrine is located in the north side of Heizaemonmaru, Daitenshu, Shotenshu, and Uto Yagura. In the stone wall about 3 m in height built over 400 years in the shrine, a part adjacent collapsed to the north gate related to the earthquake (**Fig. 19**). The stone wall of corner stone has not collapsed, but the Middle part has collapsed. In this stone wall on the behind of the stone wall was arranged a back stated round cobble stone with excellent permeability. The stone walls collapsed with ruin of the North Ote Gate were collapsed, and the stones were scattered in the grounds. Inside of the collapsed stone wall was discovered the Kannon Bodhisattva of about 40 cm (**Fig. 20**). The Kannon Bodhisattva of this stone was

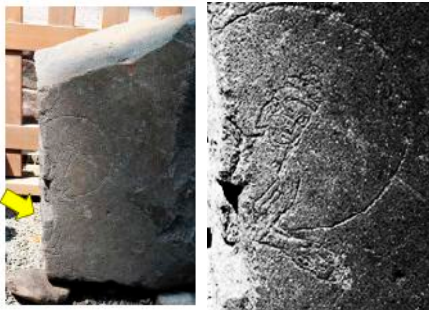
Fig. 20. Photograph showing a stone from a collapsed wall. On the inner-facing side the Kannon Bodhisattva and an arrow hole were discovered (photo by T. Ohsumi, taken August 11, 2016)

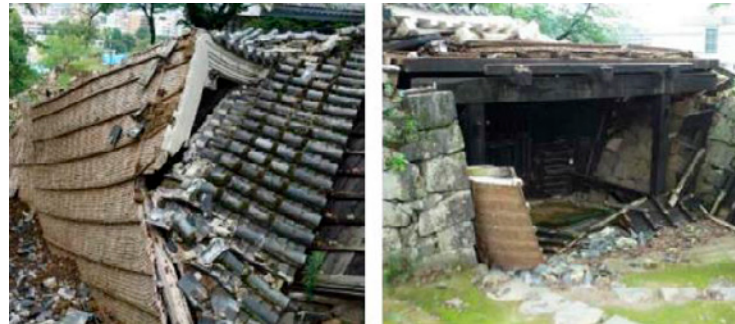
Fig. 21. Photograph of Akazu-no-mon, which was designated as an important cultural property, was heavily damaged by the earthquakes (courtesy of Prof. K. Meguro, taken Oct. 26, 2016).

damaged by the earthquakes. Akazu-no-mon, which was designated as an important cultural property, was heavily damaged by the earthquakes (Figs. 21, 22).

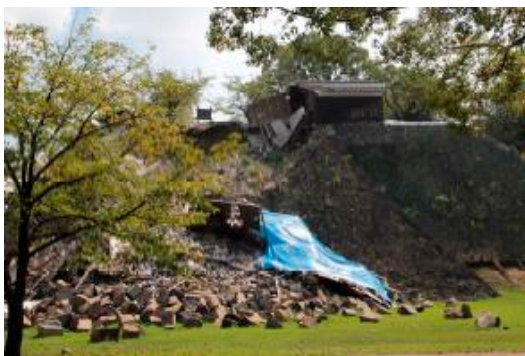
Fig. 24. Photograph of Kita Juhachiken Yagura . Located between Kato Shrine and Kumamoto Daijingu shrine, this turret completely collapsed (photo by T. Ohsumi, taken August 11, 2016)

Fig. 23 shows before the earthquakes. Kita Juhachiken Yagura, which is located between Kato Shrine and Kumamoto Daijingu shrine, completely collapsed. Behind Kita Juhachiken Yagura, there was a large V-shaped gully erosion at the top of the foundation, which worsened the collapse (Figs. 24, 25).

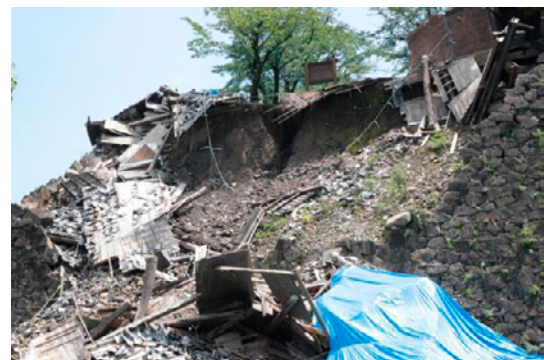
Fig. 25. Photograph of Kita Juhachiken Yagura foundation, behind which a large V-shaped gully erosion was discovered that apparently worsened the collapse (photo by T. Ohsumi, taken August 11, 2016)

- 6) Behind the Kita Juhachiken Yagura foundation, there was a large V-shaped gully erosion at the top of the slope, which seems to have worsened the collapse of this structure.

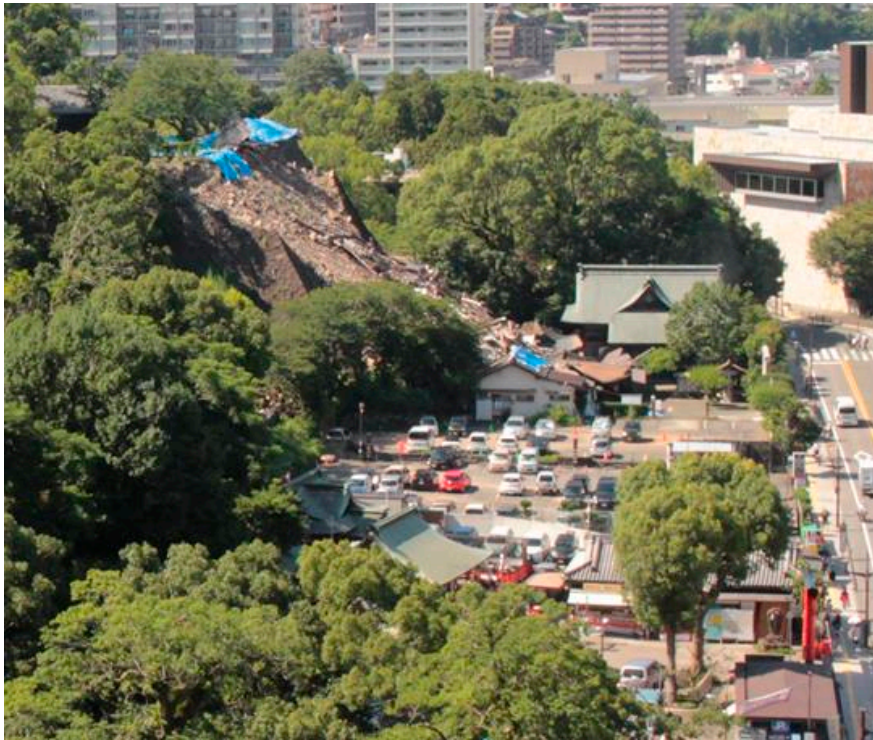
Higashi Juhachiken Yagura foundation collapsed after the main shock. The collapsed storehouse and slope fell onto Kumamoto Daijingu, breaking through the roof and crushing the shrine. After the foreshock, although tiles

Fig. 26. Photograph of Kumamoto Daijingu and Higashi Juhachiken yagura (photo by T. Ohsumi, taken July 20, 2016)

were reported to have fallen, there was no obvious damage to the stone walls (**Fig. 26**).

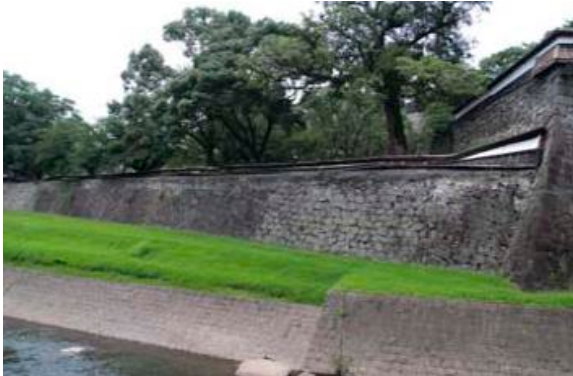
Fig. 27. Photograph of the longest wall in the castle, Naga-kabe, along Tsuboigawa river. An 80-m-long section of this wall collapsed after the earthquakes (photo by T. Ohsumi, taken July 20, 2016)

Naga-kabe, the longest castle wall, at 242 m, was connected to Hira Yagura from the eastern end of Takeno Maru to the westernmost Bagu Yagura-dai. This long wall (**Fig. 27**) on the south side was built as protection from the Satsuma clan. An 80-m section of Naga-kabe collapsed after the earthquake.

The junction of Long wall was off and the Long wall part was collapsed. Hira Yagura is in the southern corner of Kumamoto Castle. It is a RC restoration, completed in 1966, and it escaped serious damage despite a large load being applied to the joint at the time of the earthquake.

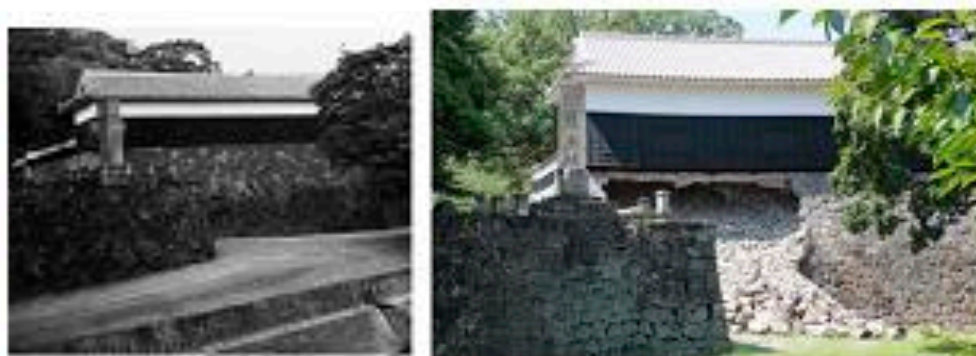
Fig. 29. Photograph of Bagu Yagura-dai before (left; photo by T. Ohsumi, taken in 1989) and after the earthquakes (right; photo by T. Ohsumi, taken August 11, 2016)

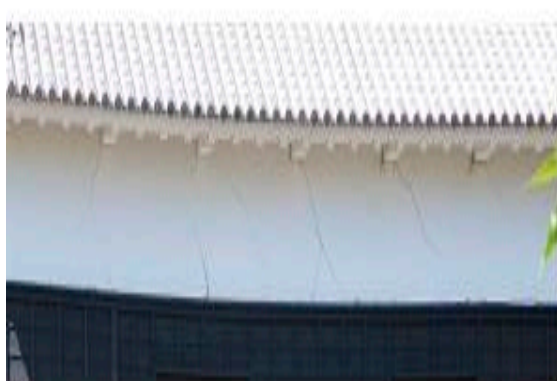
Fig. 30. Photograph showing enlargement of foundation settlement caused the white wall at Bagu Yagura (photo by T. Ohsumi, taken July 20, 2016)

- 7) The settlement enlargement of foundation caused the white wall at turret related to the earthquakes. Also, since it seems to be an enlargement of curvature of stone walls prompt action is desired.

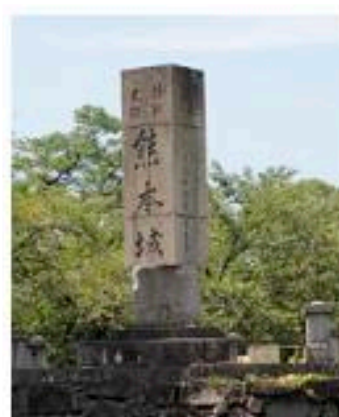
Fig. 31. Photograph showing stone monument rotated by the main shock (photo by T. Ohsumi, taken July 20, 2016)
