# Sediment disasters caused by the 2016 Kumamoto Earthquake and regional disaster history

M. Suzuki <sup>1</sup>, K. Kagohara <sup>2</sup>, K. Sakaguchi <sup>3</sup>, H. Matsugi <sup>4</sup> and S. Kataoka <sup>5</sup>

## ABSTRACT

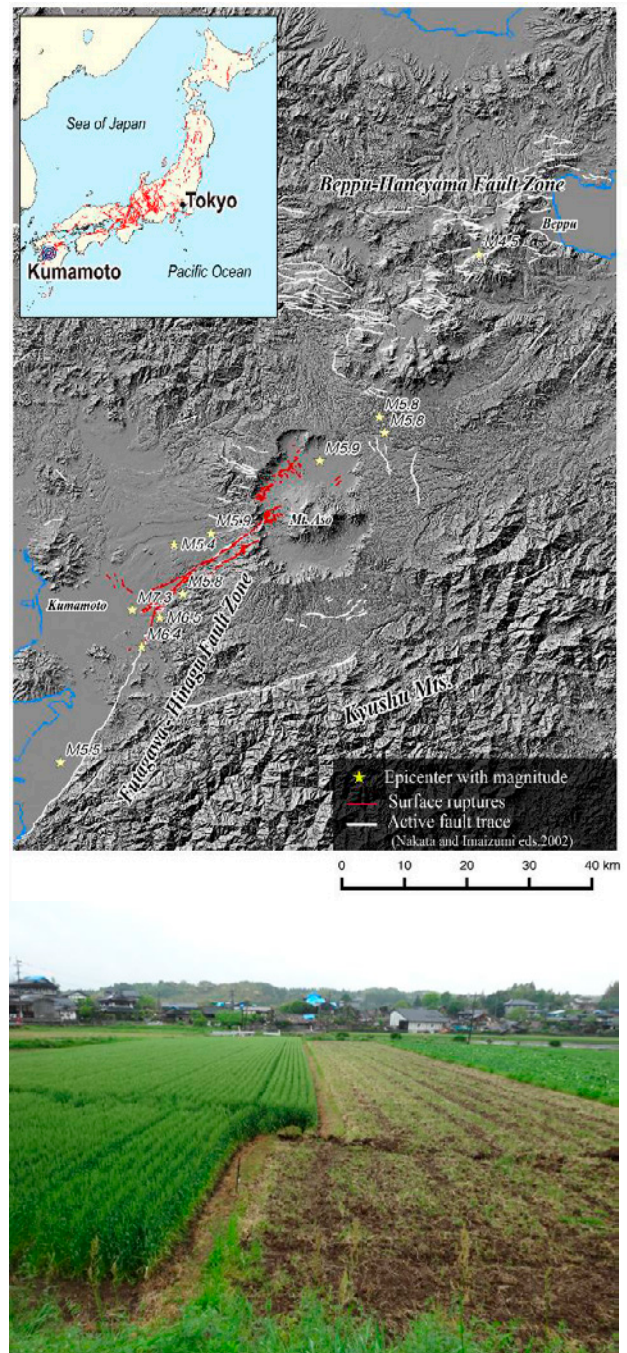
The source area of the 2016 Kumamoto Earthquake in central Kyushu is located under the NS extensional stress field created by the Philippine Sea Plate subducting beneath the Eurasian Plate. Many active faults and volcanoes are distributed in this area, as shown in **Fig. 1** (Nakata and Imaizumi, 2002). The Beppu-Haneyama fault zone and the Futagawa-Hinagu fault zone are well known major active faults in central Kyushu. In the 2016 Kumamoto Earthquake, the foreshock was caused by the movement of the Hinagu active fault. The main shock was caused by the movement of the Futagawa active fault in conjunction with the Hinagu active fault. The earthquake revealed right-lateral strike-slip surface faults extending from the southwest to the northeast. The total length of the fault series was approximately 31 km, and the maximum total fault displacement was close to 2.0 m at Dozon in the Mashiki Town and approximately 1.3 m near Tateno in Minamiaso Village. These coseismic ruptures represent the characteristic movement of the north-eastern portion of the Futagawa-Hinagu Fault zone. The magnitude and epicentre of the earthquakes were almost as predicted. Because this area has historically experienced powerful earthquakes several times, saying that people have suffered due to earthquakes would not be an exaggeration.

**Fig. 1.** Location of the epicentre with magnitude, surface ruptures, and active faults from the 2016 Kumamoto Earthquake (top; Nakata and Imaizumi, 2002). A typical surface rupture, shown for Dozon, Mashiki Town (bottom).

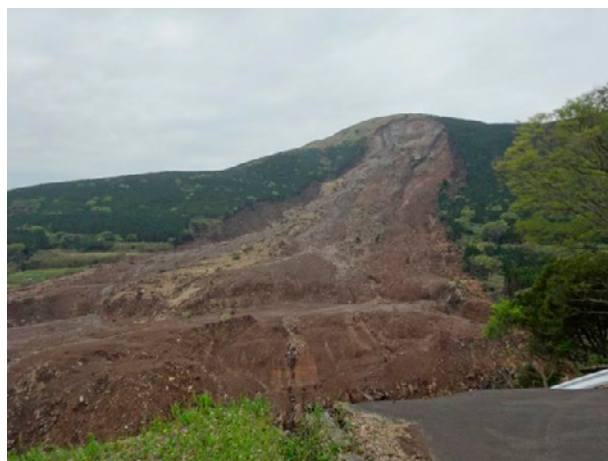
A large-scale slope failure occurred in the vicinity of the Aso-ohashi Bridge in Tateno area, Minamiaso Village (Figs. 2-4). During the earthquake, a long slope slid from the mountain ridge, 755.8 m in elevation. The failed portion was estimated to be 700 m in length, 300 m in width, and 20 m in depth, with a 35–40° slope. A 206 m bridge constructed in 1970 across the Kurokawa River collapsed, cutting off road traffic and railways. Bridge piers, abutments, and foundations withstood the collapse. A combination of earthquake vibration, overloading of accumulated soils, and surface ruptures due to earthquake faults was considered the cause of the bridge collapse. Most sediment flowed into the river with some reaching the opposite bank in the Kawayo area. The earthquakes revealed regional surface faults, which were found to extend the line of the Futagawa fault.

The failed slope was composed of volcanic soil (Kuroboku soil), andesite tuff, andesite lava, and tuff breccia. Kuroboku soil is a type of organic clayey soil originating from volcanic ash. Volcanic ash at the surface ground failed and simultaneously the bedrock lava collapsed due to the strong vibrations. Slope failure resulted in a deeper and larger slide. Aerial photographs taken by the US armed forces in 1956 (obtained from the

**Fig. 2.** Image overview of large-scale slope failure covering the Aso-ohashi Bridge.

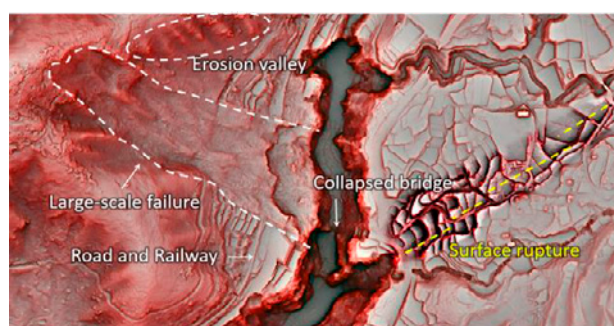
**Fig. 3.** Red relief maps and detail of large-scale slope failure. Original map obtained from Asia Air Survey Co., Ltd.

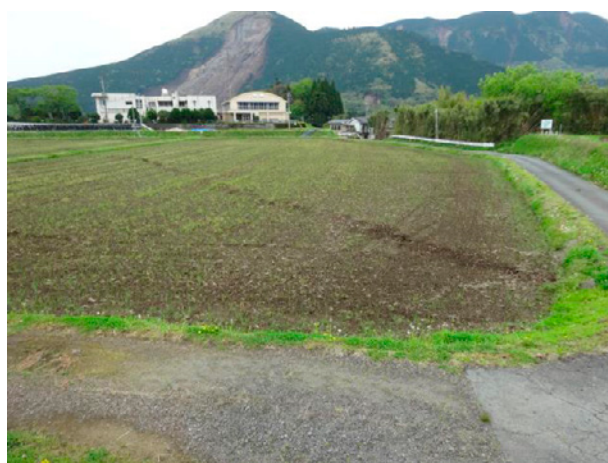
**Fig. 4.** Image showing surface cracks exposed on the opposite side of the large-scale slope failure.

Geospatial Information Authority of Japan) confirmed that erosional valleys had developed along the mountain ridgelines. Additionally, using unmanned aerial vehicles, we observed fissures and cracks on the ground and unstable rock masses along the ridge and side of a mountain.

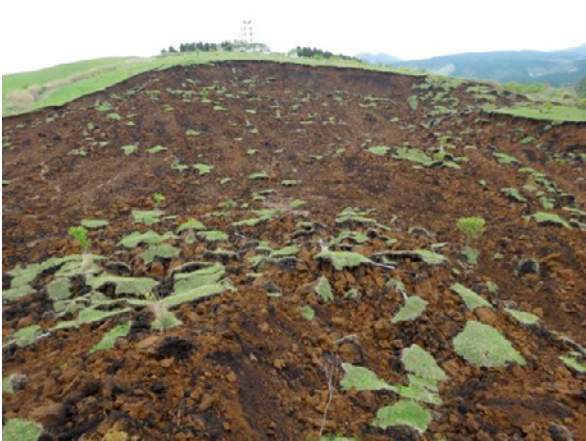
**Fig. 5.** Image of the landslide at Takanodai.

A landslide slipped on a gentle slope (10-20°) of a mountain like dome at Takanodai in the Kawayo area, Minamiaso Village (**Figs. 5-7**). The Aso Volcanological Laboratory belonging to Kyoto University is located at the

top of the dome. The landslide initiated from a dome hillside and travelled in three directions. Part of the massive soil reached a residential area, killing five people. Alternately stacked volcanic soil (Kuroboku soil, Akaboku soil), clayey soil, and pumice-fall deposits were observed at the main landslide scarp. A landslide slip surface could have developed inside the pumice-fall deposit or the boundary between the clayey soil and pumice-fall deposit. The landslide thickness was approximately 6 m to 10 m. Our observations taken at the estimated slip surface could not confirm the effect of ground water on landslide behaviour.

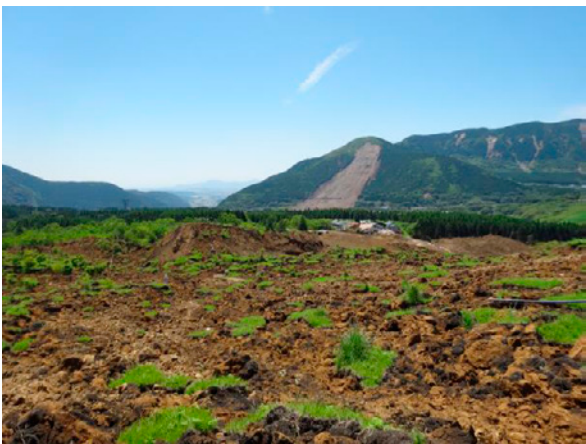
**Fig. 6.** Image showing landslide sliding conditions with a distant view of the large-scale slope failure.

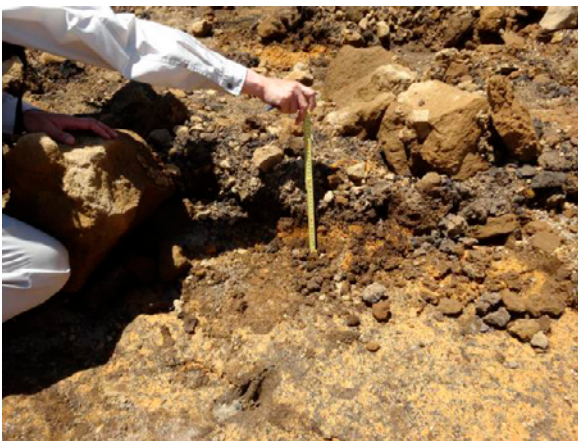
**Fig. 7.** Image showing a pumice fall deposit on the slip surface.

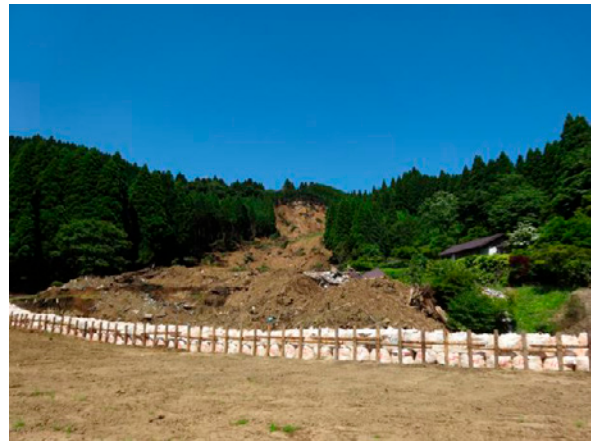
**Fig. 8.** Image showing an overview of surface failure.

Surface failure caused human fatalities in the Nagano area, Minamiaso Village (**Figs. 8-9**). Massive soil movement devastated accommodations, such as the Onsen Log Sanso Hinotori where two guests in the lodge died. In this area, surface failure occurred at two sites: at a local water collection site formed by a depression and at a slope break along a mountain ridge. Pumice-fall deposit was confirmed present around the slip surface. The pumice-fall deposit observed at the main scarp was similar to that in the Takanodai area. Although it did not rain on that day, the sample was wet. This suggests that the pumice acted as a permeable layer.

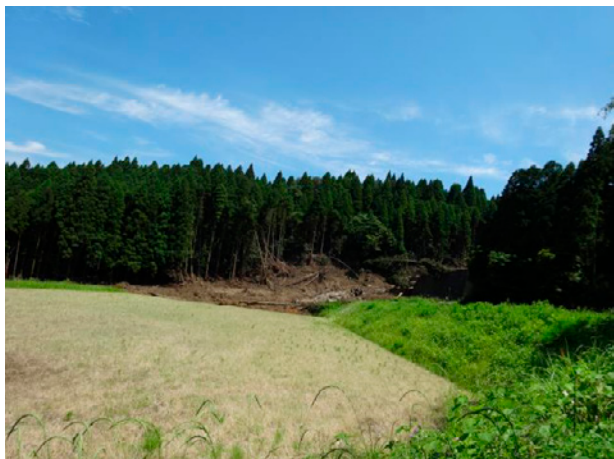
**Fig. 10.** Image showing debris deposition area and toe that occurred after the earthquakes.

stream along the Sannoutani River (**Figs. 10-11**). The river was recognized as a torrential river causing debris flow to communities. The Kuroboku soil and gravel travelled along existing channels and spread in the lower reach of the stream. The source area of the debris flow was located upstream of Mt. Koeboshidake. Numerous surface failures occurred in the natural slopes of the mountain. This implies that the debris flow may have been triggered by the inflow of river water causing sediments to accumulate along the river. Subsequently, debris flows were reactivated along the same stream when it rained on 21 June, two months after the main shock.

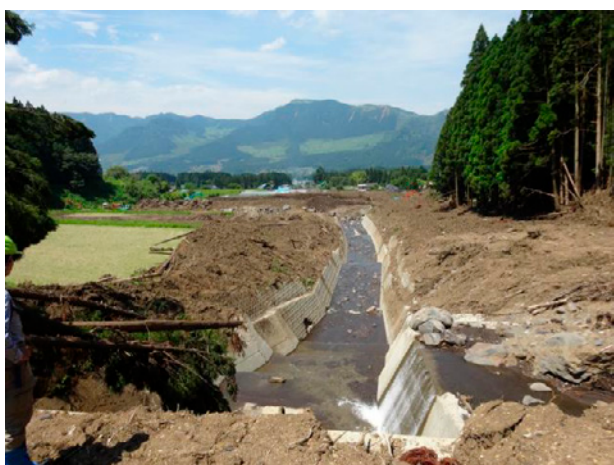
**Fig. 11.** Image showing the spread of sediment.
