Research Paper

Geotechnical damage due to the 2016 Kumamoto Earthquake and future challenges

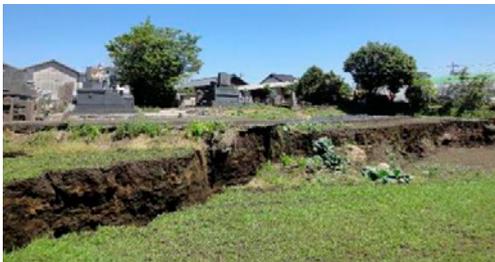
Fig. 11. Seismic subsidence in Uchinomaki area.

In Uchinomaki area of Aso city, a co-seismic subsidence (Graben phenomenon) covering an area of about 2 km long and 1 km wide was found (**Fig. 11**). **Fig. 12** shows the condition of the road passing through the area depression zone and the state of the house across the road. Another house next to this house had no detrimental effect. According to the local resident (owner of the unaffected house), the shaking was mostly vertical and the subsidence was simultaneous to the earthquake as they could hear a huge sound while shaking was still continuing. At the greatest offset, the subsidence was more than 2 m (**Fig. 13**). The geotechnical bore hole data

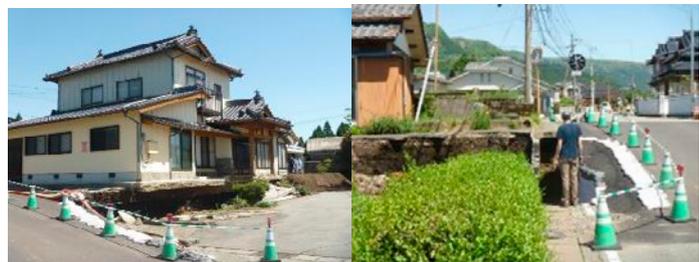
Fig. 12. Road damage and building damage due to subsidence.

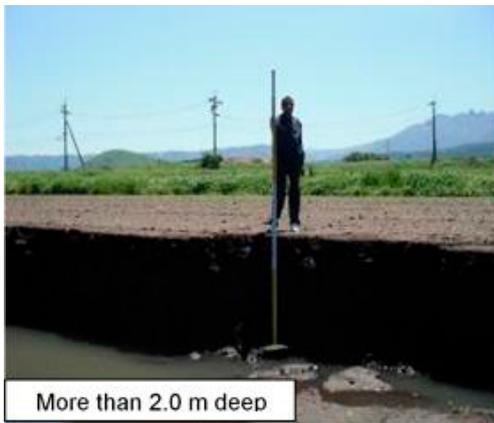
Fig. 13. Subsidence on the opposite side.

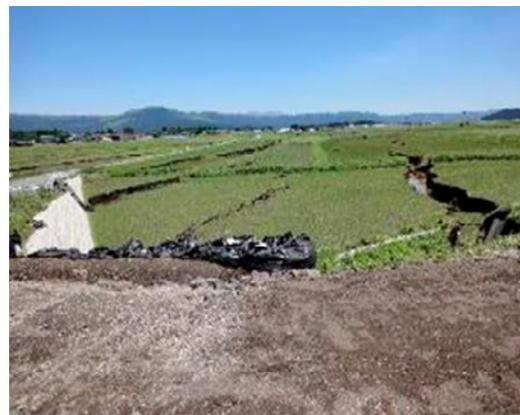
Fig. 14. Abutment failure and retaining wall damage.

within 1 km of that area suggests that the area has more than 70 m of thick clay containing water content within the range of 150 to 280 % and void ratio ranging from 5 to 8. The N value of the soil layer between 20 to 40 m depth is almost equal to zero. Thus, it can be inferred that the surface soil in that area was sitting on the top of a soft soil layer, which may have caused such subsidence. In another location around the area, more than 1.5 m wide cracks were observed leading to the damage of a bridge abutment and failure of the retaining wall (**Fig. 14**).

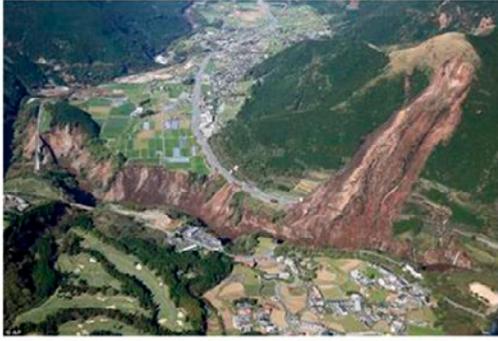
Fig. 15. Huge landslide and collapse of the Aso bridge (Photo Courtesy: American Geophysical Union).

In the Aso Caldera area, the damage was mostly related to earthquake-triggered shallow landslides and slope failures of the volcanic soils. These have led to bridge and road failures in that area. **Fig. 15** shows one of

the biggest landslides in the Minamiaso village area, the west side of Mt. Aso. The landslide covering a length of about 700 m, and width of about 200 m caused damage to the roads and bridges blocking the entire transportation network in that area. Route 57 and Japan Railway Hohi line were buried under the debris. The bridge abutment failed during the main shock, causing the Aso bridge to collapse. **Fig. 16** shows the state of the slope when the authors visited the area. It is clear that the flow of deposits is still continuing, and the debris may cause subsequent debris flows during the rainy season. There was a series of surficial landslides (**Fig. 17**) close to the Aso volcanological laboratory of Kyoto university along route 299 prefectural road. Many houses were swept away by the landslide (**Fig. 18**).

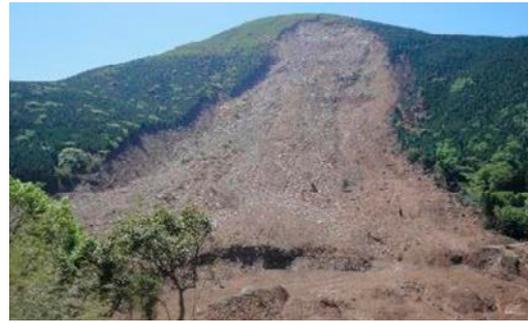
Fig. 16. State of the landslide on May 12.

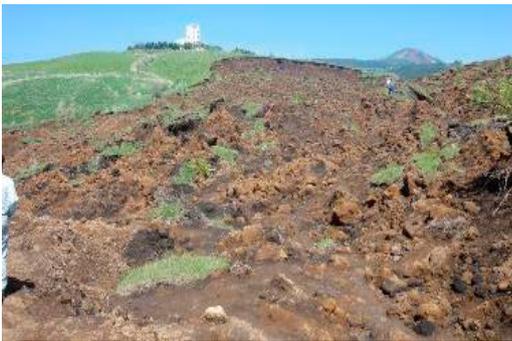
Fig. 17. Surficial failure in Aso.

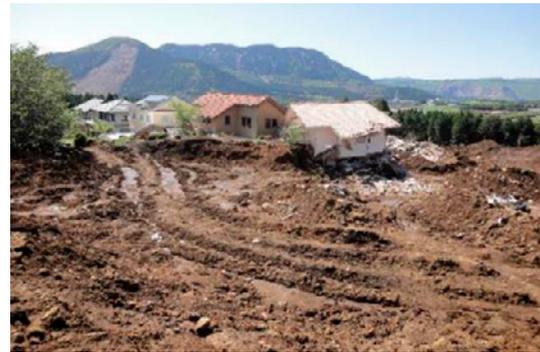
Fig. 18. Swept away houses.

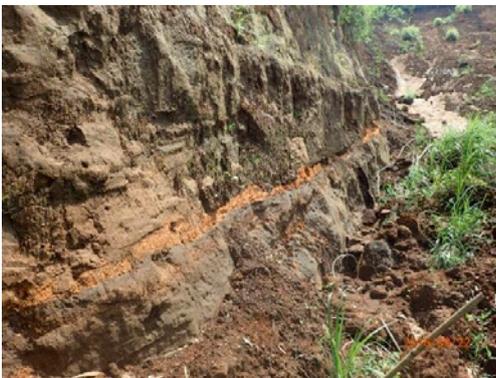
Fig. 19. Andisols and pumice layer in the slope.

The authors observed that the soils in that area were composed of typical Andisols (**Fig. 19**). They are highly porous, dark-colored soils developed from parent material of volcanic origin and have excellent water holding capacity. Orange colored pumice layer was found sandwiched between those layers. According to geologist Prof. Kazunori Watanabe, Prof. Emeritus of Kumamoto University, who accompanied the authors during the survey, the orange colored pumice may have been formed about more than 30,000 years ago due to catastrophic

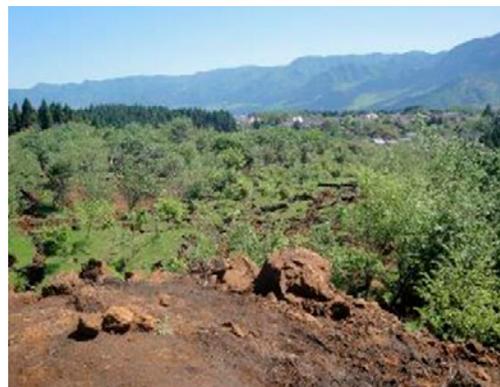
Fig. 20. Cracks in the slope.

volcanic eruption in and around Kusasenrigahama crater (Matsuda et al., 2003; Miyabuchi et al., 2004). Many cracks still remain in the slopes (**Fig. 20**). In some places, cracks as deep as 3 m were found. During rainy season starting soon, rain water may infiltrate through this crack, causing those slopes with cracks vulnerable to secondary disaster. More than 90 such vulnerable slopes exist.

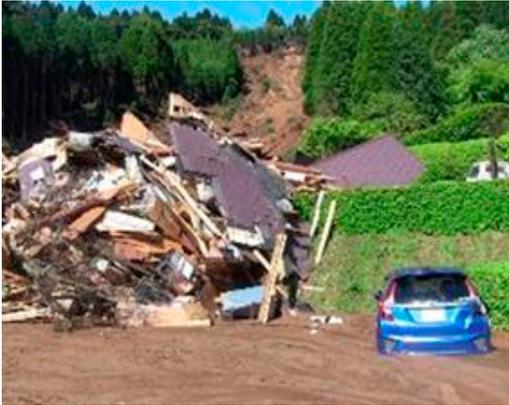
Fig. 21. Hinotori hot spring disaster.

In another location, Hinotori hot spring facilities were swept away by a landslide (**Fig. 21**) that occurred during the main shock. A honeymoon couple from Kagawa prefecture was killed due to that debris flow. The soils in that area were found to be of volcanic origin with very low plasticity. The water content was also found to be very high. This kind of soil loses strength easily during cyclic loading. Such soil characteristics in that area may have caused slope failure triggered by the earthquake loading. Since the slope failed during the main shock, the cyclic loading effect of the foreshock is another factor, which needs attention in the damage analysis of such slopes.

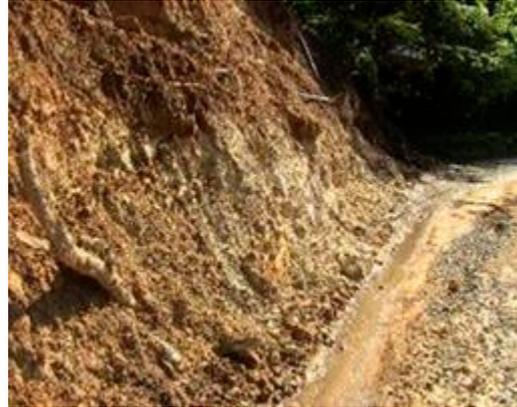
Fig. 22. Soils in that area (Haido).

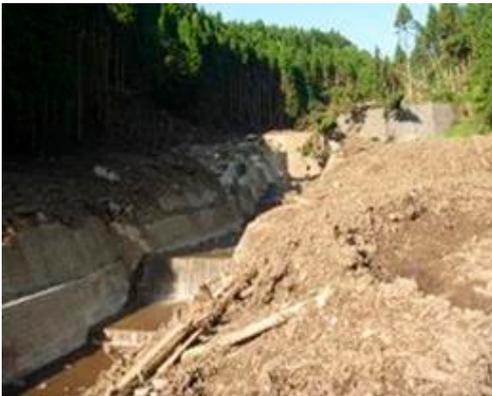
Fig. 23. Concrete check dam collapse.

A check dam was found to be collapsed in Nagano area of the Aso village (**Fig. 23**). The right side of the check dam was swept away by about 100 m, and completely overturned (**Fig. 24**). Also, many debris were found near the overturned block (**Fig. 25**). Due to the collapse of the dam, the Tarutama river is eroded at many locations as

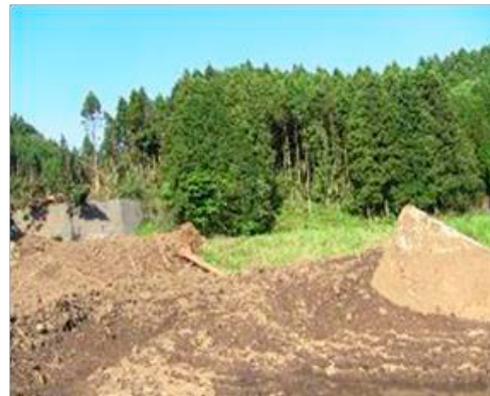
Fig. 24. Collapsed part of the dam.

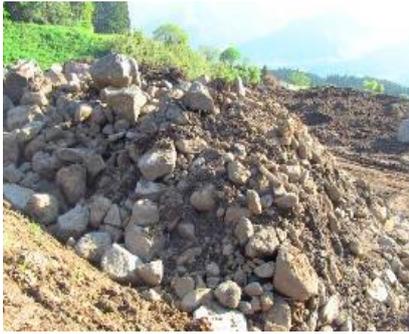
Fig. 25. Debris around the dam.

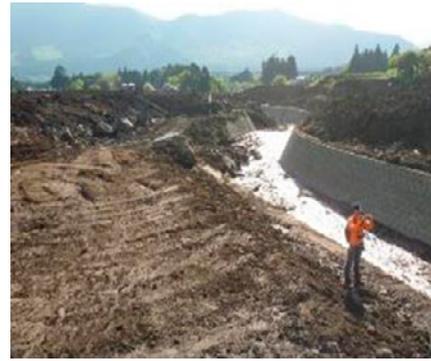
Fig. 26. Erosion of the river channel.

seen in **Fig. 26**. The exact reason of the failure is still unknown. However, continuous water flow close to the dam even before the earthquake can be one potential cause of such catastrophic failure.

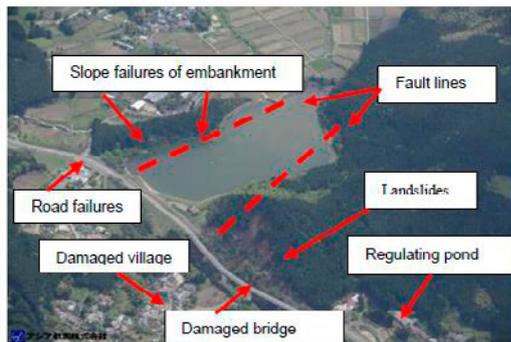
Fig. 27. A complete view of the reservoir before the earthquake and the related damage.

of 23 m for irrigational purpose. Our first survey team arrived in that area around 10 A.M. on April 16 (the day of the main shock) and conducted surveys on the dam, control room, regulating pond, slopes and the roads along the dam. This section describes the state of damage of the reservoir, spillway, drainpipes, regulating pond, etc. **Fig. 27** shows a picture of the entire reservoir and the associated damage due to the earthquake.

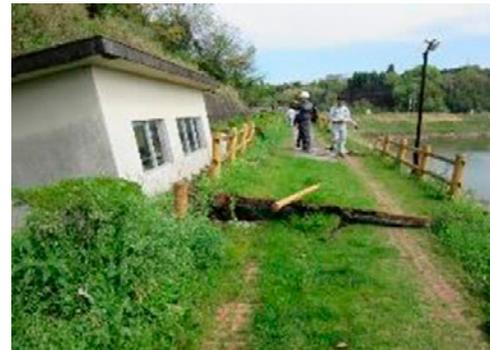
Fig. 28. Damage to control room.

Due to damage inflicted on the control room (**Fig. 28**), as an urgent measure, the water level in the reservoir was lowered by about 2 m. **Fig. 29** shows some of the damage in the upstream of the dam including the road, slopes, and the retaining wall.

Due to strong motion of the earthquake and proximity of the fault zone, the control room tilted, and as a result, spindles were lifted off, rendering the switch gears non-functional and leading to loss of the water storage function. This ultimately led to the overflow in the regulating pond of the dam (Fig. 30). The overflowed water crossed the road and created an artificial fall (Fig. 31), which caused tremendous scouring of the road embankment. The scouring also could be observed in the road embankment, which is vulnerable to collapse at any time (Fig. 32).

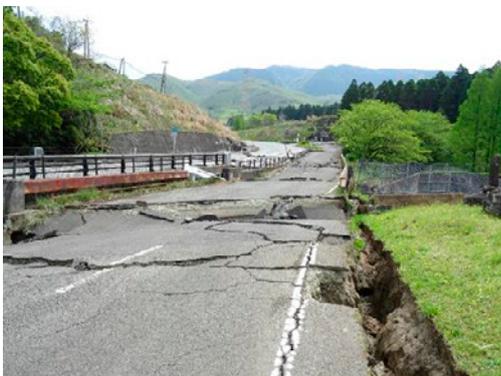
Fig. 29. Damage to roads and retaining wall.

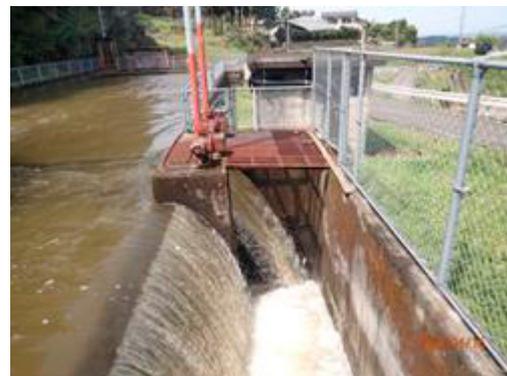
Fig. 30. Overflow of the regulating pond.

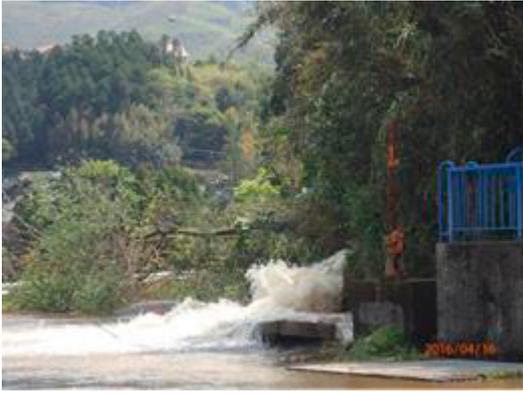
Fig. 31. Overflowed water crossing the road.

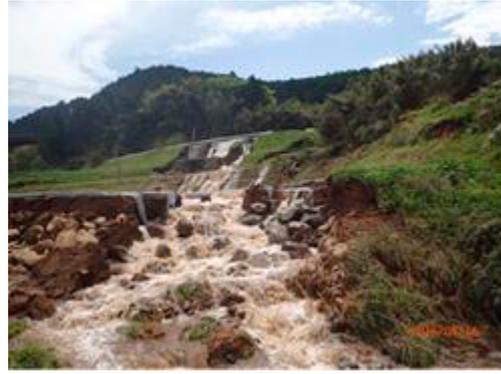
Fig. 32. Scouring of the road embankment adjacent to spillway.

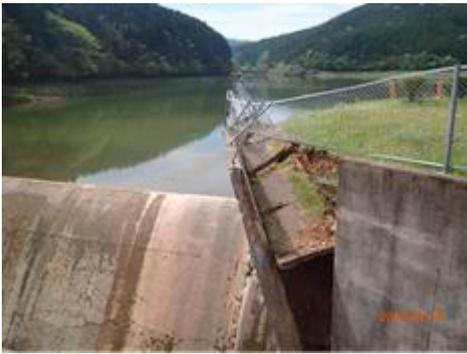
Fig. 33. Wall damage on the embankment.

The spillway did not suffer damage, however retaining walls on the both sides of the embankment were displaced (especially the right side was displaced by more than 50 cm) as seen in the Fig. 33. During the second visit of the

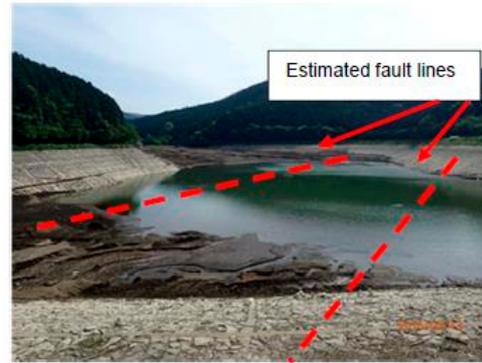
Fig. 34. Emptied reservoir and exposed fault lines.

The continuous overflow almost emptied the reservoir, which the authors observed in their second survey within four weeks (Fig. 34). We could visually observe the faults that passes through the dam. Therefore, it could be concluded that the major damage was due to these faults. We could also see slope failures at two locations of the dam embankment (Fig. 35). Regulating pond has come to the normal state (Fig. 36), however, the scouring caused

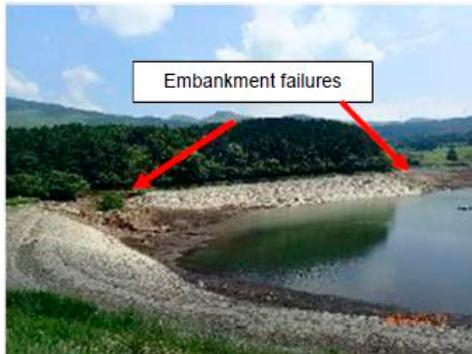
Fig. 35. Slope failures along the embankment.

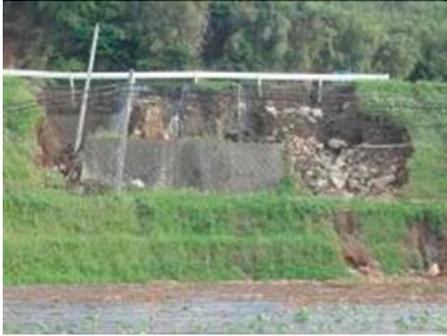
Fig. 37. Scouring of the road embankment.

to the road embankment was severe, and it is vulnerable to collapse at any time (**Fig. 37**).

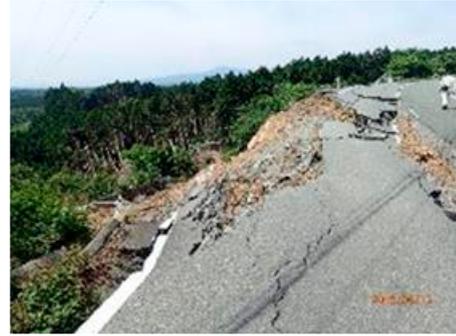
Fig. 38. Landslide blocking the access road.

There were also a lot of landslides and slope failures and road damage (**Fig. 38**) around the road including a bridge within 1 km of both sides of the faults. The main road suffered landslides as well as subsidence (**Fig. 39**). About the 90% of the houses down the road completely collapsed including an engineered retaining wall (**Fig. 40**). A preliminary survey results of the dam damage are described in Hara et al (2016).

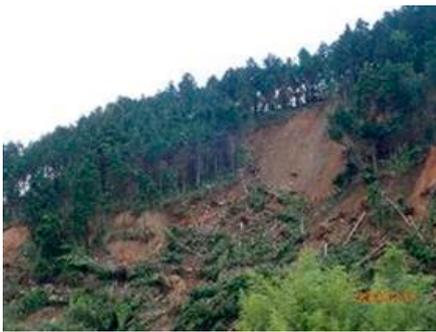
Fig. 39. Slope failure on the main road.

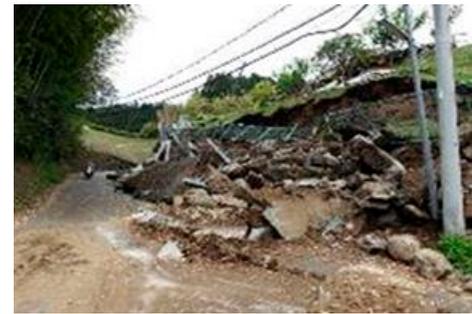
Fig. 40. Retaining wall (about 5 m high) failure.

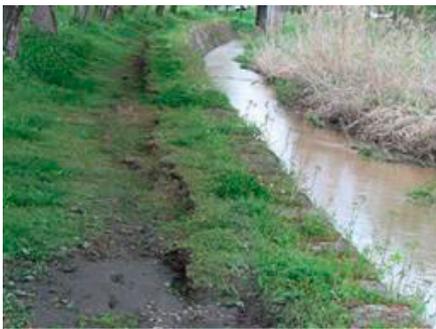
Fig. 41. Liquefaction in Akitsu river dike.

of geotechnical damage mostly related to liquefaction and associated lateral spreading. **Fig. 41** and **Fig. 42** respectively show the Akitsu river embankment with sand boils and displacement of the quay wall due to lateral spreading. **Fig. 43** shows the lateral displacement-induced failure of the embankment road. About 30 cm subsidence of the river bank and more than 20 cm of lateral displacement of road were measured. The dark colored sand boils (**Fig. 41**) indicate the existence of volcanic soils in the area. In a parking lot belonging to JA (Japan Agricultural Cooperatives Group) office of Mashiki town, which is close to the Akitsu river, a large amount of sand boils were observed (**Fig. 44**). The color of the sand boils (appears to be clean sand), however, was different from the one found in the bank of Akitsu river. In few national and prefectural roads too liquefaction induced settlement

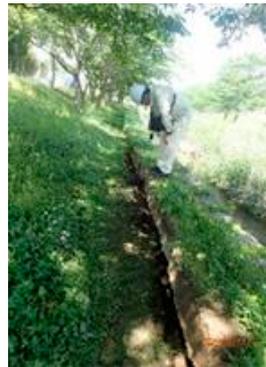
Fig. 42. Lateral displacement of quay wall.

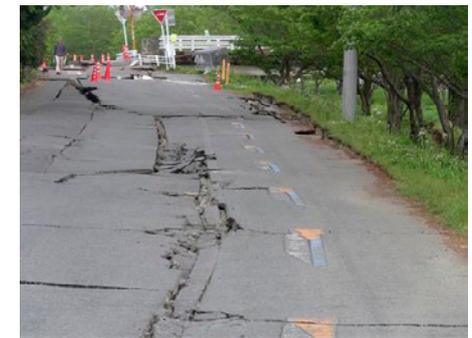
Fig. 43. Lateral spreading in the embankment road.

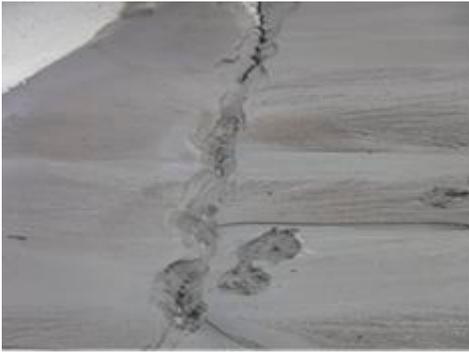
Fig. 44. Sand boils in JA parking lot.

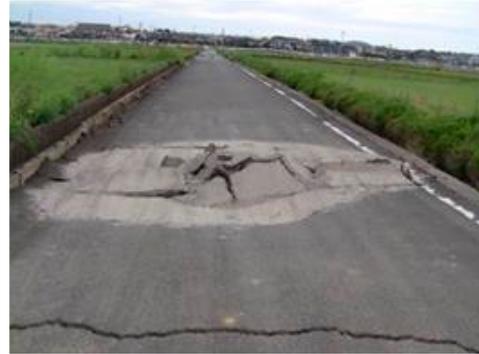
Fig. 45. Subsidence of the road.

(Fig. 45) and upliftment of manhole (Fig. 46) were observed. Many traditional Japanese style houses were damaged due to the strong motion in that area.

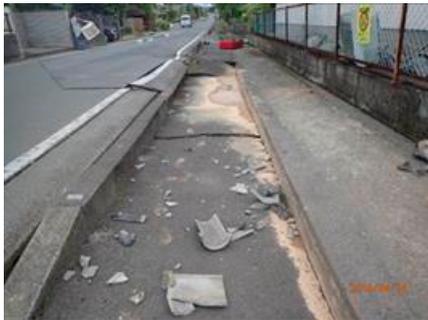
Fig. 46. Uplifting of manhole.

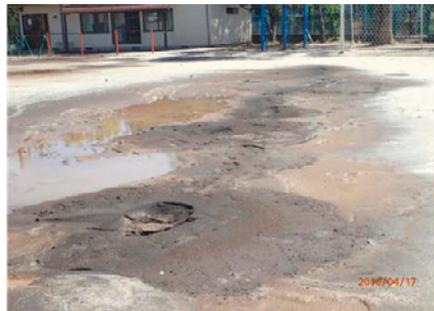
Fig. 47. Sand boils in a school ground.

Most of the liquefaction related damage were concentrated in the area, which are old river channel or floodplain. Sand boils observed in a school ground, which is the designated disaster evacuation place in that

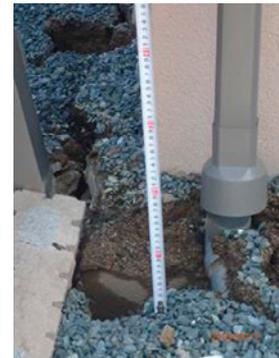
Fig. 48. Settlement of the ground around a pile supported building.

residential area, is shown in Fig. 47. Fig. 48 shows a residential building, where sub-meter settlements of the ground around the building were observed. The building itself did not undergo any differential settlement, as according to the owner of the building, pile foundations were used in the building. However, subsidence induced voids beneath the foundation is a concern of the owner (Fig. 49). Another building adjacent to the above building (Fig. 50) was found to suffer from differential settlement and tilted by more than 1 degree making it unsuitable to live. Apparently, this building was founded on spread footing. The geomorphology of this area indicates that it was developed by reclamation of an old river channel. In Hirata district of Minami ward, several buildings were damaged due to ground subsidence. Differential

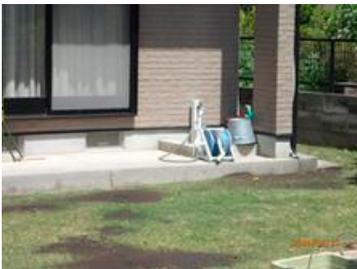
Fig. 49. Subsidence and voids beneath the foundation.

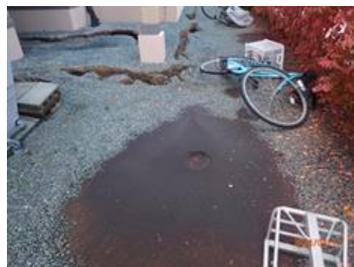
Fig. 50. Differential settlement and tilting of another building supported on spread footing.

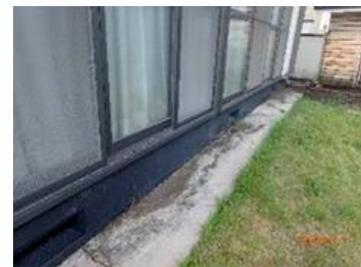
Fig. 51. Building damaged due to differential settlement.

settlements of the buildings were common features. Some boundary walls were partially or fully collapsed. Sand boils and liquefaction induced settlement of the buildings (Fig. 51) were observed. The sand boils were found to be black

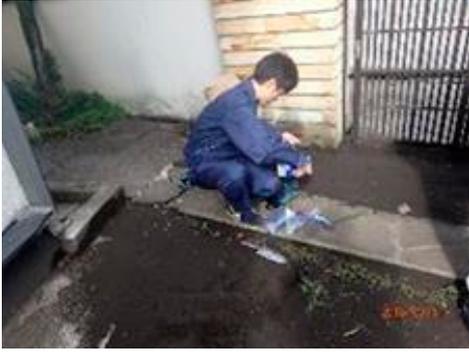
Fig. 52. Dark colored sand boils around the building.

in color (Fig.52) indicating that the soils is of volcanic origin. One of the most affected buildings in that area was a new private hospital. A subsidence of as much as 40 cm was observed around the building. Ground subsidence can

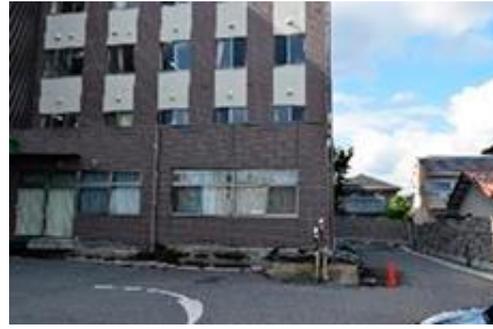
Fig. 53. Subsidence around a new private hospital building.

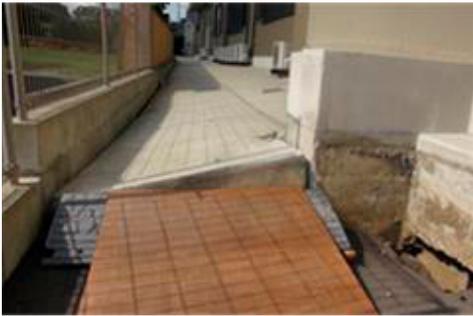
Fig. 54. Subsidence at the backside of the hospital building.

also be seen near stairs (backside) of the building (**Fig. 54**). The hospital building itself was safe with no differential settlement due to use of pile foundation. Liquefied soil can be seen around a residential building located at backside of the hospital building. About 15 cm differential settlement, and about 2 degree tilting were observed in that building. Boundary wall of the building was found to be tilted containing many cracks, indicating the effect of liquefaction.

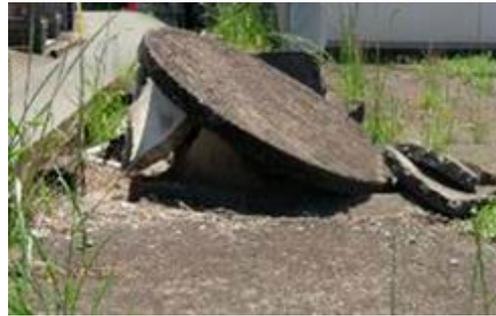
Fig. 55. Liquefaction induced road damage (Uplifted manhole).

Many roads were damaged in the affected area near the hospital. **Fig. 55** shows one of the damaged roads with uplifted manhole. About 18 cm lateral spreading of that road was observed. Drainage system was also damaged

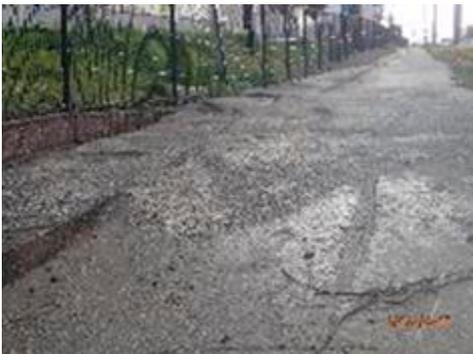
Fig. 56. Liquefaction in port complex.

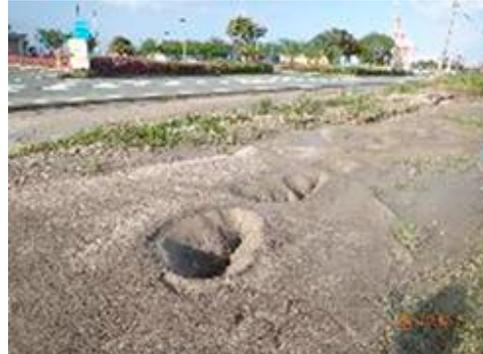
Fig. 57. Sand boils (max. dia. > 1.5m).

Although some infrastructural facilities within the Kumamoto port complex, such as roads and building entrance, were damaged due to liquefaction, the main port itself did not suffer much loss. The first author arrived in the port area in the morning of April 17. A lot of sand boils were observed in the port complex (**Fig. 56**), which resulted in the settlement of the entrance of the ferry terminal and road damage. **Fig. 57** shows some sand boils with maximum diameter of 1.5 m in the port complex

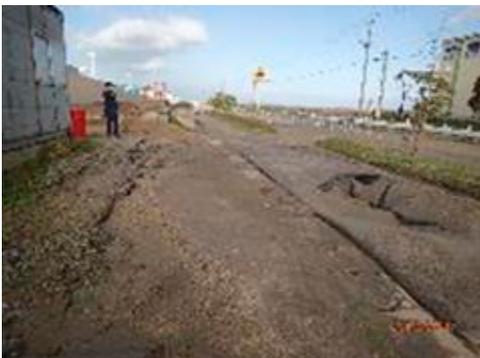
Fig. 58. Lateral spreading and sinking of road .

resulting in the maximum settlement of about 30 cm. Liquefaction induced lateral spreading and sinking of the road was also observed (**Fig. 58**). The liquefaction in the areas also led to some minor laterals spreading as seen. No significant damage to the quay wall (**Fig. 59**), however, was observed. The entrance of the ferry terminal was affected by differential settlement (**Fig. 60**) that led to the closer of the terminal for few weeks.

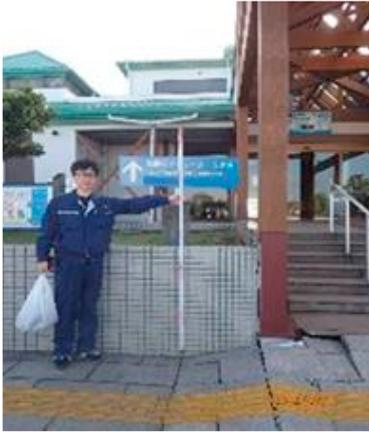
Fig. 60. Differential settlement of the ferry terminal.

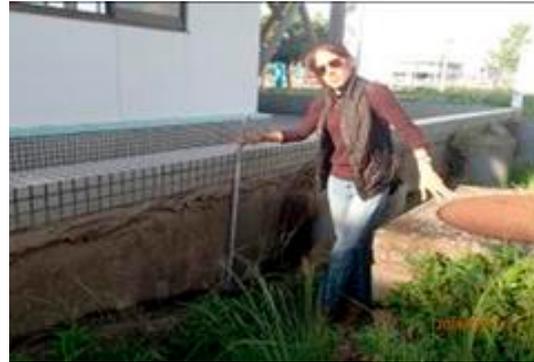
Fig. 61. Subsidence around the terminal building.

Maximum settlement around the building was observed to be more than 80 cm (**Fig. 61**). The over bridge connecting the port terminal also suffered damage due to differential settlement (**Fig. 62**). In the second visit to the area by the authors on May 11, a temporary retrofitting of the bridge (**Fig. 63**) was seen to prevent any further damage by the aftershocks. Interestingly, the soils in the port area are different from those found in the other liquefied areas discussed before. According to some information gathered by the authors, sand mats that were used to consolidate the thick clay layer in the port areas may have liquefied. The liquefied sands were found to be clean sand as opposed to the volcanic soils found in most of the other liquefied areas.

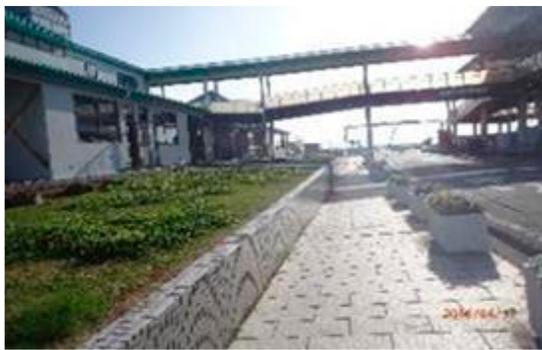
Fig. 62. Damage to over-bridge due to differential settlement.

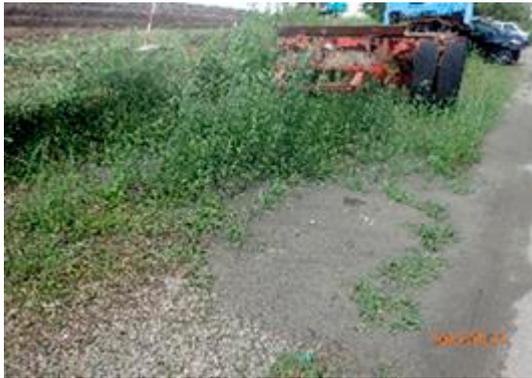
Fig. 66. Sand boils, subsidence and lateral spreading in Midori river dike.

River dikes of Kase river, Midori river and Shira river were damaged due to liquefaction and lateral spreading. Fearing the danger of further erosion due to forthcoming rainy season, the local government was very quick to do the immediate repairment work. **Fig. 64** shows the temporary repairment work in the Kase river dike using recycled concrete. **Fig. 65** shows the immediate repairment work in the dike of Midori river. Some traces of sand boils and liquefaction induced subsidence were still found in that area (**Fig. 66**).

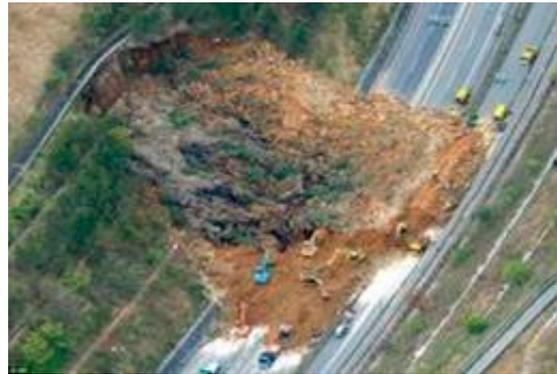
Fig. 67. Highway damage in Kyushu highway (Source: AGU and AAS).

The authors do not have any direct information on the damage to highways, as the admission were restricted to those sites, when the authors arrived there. Based on the collected information from various sources, few damages of the Kyushu Highway are summarized in this subsection. **Fig. 67** shows the damage to Kyushu highway in Kumamoto prefecture. **Fig. 68** shows the blocking of the highway due to landslides in Oita expressway, Oita

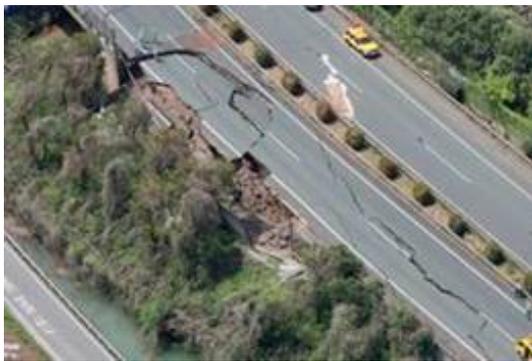
Fig. 68. Highway damage in Oita expressway (Source: AGU and AAS).

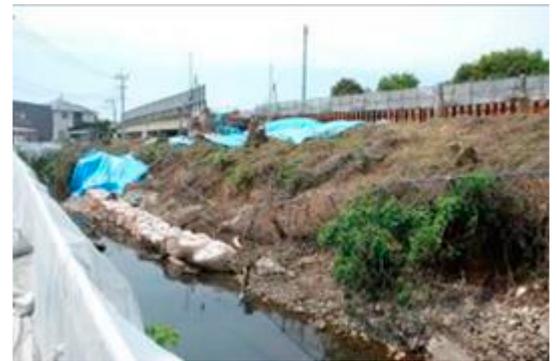
Fig. 69. Highway abutment damage in Kyushu expressway (Photo courtesy: Dr. Y. Saqawa, Kyushu).

prefecture. **Fig. 69** shows the highway embankment damage and retaining wall failure in Kyushu highway near Mashiki town. A part of the highway was closed for about two weeks. The immediate repairment work of the highway is underway as seen in the figure.
