# Field validated prediction of latent slope failure based on cracked soil approach

S. Aleksander<sup>1</sup>, I.B. Mochtar<sup>2</sup> and W. Utama<sup>3</sup>

On December 2th, 2016, slope failure had occurred in the village of Sumberjo, District Selorejo, Blitar, Indonesia,

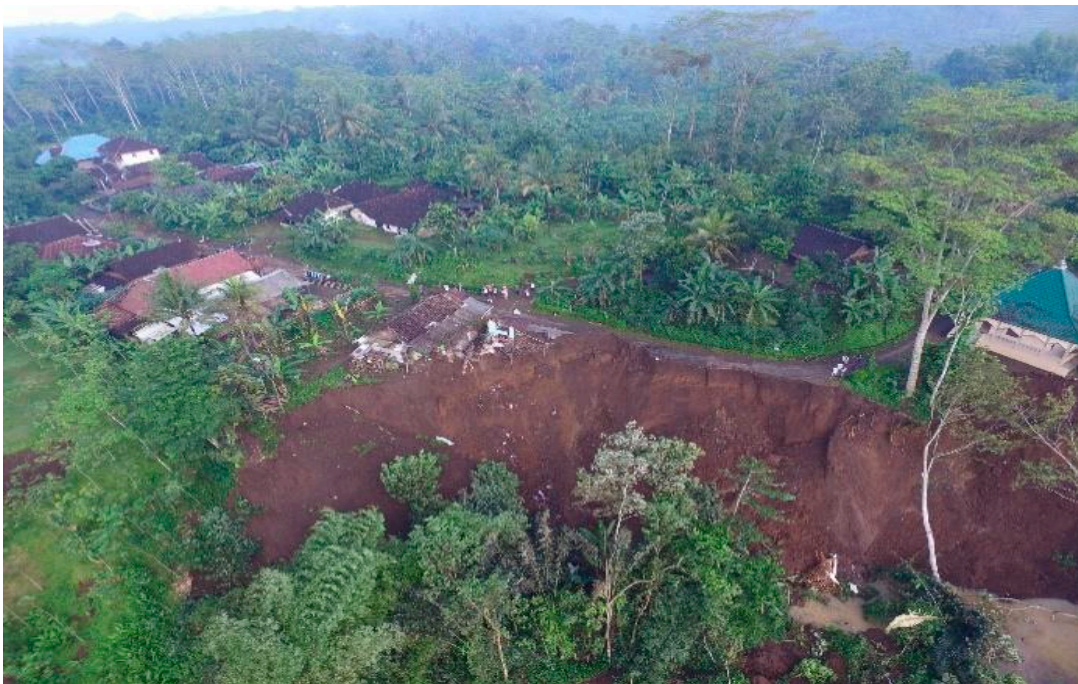
as it seen in **Fig. 1** (Alexander et. al., 2017). Based on rain measurement, the rain had fallen for about 10 hours before the slope failure with total rainfall intensity of 102 mm in 10 hours. The rain at the location of study during the 10 hours period of observation had fallen as combination of light rain, heavy rain to very heavy rain. Since the above slope had been stable for many years before under many rains, the apparent question would be whether the duration of rain or the intensity of rain that caused the slope failure.

Fig. 1. Slope failure occurred in Sumberjo Village, Blitar Indonesia (Alexander, 2017).

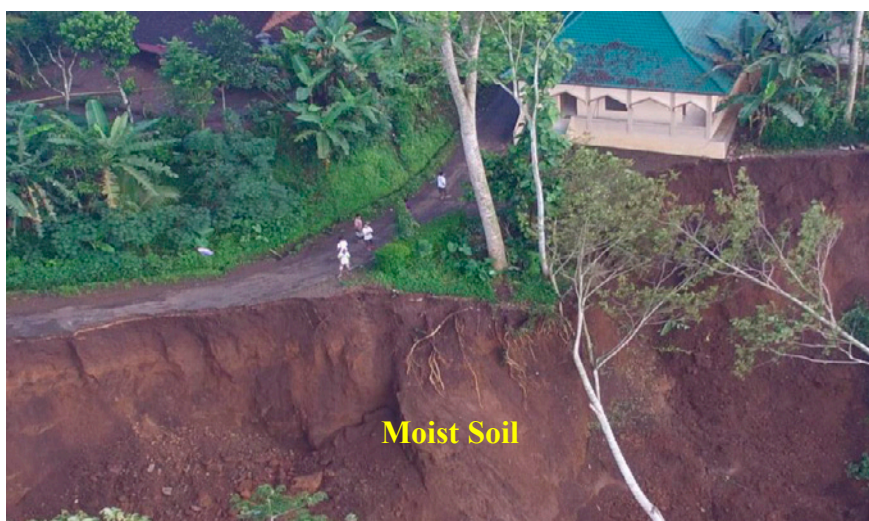
**Fig. 2.** Typical mostly dry and moist soil layers along the failed slope (assumption of saturated slope prior to failure is not proven). (Source: Alexander, 2017).

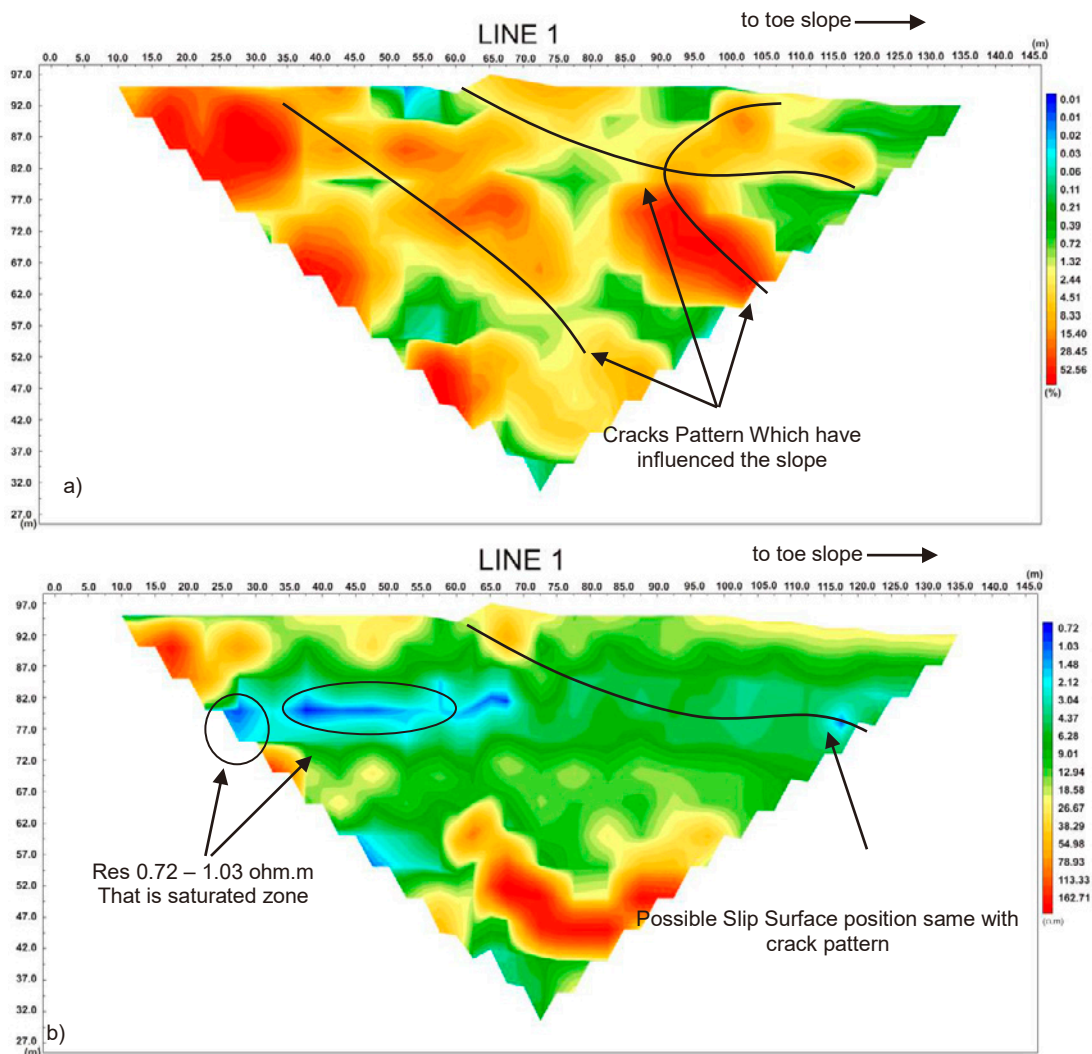
The magnitude of TR value along the failure plane are 18.58 – 78.93 ohm.m and these values appears along 50 to 55 meters length of the slope with direction of the cracks similar to the direction of slope failure. Furthermore, just below failure plane one could locate the cracks from the IP values that range between 0.72 – 15.40 %, occurring in Line 1. For Line 2 the failure plane is shown with TR values between 12.99 – 18.83 ohm.m to spread for 40 – 42 meters length with IP value of 0.52 – 39.31 %. For Line 3 the failure plane shown TR value 15.44 – 23.47 ohm.m which is spreading for 30 – 36 meters with IP value of 2.61 – 45.56 %.

Fig 5. Interpretation result of Line 1, showing the existence of cracks pattern that might have influenced the slope stability. (a). Result of Induced Polarization, (b). Result of Tomography Resistivity.

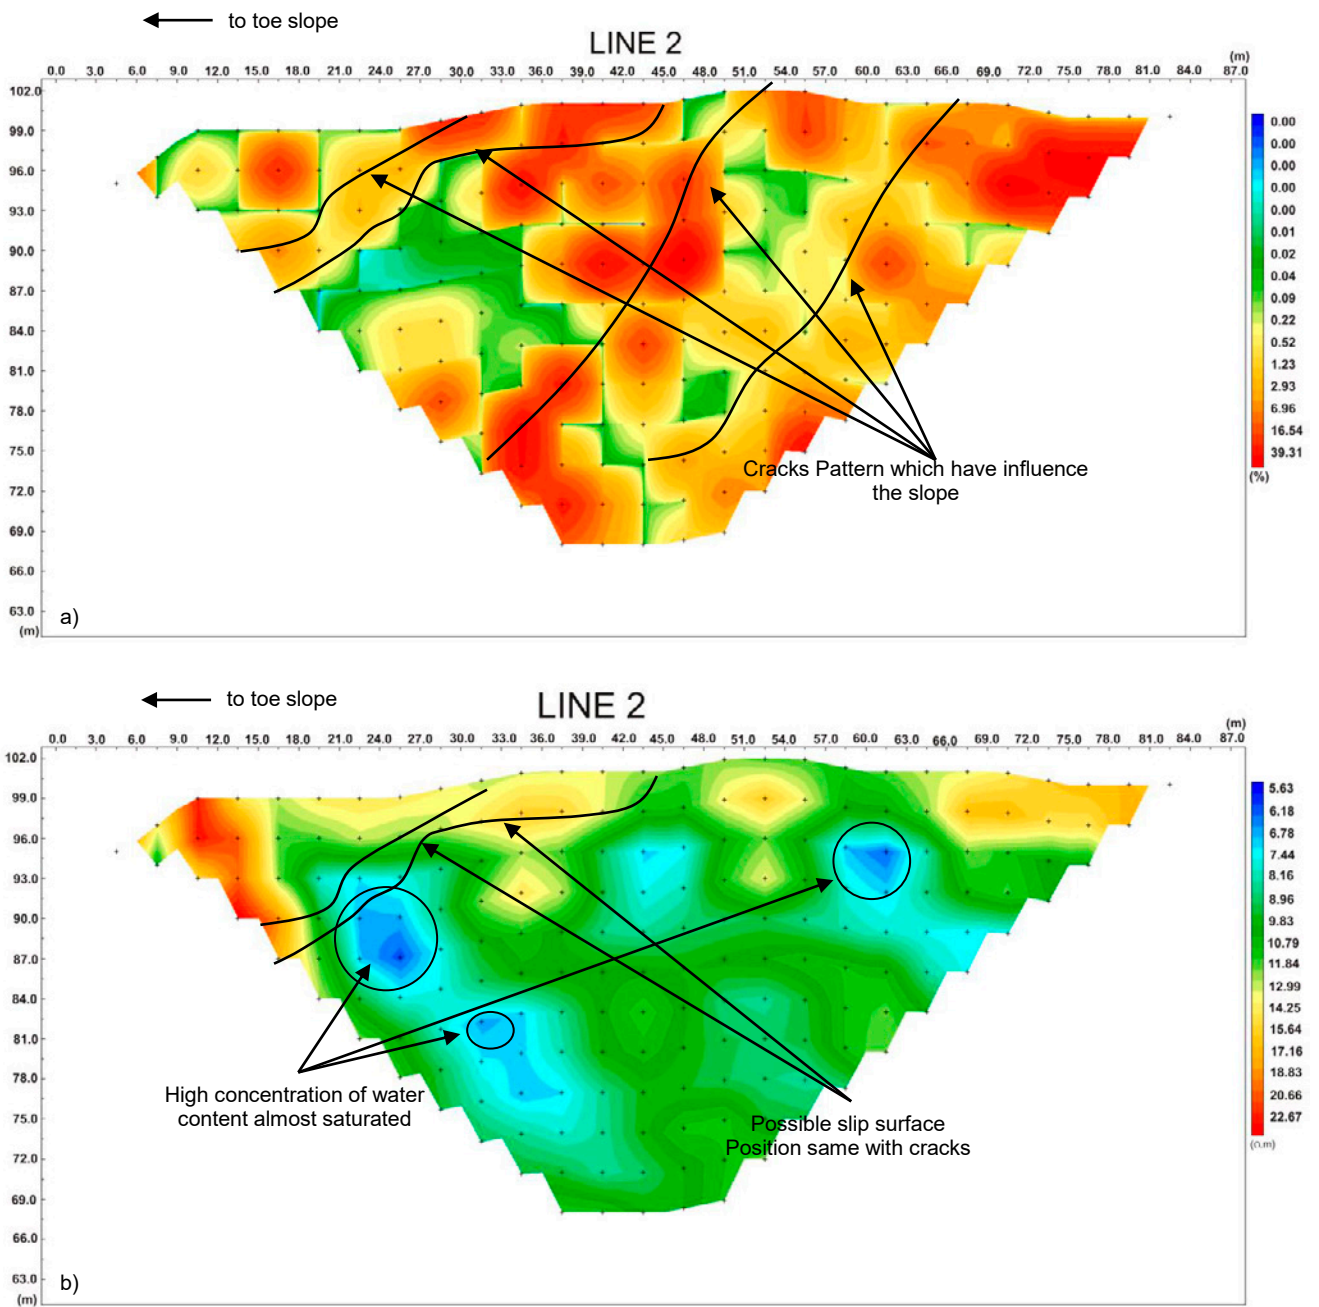
**Fig. 6.** Interpretation result of Line 2, showing the existence of cracks pattern that influence the slope stability. (a). Result of Induced Polarization, (b). Result of Tomography Resistivity.

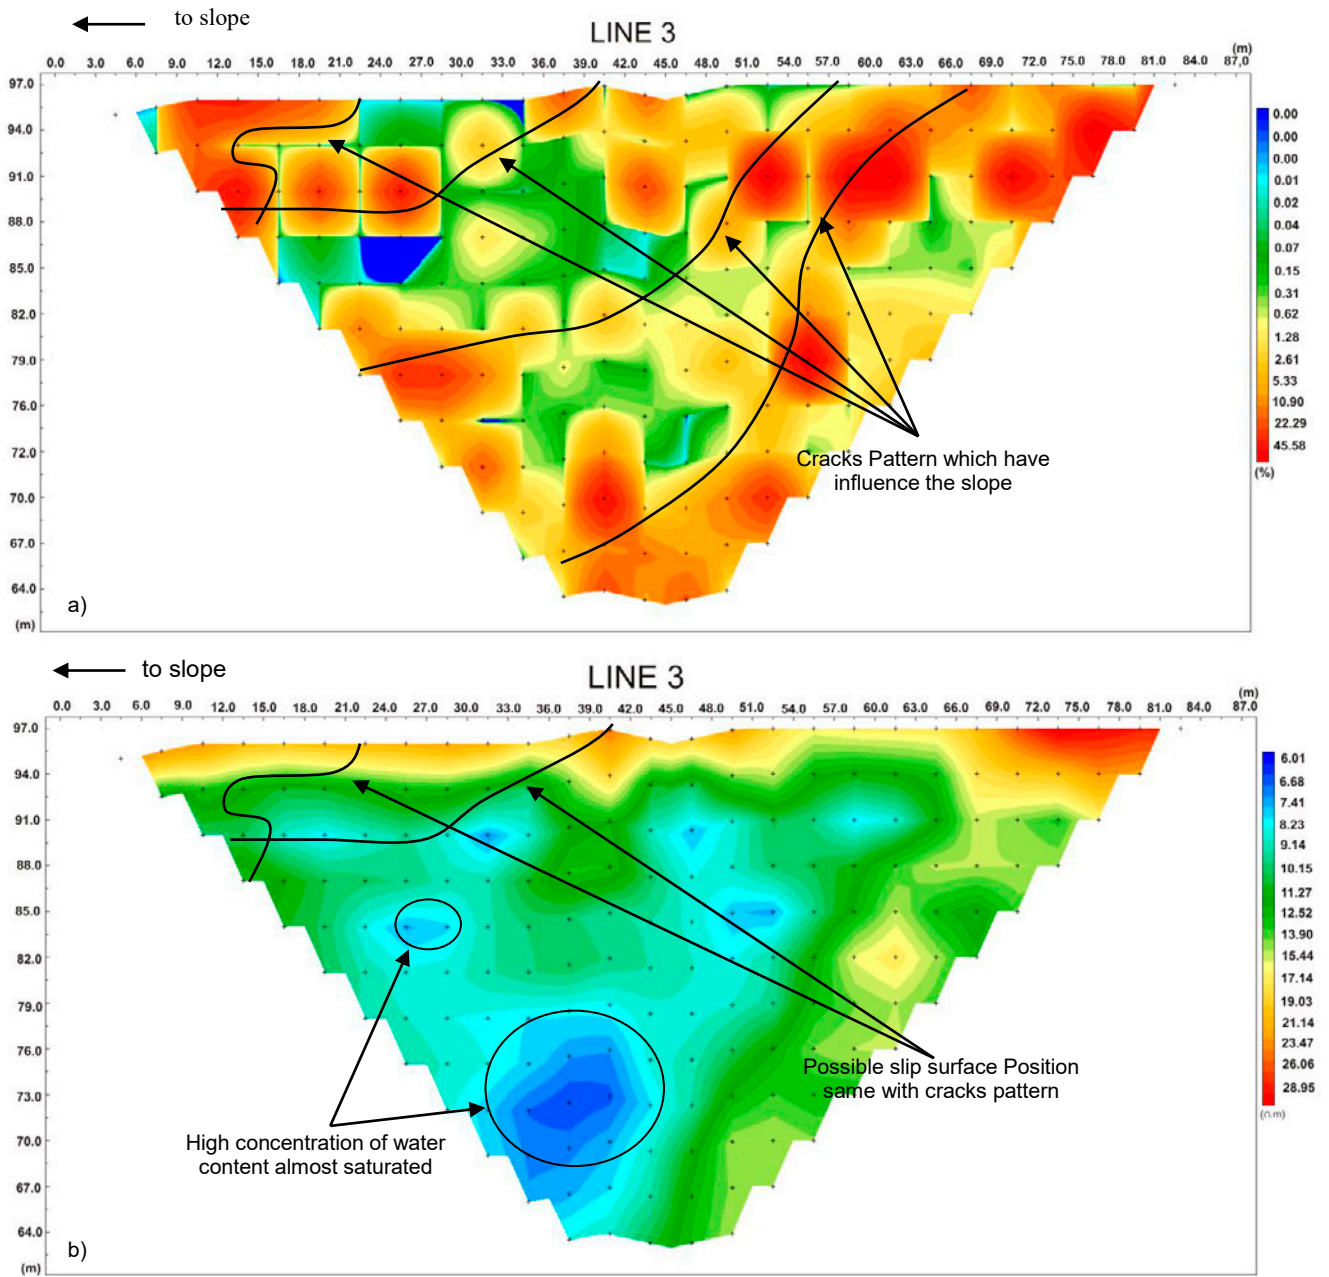
**Fig. 7.** Interpretation result of Line 3, showing the existence of cracks pattern that influenced the slope stability. (a). Result of Induced Polarization, (b). Result of Tomography Resistivity.

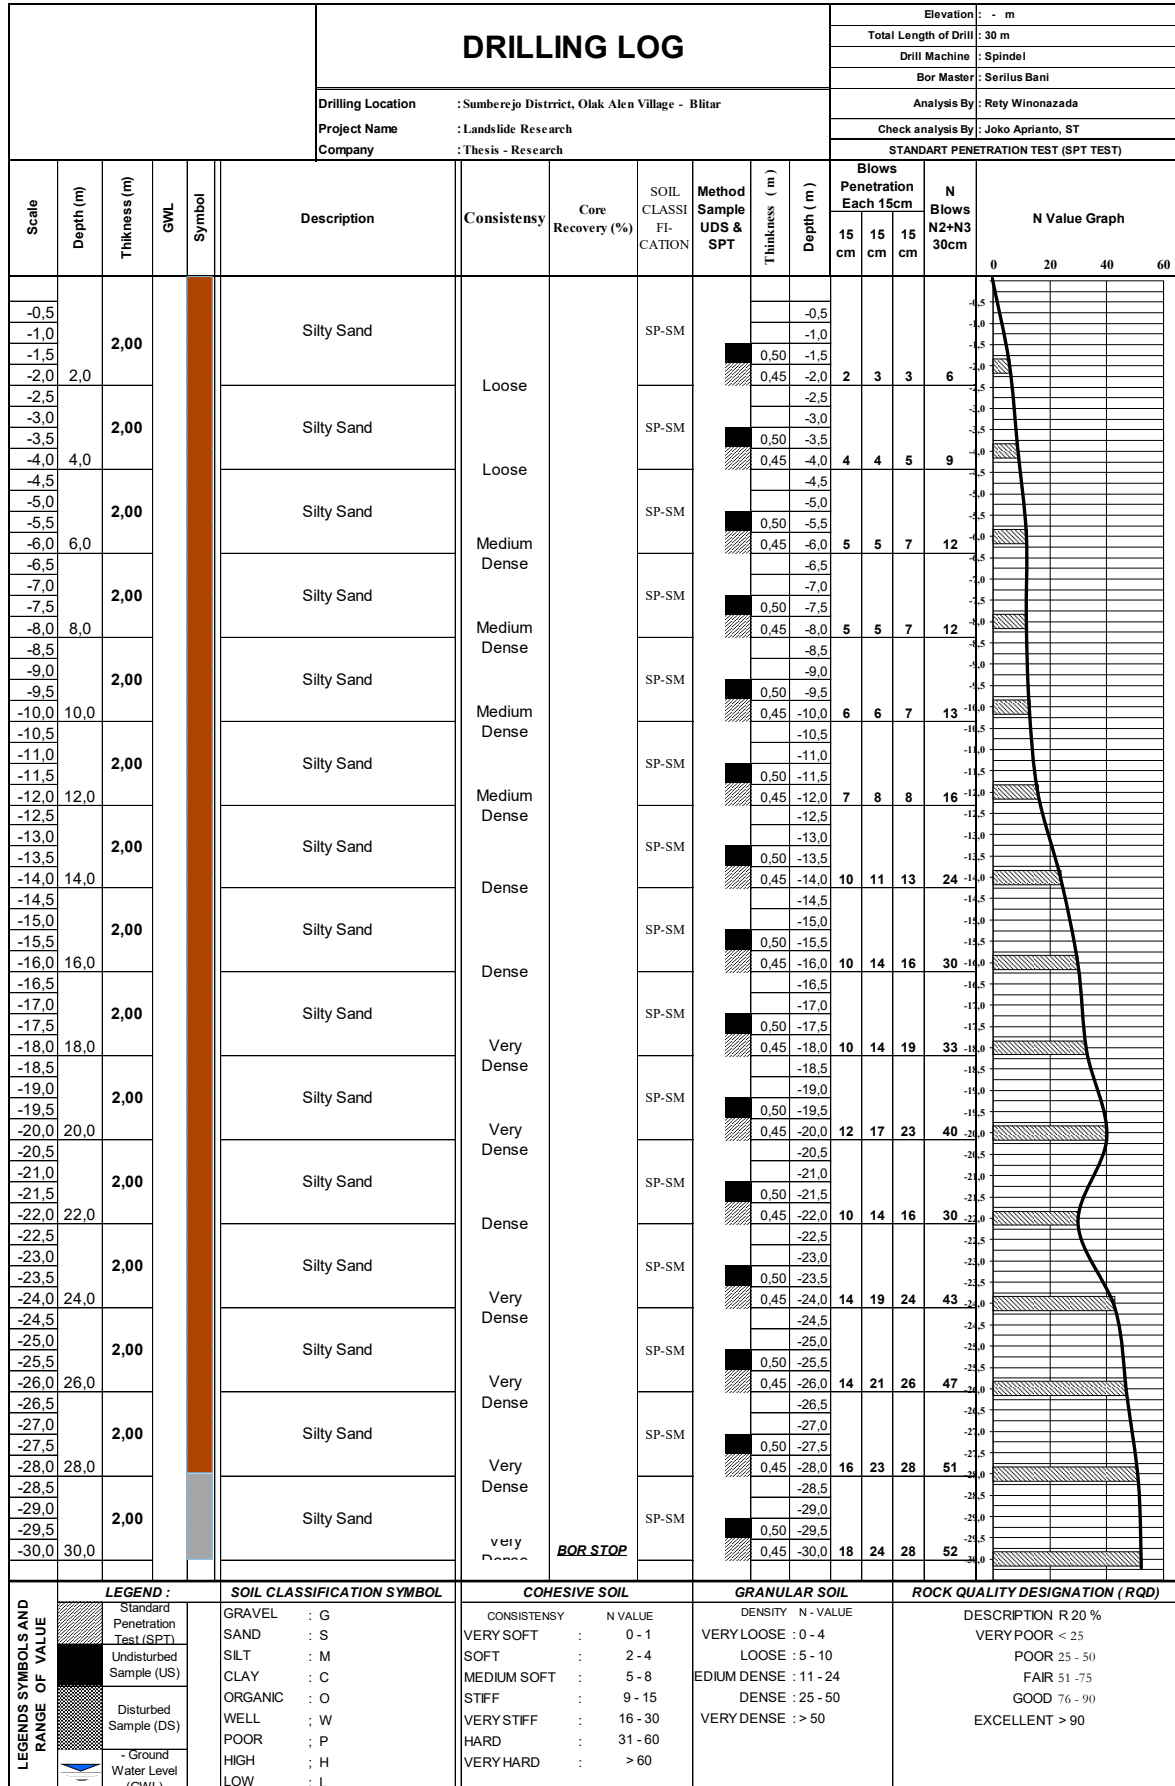
Soil investigation was performed using SPT and boring test to obtain soil samples. From boring test to the depth of 30 meter at the study location, six layers of soil were obtained and they were predominantly of soil from loose silty sand to very dense silty sand, soil such as those given **Fig. 8**. For laboratory test result, the soil parameters are given in **Table 1**.

Fig. 8. The result of soil Investigation for SPT and Boring.

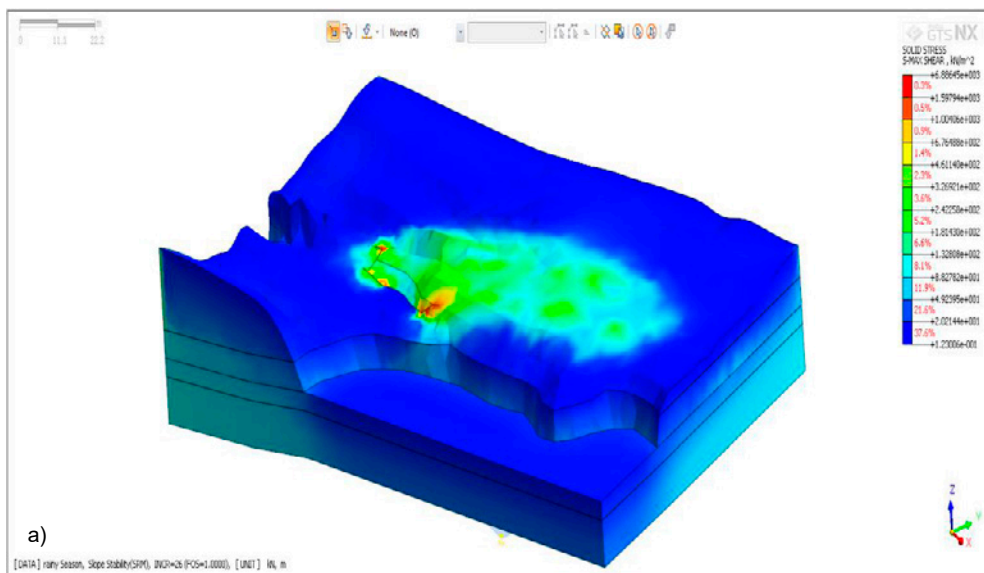
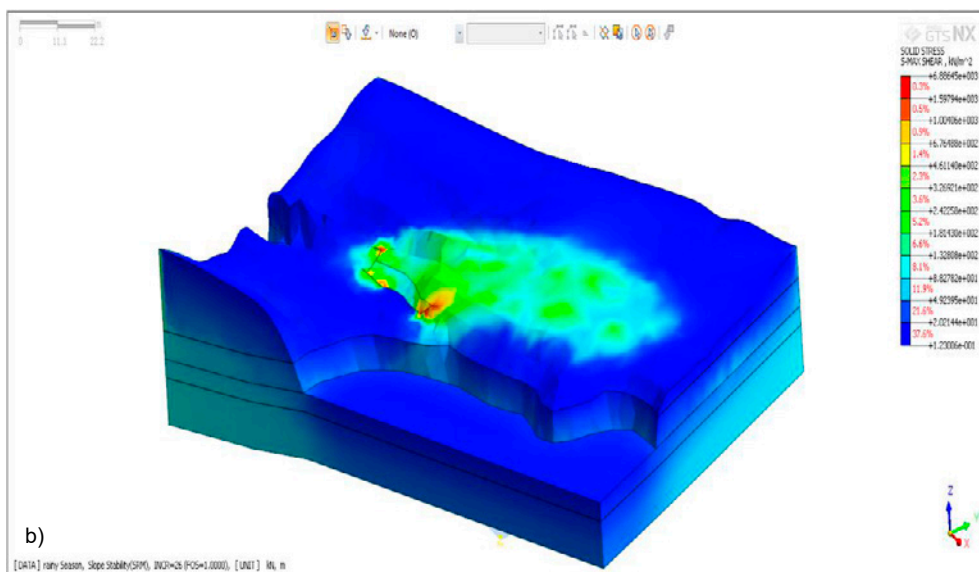
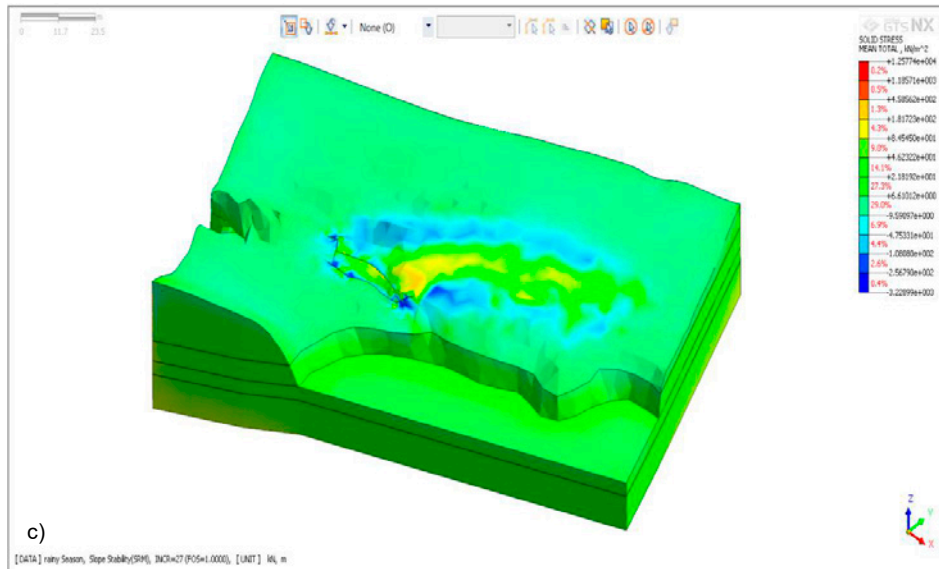
After landslide occurred at December 2<sup>nd</sup>, 2016, geoelectric measurement were conducted on the slide as well as boring on the soil with SPT. From those analysis and by means software Midas, the Safety Factor, SF = 1, was obtained and the maximum shear stress of  $1.59 \times 10^3$  to  $6.88 \times 10^3$  Kn/m<sup>2</sup> was estimated. The location of maximum strain of 2.5 that can be drawn as in **Fig. 11**. In **Fig. 11**, the highest concentration of stresses and strains should be given special attention, because these area can be predicted as the next location where sliding will be sliding

**Fig. 11.** The existence of area with maximum stresses and strain, inside the slope. (a). Result of analysis shows the concentration of maximum stresses are colored in red, (b). Result of analysis also shows the highest concentration of strain appeared in red color, (c). Result of analysis show mean total pressure.

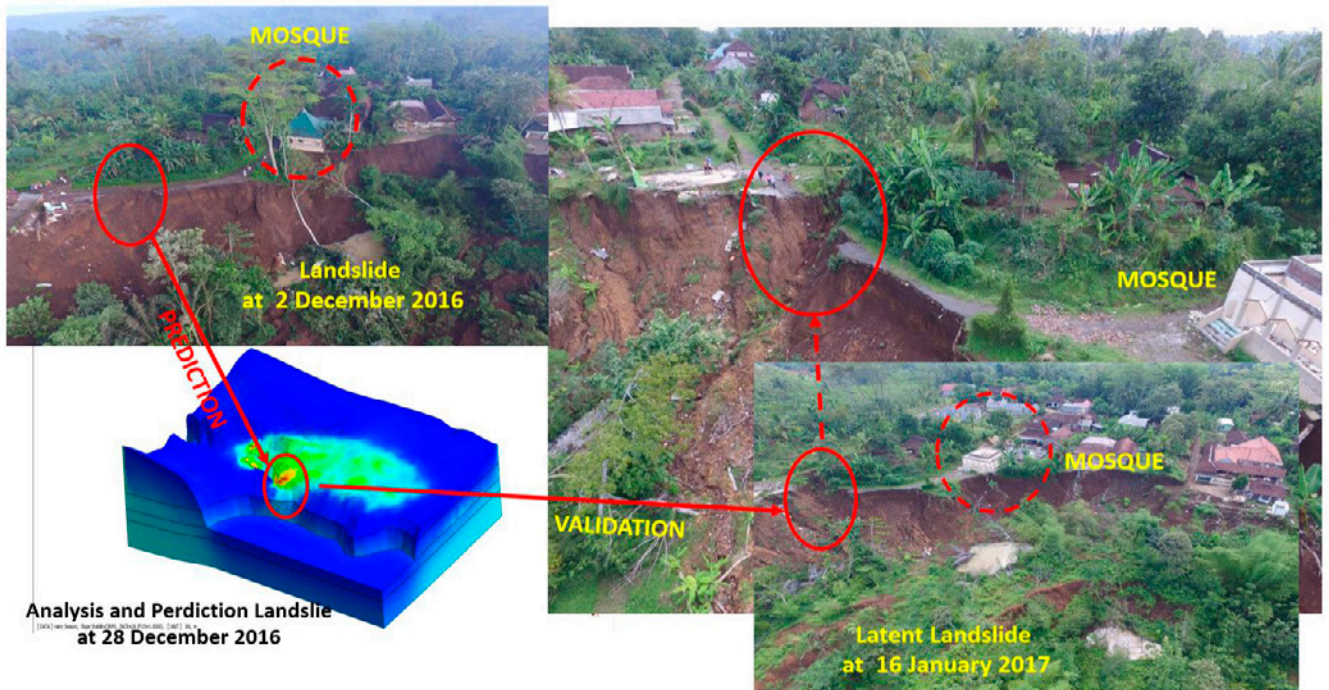
The result of previous analysis showed the area highest concentration of stress and strain can be predicted to be next location to experience sliding. This has been proven in field that on January 16, 2017, another landslide did occurred and the new landslide was located exactly at the position showed by analysis using software. The location where the highest of stresses and strains was detected. The actual part of the remaining slope where failure occurred afterward as seen in **Fig. 12**.

**Fig. 12.** The area where the highest stress and strain were found base on analysis of slope after failure in December 2016 and also the location where the next slide occurred in January 2017.
