Technical Note

A case study on tail brush induced loads upon segmental lining

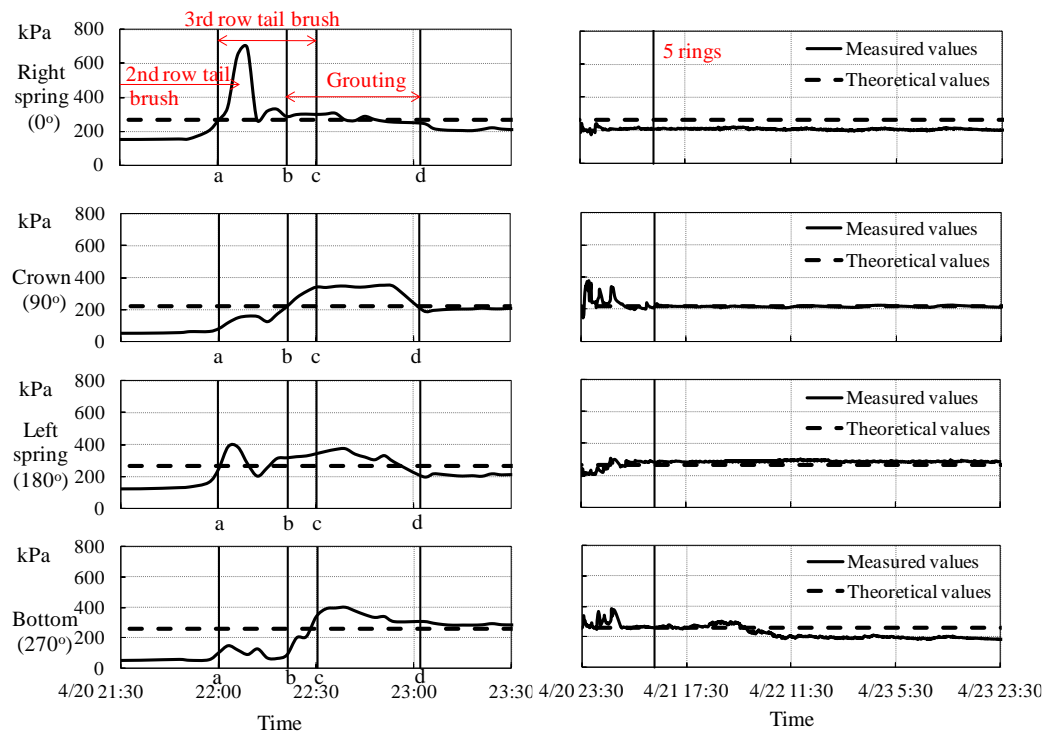
Fig. 3. Time history of earth pressure upon segments

Note: As the data were recorded after the assembly of next ring of section A, the pressure induced by the first row of tail brushes and some of that induced by the second row of tail brushes was missed.

The time histories of the pressure measured on the segments of the two monitored sections are shown in Fig. 3. In Section A, the real-time data recording started after the assembly of the next ring. At that moment, the pressure gauges had already been passed by the first row of tail brushes and had touched the second row of tail brushes. Therefore, the pressure induced by the first row and a part of that induced by the second row of tail

brushes is found missing in Fig. 3. By crosschecking with the shield advancing records, four pivotal moments are identified in **Fig. 3**. Time "a" indicates when the third row of tail brushes begins acting upon the earth pressure

When passing through the third row of the tail brush, most of the measured pressures increased and became larger than the theoretical values. The large discrepancy between the pressures induced by the first~second rows and those by the third row of tail brush was obviously due to the different materials used in the three rows of tail brush. As mentioned in session 2, the first and second rows were conventional wire brushes, while the third row was steel plate brush as shown in **Fig.4**. The outmost steel plate brush is much stiffer than the wire brush. It can provide better sealing effect than the wire type. On the other hand, it imposes unexpected pressure upon segments.

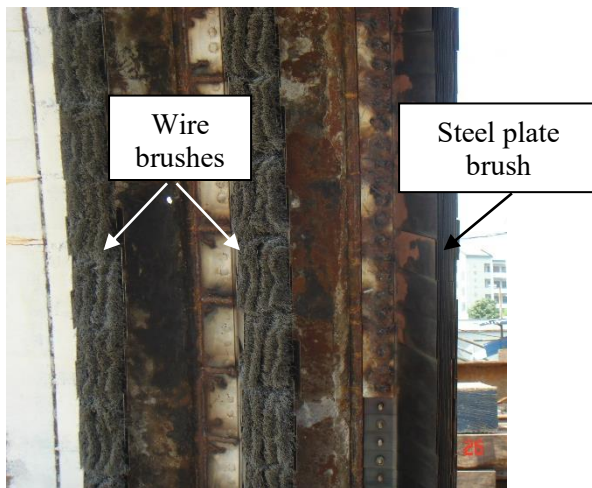
Fig. 4. Photograph of tail brushes

In general, there are three rows of wire brushes in the shield tail, together with grease to prevent water, soil and grouting material leaking through the tail void. The replacement of the third row of wire brushes by steel plate brushes was done because of wearing out too quickly of wire brushes to maintain a sealing effect.

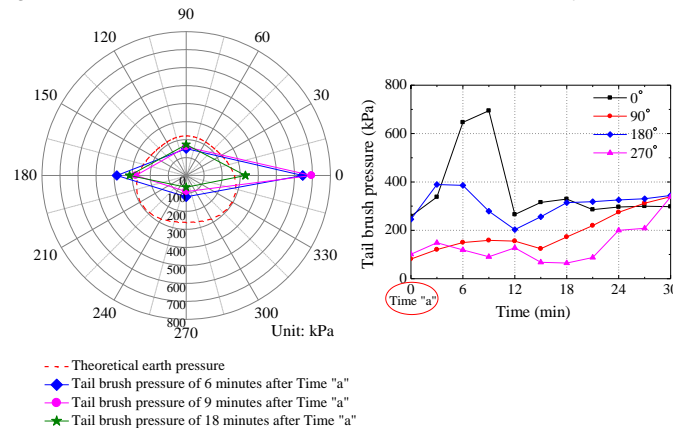
Fig. 5. Pressure distribution induced by 3rd-row steel plate tail brush of section A

The distribution of tail brush induced lining pressure of Section A during passing through the third row of tail brush is shown in **Fig. 5**. Such a non-uniform pressure distribution is prone to produce excessive bending moment in the tunnel lining. In the case of a shallow tunnel like this project, since the design maximum moment is relative small, a small amount of excessive bending moment can easily lead to cracking in the RC segments.

In the tunnel, water leakage from cracks in segments were observed right after passing of the tail brushes, creating voids.

This phenomenon in turn proved that the non-uniform pressures distribution induced by the steel plate brush is one of the main factors for cracking which reduces the durability and service performance of RC segments.
