Review Article

Hazards induced by anthropogenic activities, a lesson learned from recent underground construction works

K. Elbaz¹, S.L. Shen² and W.C. Cheng³

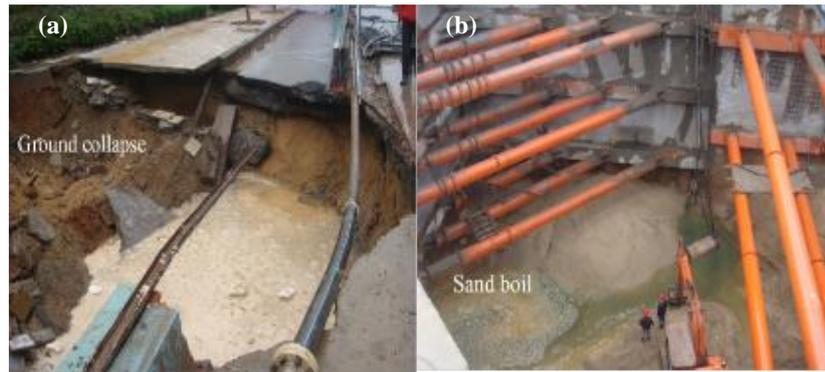
One day before the accident the lowest level of the excavation on the west side of north shaft was being excavated at a depth of 15.5–17.8 m. On October 11, 2010, large water seepages and sand boils suddenly developed between the western cast-in-place piles at a depth approximately 16 m. Since the large amounts of sand and water were leaking so fast, the ground collapsed suddenly 1.5 m from the edge of the adjacent three-axis mixing piles at the west of the north launch shaft, as shown in **Fig. 1 (a)**. The overall collapsed area was approximately 40 m² with 4 m deep, and the total amount of displaced sand was 140 m³. On October 14, 2010, the seepage of the sand appeared again on the east side of the north launch shaft and the excavation was extended down to the deepest level, as shown in **Fig. 1(b)**. Possible causes of the failure are illustrated as follows:

(i) The existence of silt and other soil between the three-axis mixing piles, the poor construction quality, and the large permeability coefficient of three-axis mixing piles allowed the soil to flow easily into the excavation pit, resulting empty holes between the piles.

(ii) Because of the bi-slurry grouting process, the soil reinforcement in the north launch shaft executed in a good manner in the coarse sand, but was poorly in the clay and silt sand, so the sand boils were developed rapidly, as shown in **Fig. 1(b)**. Consequently, the ground surface collapsed after the sand submerged the excavation pit.

(iii) After grouting, parts of sandy areas were not sufficiently strengthened, due to the high difference of ground water level; resulting the occurrence of leakage water into smaller zones in sand layer.

(iv) Some monitoring data during the construction were not obtained by equipment and construction materials (Feng and Lu, 2016).

Fig. 1. Collapse at the east of the north launch shaft; (a) ground collapse; (b) sand boil (Feng and Lu, 2016)

(i) The poor quality of grouting material causes many hazards such as water seepage, sand boil, and ground deterioration. Therefore, assuring the quality of grouting is essential to determine how to deal with these hazards during construction.

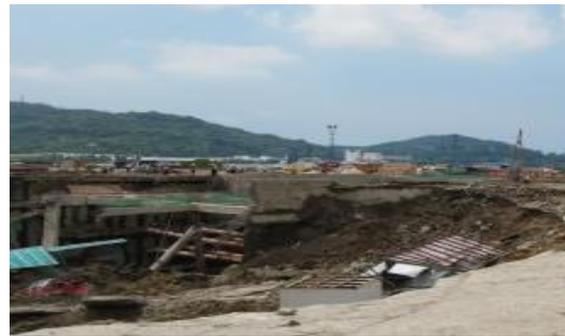
Fig. 2. The collapse of Hengqin tunnel (Macau Daily, 2012)

On the night of July 19, 2012, four workers were operating on the surface of the tunnel reported that they hear strange noises coming from the site and felt abnormal ground movements. They immediately informed tunnel workers through a wireless communication system to evacuate. After that the ground surrounding the tunnel entrance was collapsed, and five pieces of heavy machinery were buried inside the tunnel as shown in **Fig. 2**. The possible causes of the tunnel collapse were:

(i) The construction of support structures failed to keep up the pit breaking procedure; consequently the internal and external pressure had become unbalanced finally led to the collapse of the temporary fencing work.

(ii) The designers didn't take the effect of heavy rains during the period of construction into consideration. The heavy rains led to increase the water in the stratum, causing high ground water levels.

(iii) The soil borings were not adequate and the structure of the ground was weak, causing much more pressure on the foundation pit pile (Geotechnical Engineering Office, 2015).

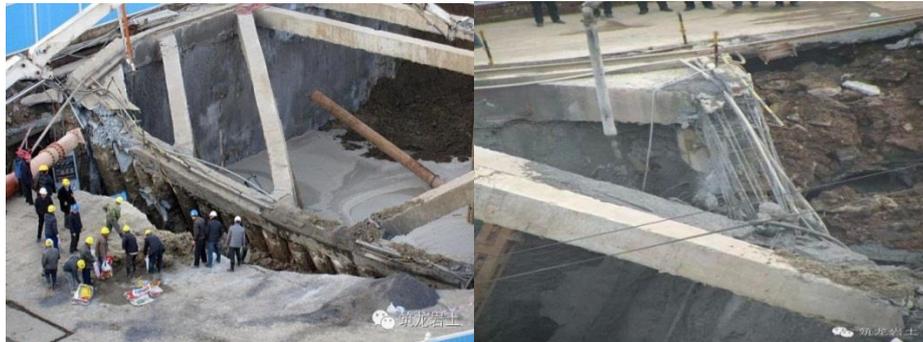
Fig. 3. Wuhan metro tunnel collapse.

On December 30th, 2012 after finishing 17m from excavation, cracks were found in the first reinforced

concrete struts. The cracks become evident in the side of the road around the excavation, especially in the southern shaft. Seepage of water filled the pit and before the end of the day it collapsed. Furthermore, 12 bored piles were destroyed, and cracks and settlements were appeared in the crowded roads around the excavation, as shown in **Fig. 3**. The collapse occurred because of break the outside sewage pipe which caused leakage into the excavation, finally caused failure piles. Although the design was safe and reliable enough, it was found that not only the diagonal struts that used to support the excavation sides not enough for any unexpected failure but also struts are not located in its right positions.

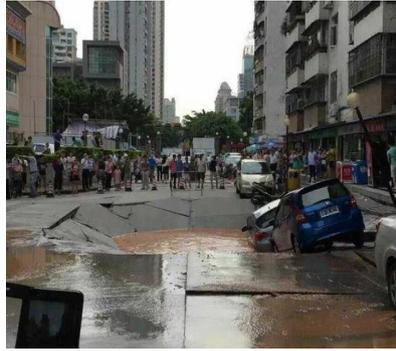
Fig. 4. Collapse of Shenzhen metro tunnel

The tunnel of Wong Fook section is located in the intersection of Fuk Man Road and Fuqiang Road in Shenzhen metro tunnel line 7 at Futian District. The total depth of the tunnel is ranges from 20 to 25 m. The field investigation showed that the soil profile consists of three layers; medium sand, gravelly sand, and weathered rock. On June 25th, 2015 ten meters of Shenzhen tunnel Metro line 7 collapsed, causing 10 m diameter and 3 m deep potholes on the surface above. The collapse caused one

death and three injuries, with an additional person trapped in addition to, two cars parked on the roadside dropped into the pit, as shown in **Fig. 4**. The possible causes of this collapse were the local subsidence that occurred during the process of changing the cutter tools of the shield machine. The rupture of the upper part of water supply pipe and the influx of mud shield machine warehouse.

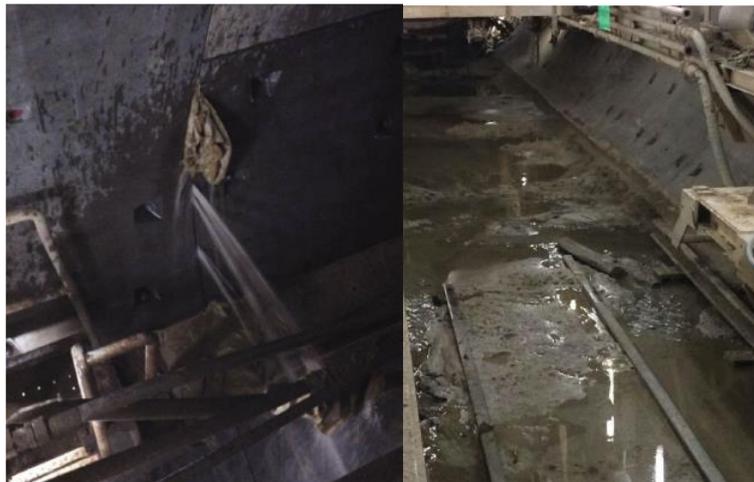
Fig. 5. Leakage of water at gap in between assembled segments (Ren et al, 2016).

In September, 2015 after the construction of Xie-Zhong section they found that there were a lot of water filled the tunnel from the gaps in between assembled segments as shown in **Fig. 5**. The main reason of the leakage is the poor quality of grouting causing voids between segments leading to water filled the tunnel.
