Research Paper

## Slope Failure Due to Effect of Damrey Typhoon in Penang Island

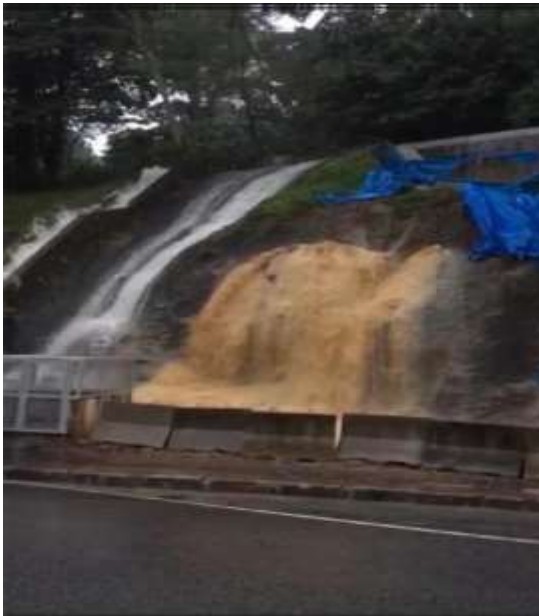
Fig. 3. A Slope failure adjacent to USM Hostels.

**Fig. 3** shows the failure that has occurred just after the stormy weather in November 2017. The picture shows the severity of the area which create streams of water flowing from the hill top and caused failure within the ground of USM. The overflow of water has created tress falling, transporting soil, debris and blocking sump drain at the top and bottom of the hill.

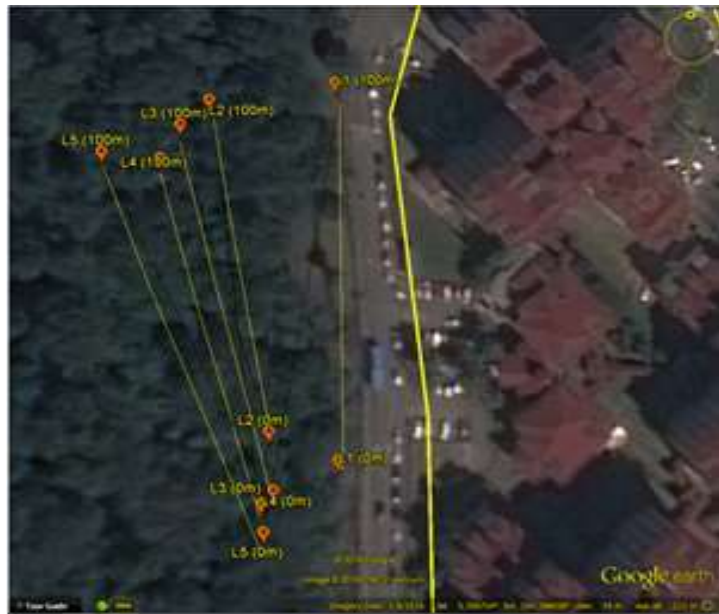
Fig. 4. 2D Resistivity line across the USM Slope.

A 2D resistivity tests were carried out to further investigate the ground conditions of the area to support in designing for ground stabilization. The survey was carried out with 2.5 m minimum electrode spacing using Wenner Schlumberger. The data collected were processed using RES2DINV software. The 2D were mapped as shown (L1) and Pole Dipole array (L2-L5) was second applied as shown in **Fig. 4**, the location of each line.

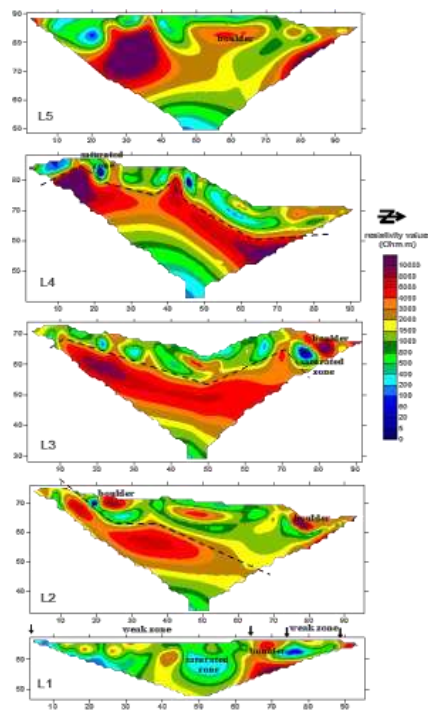
Fig. 5. 2D Resistivity survey mapping.

The profiles (L1-L5) trends S-N direction to a length of 100 m (**Fig. 5**). The inversion displays the ranges by resistivity values from 5 Ohm.m to 1000 Ohm.m indicating the overburden material which consist of saturated zone (1-100 Ohm.m) and alluvium (silt, clay and sand) with resistivity values of 100-800 Ohm.m up to a depth of 15 m. The intermediate second layer exhibits resistivity values that ranges from 1000-2000 Ohm.m represents the weathered granitic rock. The high resistivity zone with range of > 5000 Ohm.m at depth of > 15 m indicates granitic rock.

From the result obtained, the weak zone is relatively thick with an estimated thickness of 15 m with low resistivity value (1-100 Ohm.m) and alluvium (100-800 Ohm.m).

The shallow fractured/ weathered granite with resistivity values of 1000-2000 Ohm.m therefore is considered unstable. There were boulders located at a distance of 75 m of L1, 25 m and 80 m of L2, 85 m of L3 and 60 m of L5 covered by top soil. Therefore, it shows that how the ground can be vulnerable if the water seeps through the soil and weathered rock.
