Research Paper

Earthquake Resistant Assessment of Building Construction Technique in the Nayagaun Settlement of Kavre before Gorkha Earthquake

R. Pradhan ¹ and P.M. Pradhan ²

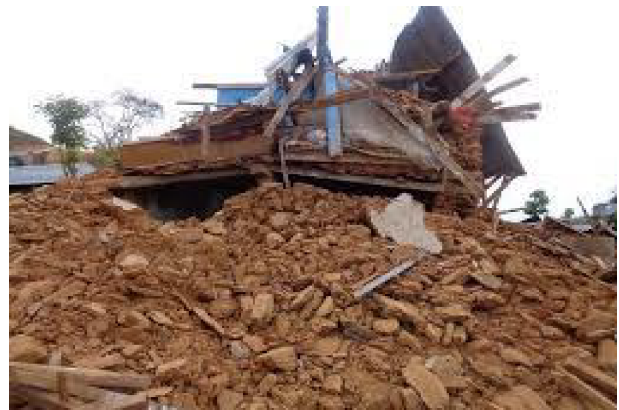
Fig. 3. Collapse of stone masonry in mud mortar building in the study area due to Gorkha Earthquake
 (Source: Santosh Lama, ward 3 beneficiary)

Unreinforced masonry buildings are found in most of the areas in Nepal. The condition of Nayagaun settlement after Gorkha earthquake can be observed in **Fig.3 and Fig.4**. Most of the buildings were of stone

masonry constructed without the earthquake resistant components. More than 98% of the buildings in Nepal are being built by owner-builders who follow the advice of local mason (Dixit, 2004). The majority of buildings were built without modern construction codes. The construction and structural deficiencies were the major causes of failure of the buildings.

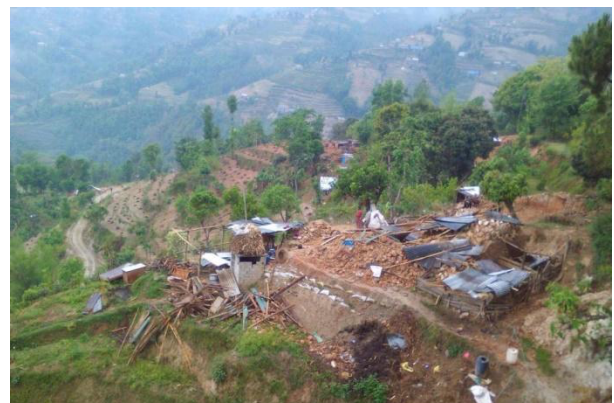
Fig. 4. Collapse of residential buildings in Nayagaun settlement
 (Source: Santosh Lama, ward 3 beneficiary)

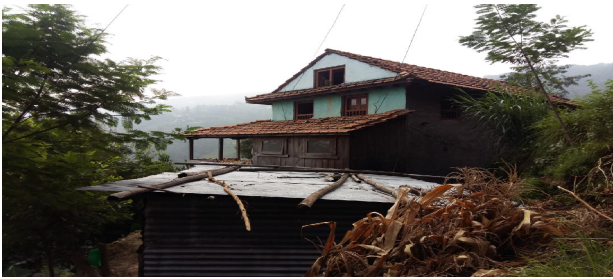
Only a building constructed on 2050 B.S was not much damaged by the earthquake shown in **Fig 11**. The reason was that the building was constructed including all the earthquake resistant elements like: sill and lintel

bands, proper opening size was maintained and all the roofing members are connected properly with each other. Almost all buildings were of Mud mortar and foundations were generally about 1- 2 feet and hardly up to 3 feet. The integral components of the masonry building as shown in **Fig 12** helped the building to survive during Gorkha earthquake.

Fig. 11. House in Nayagaun that survived after Gorkha Earthquake

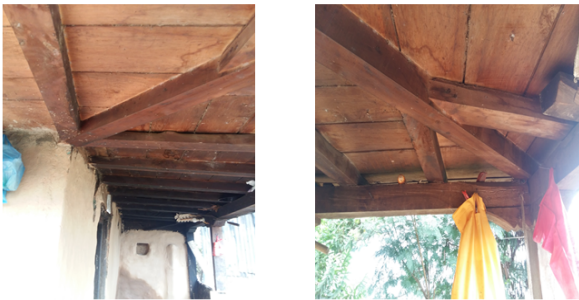
Fig. 12. Proper joint connections in the house that help to prevent the building from collapse
