Massive Fire Incidents of Multiple Aboveground Storage Tanks due to Vapor Cloud Explosion

Abstract

Keywords: Aboveground storage tank; incident; multiple tanks fire; overflow; vapor cloud explosion

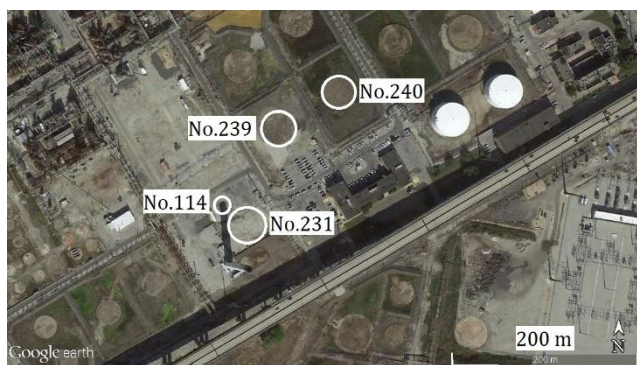
Figure 2. Former Gulf Oil refinery in Philadelphia taken on October 8, 2011 (from Google Earth)

Figure 2 is a Google earth photo taken on October 8, 2011. The burned tank had already been removed, but the tank foundation remained. The cause of this incident is that the No. 231 tank overflowed while receiving crude oil, and the leaked hydrocarbon vapor ignited at the boiler room. In 1985, Gulf Oil Corporation merged with Standard Oil of California Co. to become Chevron Corporation. A massive fire broke out again at this refinery on June 21, 2019. The refinery was owned by Philadelphia Energy Solutions Inc. at the recent incident.

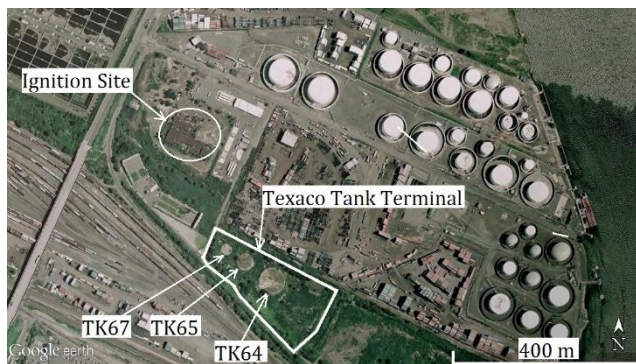
Figure 4. Former Texas tank terminal in Newark taken in July, 2007 (from Google Earth)

The point marked "Ignition Site" in Fig.4 is a steel drum repair plant of Central Steel Drum Company, which is about 300 m away from TK67. An incinerator was ignited at this plant, and VCE occurred at 0:25 am on January 7. At the time of the explosion, the wind speed was 5 m/s from the southeast. In Fig.4, the incinerator was on the leeward side of TK67, and it was easy for vapor cloud to flow.

The three tanks continued to burn for three days and were extinguished when the gasoline was burned out. The burned gasoline is 3 million gallon (11,400 m³). The incident killed a 40-year-old Texaco truck driver and injured 24 people. In addition, 45 freight cars were damaged in the freight train yard of Oak Island Conrail, which is adjacent to the southwest side of the site at the lower left of Fig. 4.

Texaco merged with Chevron in February 2001 to become Chevron Texaco, and changed its name to Chevron Corporation in May 2005. There are several dozen tanks on the north side of the Texaco terminal at the top of Fig.4. These tanks were also present at the time of the 1983 incident. The owner at that time is unknown.

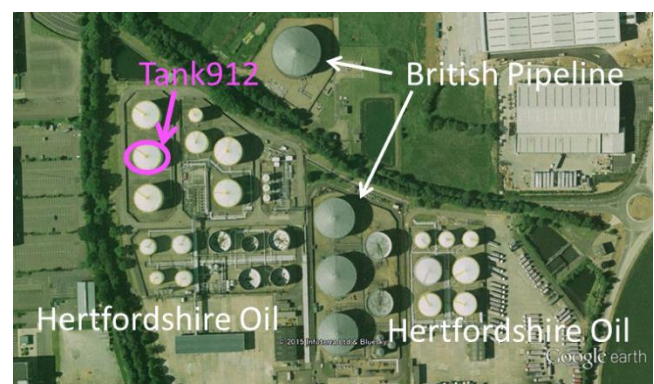
Figure 5. Buncefield tank terminal taken before the incident (from Google Earth)

London, UK. The fire that burned 23 oil storage tanks lasted for five days. Forty-three people were injured and about 2,000 residents were temporarily evacuated in this incident, but fortunately there were no victims. The incident investigation committee jointly established with the UK Health and Safety Executive and the Environmental Agency issued a final report [4] in December 2008. Figure 5 is a Google earth photo of the Buncefield tank terminal taken on December 31, 2000 before the incident.

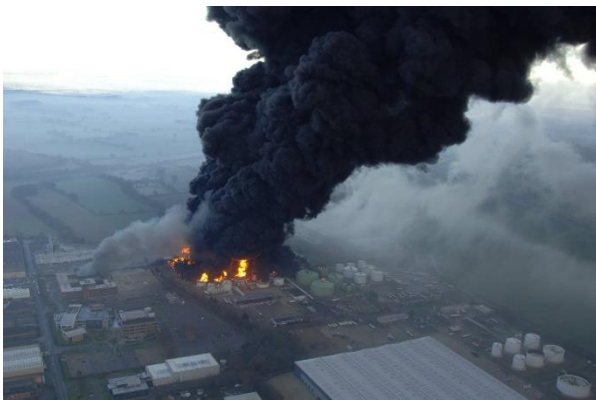
Figure 6. Massive fire in Buncefield tank terminal [4]

Figure 6 is an aerial photo of this fire, and Figure 7 is a Google earth photo taken on December 31, 2006, one year after the incident. It is confirmed that the burned tanks remained and did not hold the prototype.

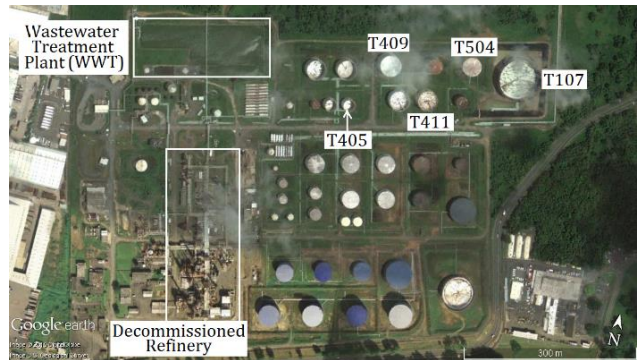
Figure 9. CAPECO tank terminal before the incident taken on November 30, 2006 (from Google Earth)

diesel, etc. Figure 9 shows this tank terminal layout before the incident.

CAPECO site consists of four areas: a tank terminal, an abandoned refinery, a wastewater treatment plant(WWT), and a management building as shown in Figure 9. WWT is a pond for storing rainwater and oil containing water, and has its treatment facility.

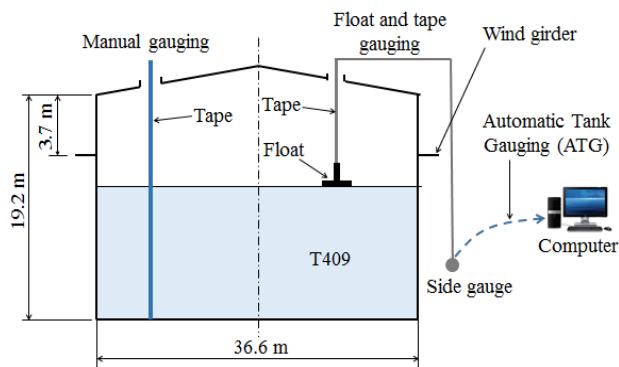
Figure 10. Tank gauging system in T409 tank

Figure 10 shows a liquid level gauging system of the T409 tank. As the transmitter of the float type liquid level gauge was in failure, the liquid level could not be controlled by computer using the automatic tank gauging. In addition, the high level alarm and the overflow prevention system, which were independent from the liquid level gauge, were not installed. As shown in Figure 10, T409 had a diameter of 36.6 m, a height of 19.2 m and a nominal capacity of 19,000 m³. It was a fixed roof tank with an aluminum internal floating roof.

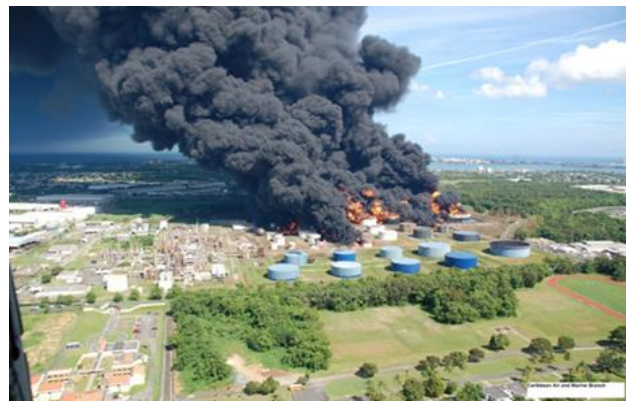
Figure 11. Massive fire in CAPECO tank terminal [5]

extinguished at 11:30 am on October 25, 59 hours later. Figure 11 is a photo of a fire in the CAPECO tank terminal [5].

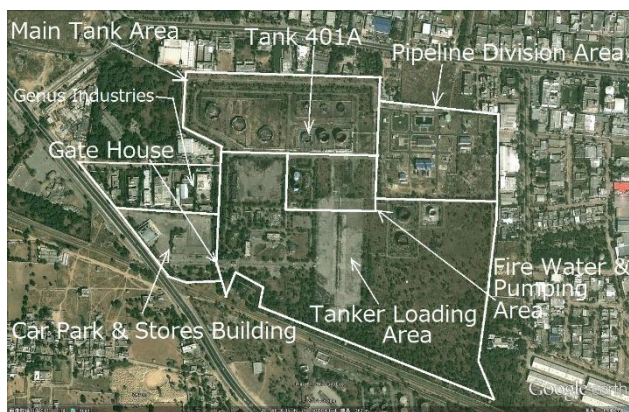
Figure 12. Layout of IOCL tank Terminal (from Google Earth)

Figure 12 is a Google earth photo showing the layout of the tank terminal taken on November 14, 2011, two years after the incident. In the tank yard, which is upper middle in this figure and called "Main Tank Area", nine tanks which burned in the incident remained. These tanks stored fuel transferred from the IOCL refinery in Kojari, Gujarat. Piping Division Area was the pipeline relay station that sent crude oil to other IOCL refineries. There were two fire water storage tanks in the Fire Water & Pumping Area.

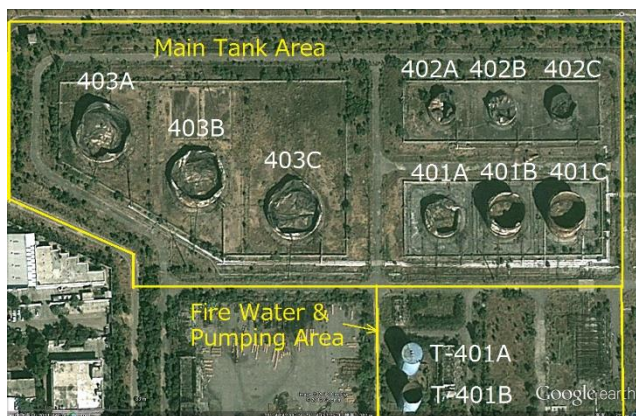
Figure 13. Main Tank Area of IOCL tank terminal (from Google Earth)

Figure 13 shows the enlarged Main Tank Area. Table 2 shows the tank list of this terminal. There were 11 oil storage tanks, and the total nominal capacity was 110,370 m³. Nine of the eleven were located in the Main Tank Area and were grouped by three. “Motor spirit” in the table means gasoline.

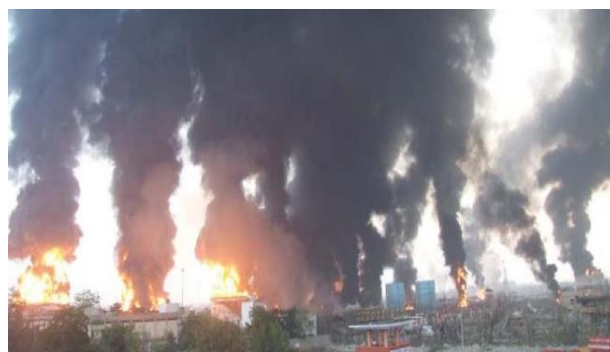
Figure 14. Massive fire in IOCL tank terminal [6]

Around 7:25 pm, a thick vapor cloud spread throughout the terminal, and then a major explosion occurred. The ignition source is unknown. This explosion killed 11 people and injured 45 people. Simultaneously, nine oil storage tanks in the Main Tank Area also exploded, and the fire lasted for 11 days until the fuel was burned out. The 409A and 409B gasoline storage tanks, which were away from the Main Tank Area, burned after several hours from the explosion. Figure 14 is a photo of this fire.

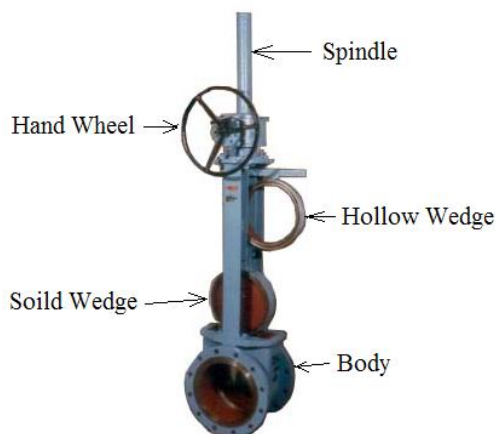
Figure 15. Hammer blind valve [6]

Hammer Blind Valve has the advantages of simple shape and easy operation, and can completely block the flow in the piping at one location. In addition, the “open” or “closed” state can be easily visually confirmed from the outside. Figure 15 shows the same type as the Hammer Blind Valve used in the 401A gasoline tank outlet line.

When the Hammer Blind Valve is “close”, the solid wedge is inserted into the body of the valve. When performing the operation from “closed” to “opened” or vice versa, both wedges are pulled out temporarily and the inside of the pipeline is exposed to the atmosphere. In 10 inch piping, the opening size is 305 mm x 152 mm. When changing the Hammer Blind Valve from “closed” to “open” or vice versa, the gate valves on both sides must be closed before operation. According to the photo taken after the incident of the 401A tank Hammer Blind Valve, both solid wedge and hollow wedge were outside the body, and the opening was made. In this outlet line, both the upstream MOV and the downstream HOV were “open”. Therefore, gasoline was ejected from the opening of the Hammer Blind Valve.

The investigation committee [6] assumes the following valve operation errors. The operator A first opened the downstream HOV and then tried to open the Hammer Blind Valve. During this operation, there was a leak from downstream due to backflow in the opening, and the MOV “close” button should have been pressed. However, he was panicked and accidentally pressed the “open” button.

In this tank terminal, the automatic gate valve on the outlet line could be remotely operated from the control room until 2003, but at the time of the incident, only the button was operated near the valve. Leakage could be stopped if the button panel was outside the dike area or the valve could be operated remotely.
