# Basic Study on Deformation Evaluation of Steel Wire Mesh for Rational Gabion Structure Design

Gabion structures are used in a variety of ways in Japan and around the world because they allow for the creation of simple structures at highly reasonable construction costs and completion periods. Previous earthquake damage surveys have shown that, in many cases, gabion structures did not collapse even though deformation was allowed, and have demonstrated that the wire mesh used in their construction has a high confinement effect on the stones filling the gabion. Despite this, gabions have not been actively utilized, nor have they been used to construct permanent structures in Japan because the design and construction of such structures are based on experience, and a standardized design method has not been developed. Hence, in order to facilitate development a design method for gabion-based structures, we must first go back to the basics and establish a detailed explanation of the wire mesh deformation mechanism of such structures. In this study, we performed tensile tests on wire meshes of different shapes in order to determine their strength and deformation characteristics and then

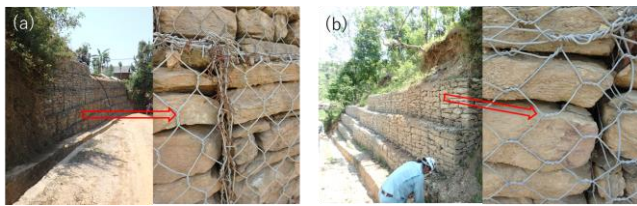
Figure 8. Trial construction of a gabion-based retaining wall [7]. The direction of the turtle-shell-shaped wire mesh had not been considered. (a) Mesh line is vertical. (b) Mesh line is horizontal

However, mesh shapes and their corresponding deformation and strength characteristics have yet to be studied. In a field trial construction case in Nepal [7], as shown in Fig. 8, the direction of the wire mesh in relation to the assumed direction of retaining wall deformation had not been taken into account, and whether or not this may be a dominant factor remains unclear.

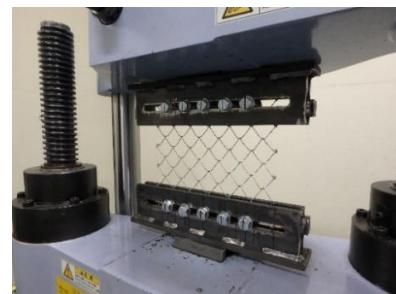
Figure 10. Test apparatus

Using the test apparatus shown in Fig. 10, tensile tests were carried out after running bolts through the edges of the wire mesh and fixing them in place. Note that due to the difference in shapes between the rhombus and turtle shell meshes, the number of bolts secured at the edges depends on the mesh shape and could not be standardized. In this paper, the test results were evaluated by comparing the tensile behavior with respect to the relationship between the applied tensile force T (kN) and the stroke of the testing apparatus. In principle, the rate of tensioning used was 40 mm/min using displacement control. For Case 1, the test was also conducted at 10 mm/min in order to investigate the dependence on the loading rate.
