The Effectiveness of Petobo Temporary Shelter

Asiana Rahmawati^{a,*}, Mohammad Mochsen^b, Abdul Mufti Radja^c

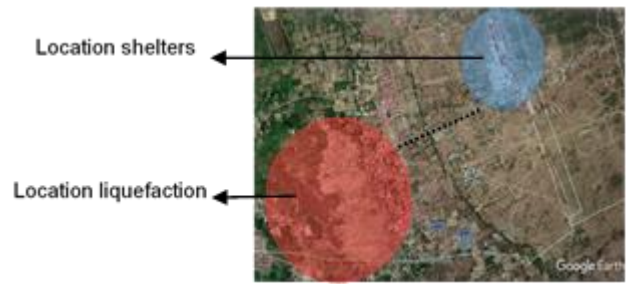
Figure 3. The distance to the location of shelters Petobo liquefaction

From Table 1 above, the residents of Petobo shelter answered that the location of the shelter is currently unsafe. This is because the location of the shelter is only ± 1 km from the former location of liquefaction (see Fig. 3), the residents of the shelter are still traumatized by the disaster that befell them. Many residents want to move out from this location, but they have no choice but to stay in the shelter.

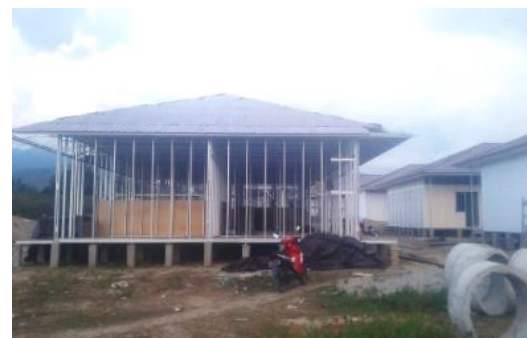
Figure 5. Mild steel structure in Petobo shelter

From Table 2, most of the residents of the shelter said that the ability of shelter building structure is effective enough to withstand the load. Petobo shelter structure using mild steel with disassembly models (see Fig. 5). When an earthquake occurs, the structure remains sturdy and only a fraction of the shelters which suffered from minor damage, but the shelter is still habitable.

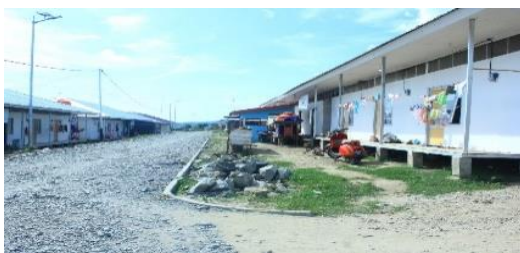
Figure 7. Shelter Petobo separated by road

From Table 3, the residents of the shelter answered that the fire safety in the shelter was quite effective. This is because the distance between the residences is varied. Petobo shelter site was designed using a grid layout with a rectangular area separated by a road, where the width of the road is 8 meters (see Fig. 7). While respondents who answered less effective and ineffective because their shelter units are facing each other and the distance is close to each other, it is about 3-5 meters (see Fig. 8).

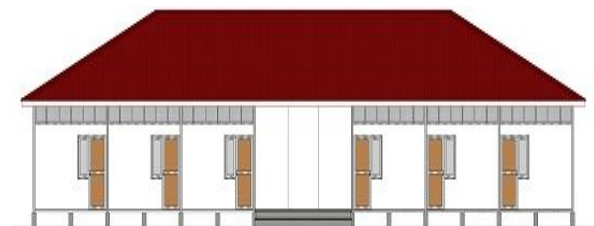
Figure 10. View of Shelter building of Petobo

From Table 5, it can be seen that the residents of the shelter said that the availability of openings in the shelter units are less effective for air exchange. This is due to the design of openings layout such as doors, windows, and vents at the shelter units (see Fig. 10). Occupancy openings are located on one side of the room, where openings on the same side make the air come in the room through the same side as the air is out. This makes the air exchange in the residential units less than optimal.

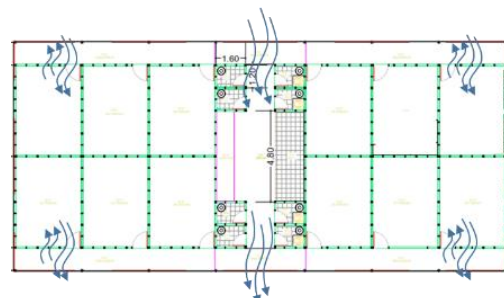
Figure 11. Air exchange in shelter units of Petobo

Air exchange at supporting facilities located in the central part of the shelter is also less effective (see Fig. 11), because the positions of the opposite openings are the same size. This makes the air exchange inside lower. Besides, the location of the toilet and public bathroom adjacent to the residential unit makes the residents less comfortable because of the smell of the toilet.

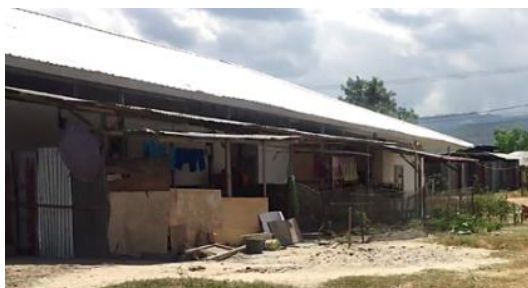
Figure 13. Minimize the light entering the shelter unit

From Table 6, the residents of the shelter answered that the availability of lighting system at Petobo shelter is effective. This is due to the fact that residents of the shelter feel that they had enough natural light enter the shelter unit through the openings such as doors, windows, and vents. Some residents in the shelter also answered less effective because the light entering the room is excessive, causing glare, but there are treatments of the residents to minimize glare in buildings (see Fig. 13) by using curtains, and some are using canopy with improvised material.

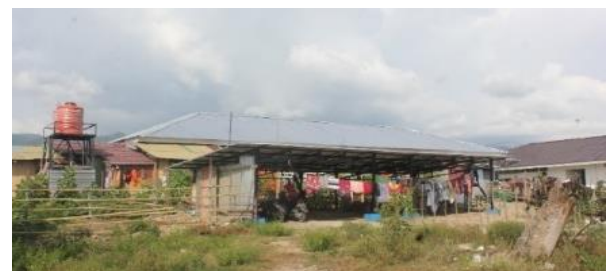
Figure 15. Solar cell in shelter of Petobo

Based on the Table 7, residents of the shelter answered that the availability of sanitation system in Petobo shelter is less effective for the needs of residents. This is due to the sanitation system in the shelter, namely the availability of clean water for bathing and drinking, and the waste water disposal system is very lack. The source of clean water in Petobo shelter is a wellbore, which uses an indirect system and a solar cell (see Fig. 15).

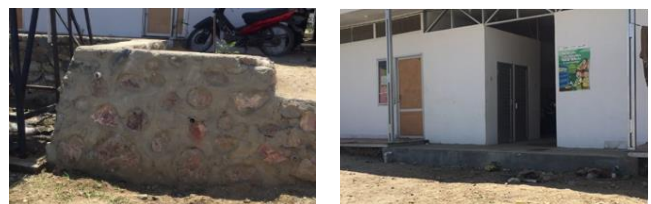
Figure 16. The liquid waste disposal pipe

As for the waste water disposal system in Petobo shelter, not all the units in Petobo shelter have drainage. Besides, the liquid and solid waste disposals are put together towards septitank (see Fig. 16), thus some septitanks in the units are overflowed and leak.

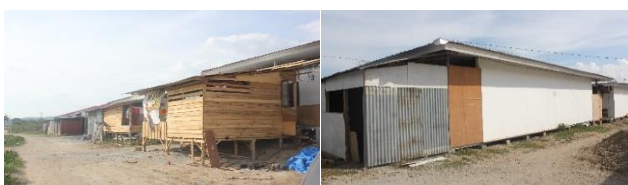
Figure 18. The addition of space in the units of Petobo shelter

Based on the Table 9, the residents of the shelter answered that the space comfort in Petobo shelter is less effective. This is because the area of the shelter units is not proportional for the number of residents. On average residents who have 3 or more family members feel uncomfortable staying in the shelter. Many residents add more spaces to their residential units (see Fig. 18), with remains of liquefaction materials.

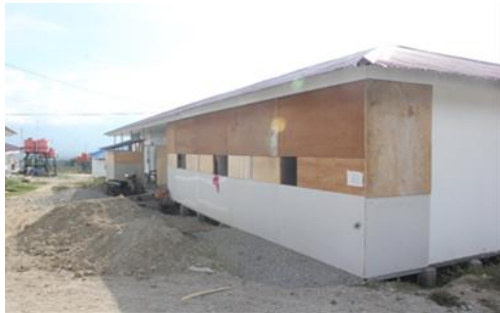
Figure 22. Privacy in Petobo shelter

From Table 11, the residents of the shelter answered that the privacy in Petobo shelter is ineffective or non-existent. This is due to the absence of a public toilet distribution for men and women. Thus, it is vulnerable to sexual harassment in public facilities in the shelter unit. In addition, many residents limit their occupancy as a form of privacy (see Fig. 22).

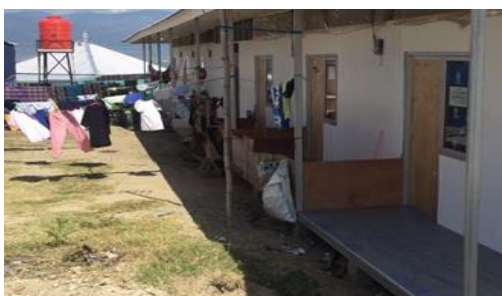
Figure 24. Build up the the boundaries at the residence unit Petobo Shelter

From Table 12, it can be said that the residents feel very noisy at the shelter of Petobo. This is because the covering material of the wall and floor do not muffle the sound. That is why if people walk or children run around the shelter unit, it will cause noise. One of the methods used by the residents to reduce noise is to build up boundaries between their residences and others (see Fig. 24). The Effectiveness of comfort of shelter building based on the residents' perception is shown in Table 13.

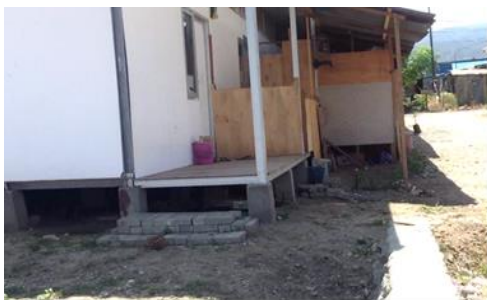
Figure 27. Stairs to help ascend to the residential units

From Table 15, most of the residents of the shelter answered the ease of accessibility for people with disabilities and the elderly in Petobo shelter is less effective. This is due to the lack of access for people with disabilities. Some residents provide their own stairs to help ascend to the residential unit (see Fig. 27).

- a. It needs further evaluation related to the location of the shelters that are adjacent to the liquefaction location.
- b. It is better for having privacy between sexes for the convenience of residents, and to reduce the potential for crime at the shelter.
- c. It is necessary to plant vegetation at the shelter area to reduce heat and filter out dust.
- d. Although the temporary shelter is only inhabited in a short period of time, it is necessary to pay attention to the need for clean water sources, liquid and solid waste storage, supporting facilities such as parking, security posts, and guardrail.
- e. Temporary shelter design needs to pay attention to the convenience for elderly residents and people with disabilities.
