## EARTH SEWING TECHNIQUE FOR THE PRESERVATION OF FANASAKO HISTORICAL KILN SITES

**ABSTRACT:** The Funasako historical kiln sites, which are located in the northern part of Kyushu Island in Japan, have been considered as public exhibition areas. This requires preservation of the kiln remains by reinforcement of the soil. Considering the complicated local topography, the reinforcement method that was proposed is a combination of chemical grouting and soil nailing, and is termed the Earth Sewing Technique (EST) in this paper. In order to prevent disturbance of the soil in the kiln remains, a drilling hole diameter for soil nailing of 7 mm with a tendon (bolt) that has a diameter of 3 mm was selected. Field full-scale pullout tests at a model kiln site were carried out before applying the reinforcement technique to the real historical kiln sites. This paper presents the field pullout results and the results of a series of laboratory pullout tests that were conducted to investigate the critical factors affecting the performance of the EST. Design parameters have been recommended based on rational interpretation of the field and laboratory pullout test results. The pullout strength-wat

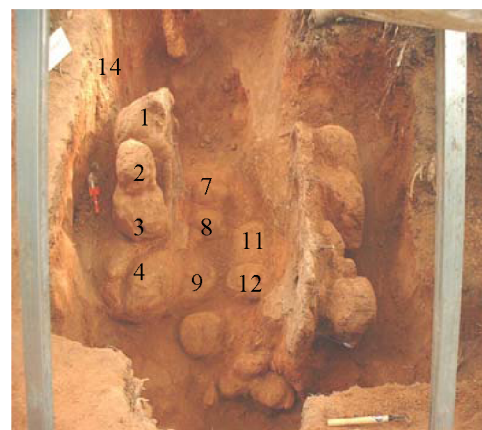
Fig. 3 Photo of field full-scale model kiln site

The field full-scale model test site is shown in Fig. 3, and is about 10 m away from the real site (Fig. 2). This site is very close to the historic kiln site and therefore would represent as well as possible the geotechnical conditions of the kiln site being investigated. The geotechnical properties of the soils at the site are listed in Table 1. The soil is

threaded bolts with a diameter of 3 mm and a tensile capacity of 6.95 kN. Cement slurry (water/cement ratio = 0.45) added with expansion material (Expan-K) of different percentages (0%, 1%, 3%, 5%, and 7%, on a weight basis) was adopted as grouting material. A total of 14 tests (locations shown in Fig. 3) were conducted in both the chemical grouted soil and natural soil. The testing condition and a summary of the results are summarized in Table 2.

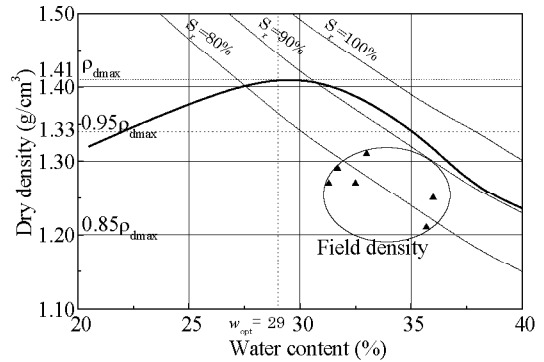
Fig. 4 Compaction curve of soil from Funasako kiln site

classified as sandy clay with some amount of silt. The standard laboratory compaction curve of the soil is shown in Fig. 4. The field density values are also plotted in Fig. 4. The density at the top layer of the test site was about 1.24  $g/cm^3$ , and at the bottom was about 1.29  $g/cm^3$ . The natural water content varied from 31% to 36%, with a degree of saturation of about 80%. The high degree of saturation might due to the rainfall that occurred a few days before extracting the samples.

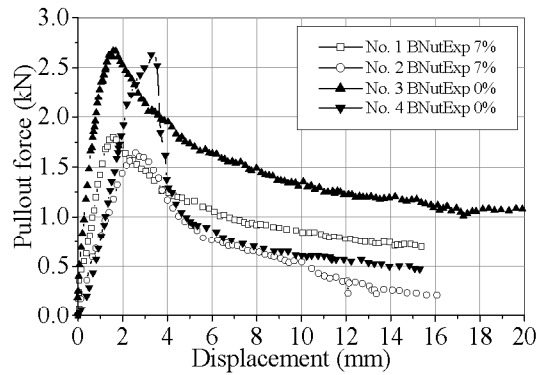
Fig. 6 Field pullout tests in chemical grout soil (With A, for Cases 1, 2, 3, and 4)

Figure 6 shows the pullout force-displacement relationships for Cases 1, 2, 3, and 4, and Fig. 7 those for Cases 7, 8, 9, 11, and 12. All the 9 cases are nailed in chemical grouted soil (With A) with a water content of approximately 22%.

For cases 1 and 2, which were located at the upper portion of the trench, the bolt and cement grout were pulled out as a unit representing a rigid cylinder of about 8 mm in diameter, and no obvious crack was visually observed. The maximum pullout forces were 1.81 kN and 1.66 kN, respectively, which values were much lower than those for other cases. This may be due in part to the density at the upper portion being lower relative to that at other locations. For Cases 3 and 4, which were located at the middle layer portion, the maximum pullout forces were 2.63 kN and 2.65 kN, respectively. During pullout of the reinforcement, the solidified body of the chemical grout was found to have broken, and cracks were observed. The cracks could be the

reason why the ultimate maximum resistance was not fully mobilized in these two cases.

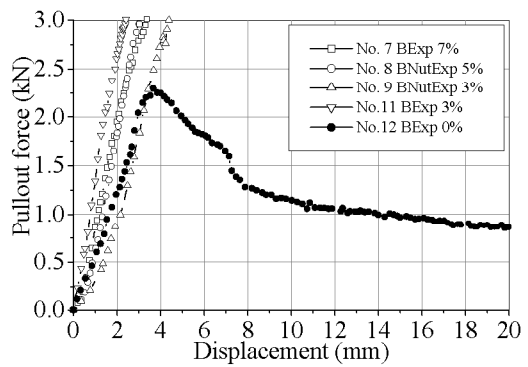
Fig. 7 Field pullout tests in chemical grout soil (With A for Cases 7, 8, 9, 11, and 12)

For Cases 7, 8, 9, 11, and 12, which were located at the bottom of the model kiln site, the pullout tests were stopped when the pullout force reached 3.00 kN (except in the case of No. 12) due to the loading limitation of the pullout equipment. No obvious cracks or breaking of the solidified body was observed. For Case 12, the maximum pullout

force was 2.29 kN; the value is relatively lower in this particular location because of its poor chemical grouting.

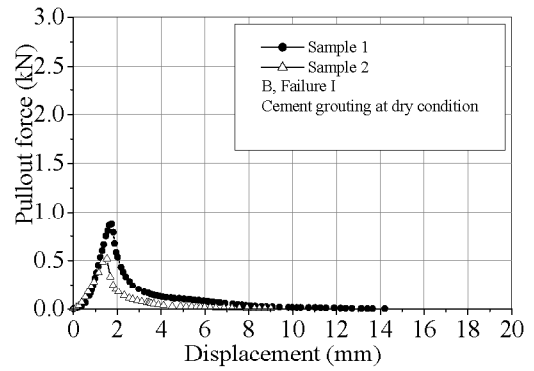
Fig. 10 Lab pullout test results for Case 20

Figures 10 and 11 show pullout force-displacement relationships for Cases 20 (with a bolt used as a tendon) and 21 (a bolt with a nut used as a small end anchor (BNut)), respectively. Both cases represent the dry condition. Pullout failure mode was observed to be Mode I for both cases. The occurrence of this type of failure mode can be attributed to the following processes. Upon grouting, the water in the cement slurry might have been absorbed by the surrounding dry soil immediately, which would result in the lower strength of cement grouts. For both cases there is a sharp drop in pullout resistance after maximum pullout force, implying that the slipping might have occurred between the tendon and the grout interface. From the results shown in Figs. 10 and 11, it can be observed that the small end anchor (Nut) has little effect on the peak force. However, a higher residual force was observed in Case 21.

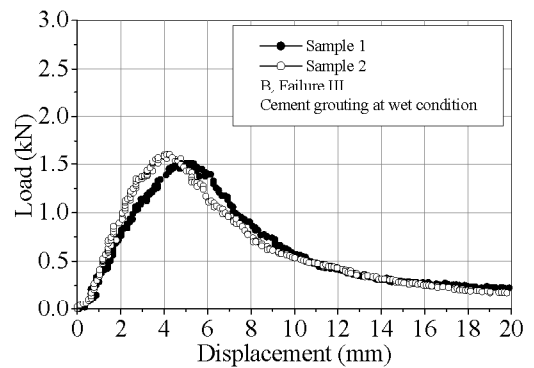
Fig. 12 Lab pullout test results for Case 22

Figure 12 shows the pullout force-displacement relationship for Case 22. This is a typical case for cement grouting at the wet condition. Pullout Failure Mode II and Mode III were observed for all the specimens. The tendon and the cement grout were pulled out together as a rigid cylinder body with a diameter of about 7-9 mm. The pullout curve was relatively smooth.

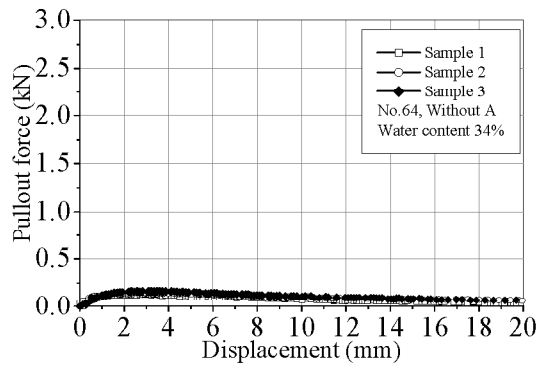
Fig. 19 Typical pullout results at high water content (Case 64)

Figures 18 and 19 show the pullout force-displacement relationships for Cases 60 and 64, which corresponded to the low (4%) and high (34%) water contents, respectively. The peak pullout forces are mobilized at a displacement of about 4 mm. This phenomenon is similar to the one observed in the field pullout tests.

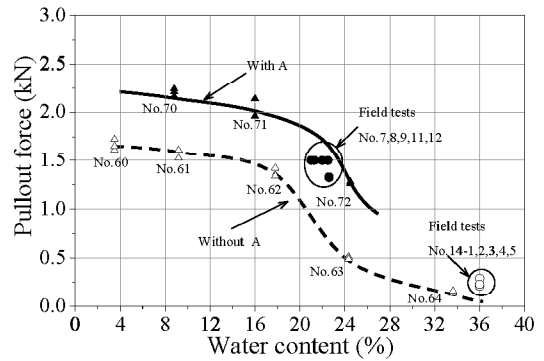
Fig. 20 Pullout force vs. water content relationship (Cases 60, 61, 62, 63, & 64 and Cases 70, 71, & 72)

The maximum pullout force-water content relationship for all the tests of the two series are shown in Fig. 20. It can be observed that there is an abrupt decrease of pullout capacity with the increase in water content to around 20-24%. The field pullout force corresponding to a length of 150 mm is also plotted in Fig. 20 (circular symbols). The field data matches well with the laboratory data. The pullout force-water content relationships developed in the

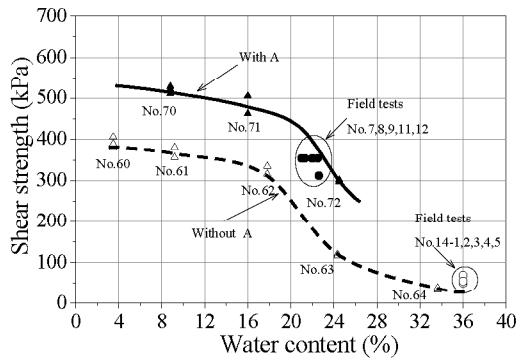
Fig. 21 Pullout shear resistance-water content relationship (Cases 60, 61, 62, 63, & 64 and Cases 70, 71, & 72)

where  $\tau_{ult}$  – Ultimate interfacial pullout shear strength between soil and reinforcement;  $P_{ult}$  = Ultimate pull out force of soil nail; D = Diameter of nail or nail-grout combination; L = Nail length. In this study, for both field and laboratory pullout tests, the diameter of the nail-grout combination is observed to be about 7-9 mm. An average of 8 mm is used for the calculation of interfacial shear resistance in equation (1). From Fig. 20, the interfacial shear resistance-water content relationships have been computed and are presented in Fig. 21. These relationships indicate that the water content plays a significant role in the mobilization of the pull out shear resistance.
