Research Paper

Retrofitting design of Kathmandu University library building after Gorkha earthquake 2015

This is a case study for Retrofitting Design of Kathmandu University Central Library Building (Block#3) after Gorkha Earthquake 2015. The building lies south to the Administrative Building of Kathmandu University, located at Dhulikhel, Kavrepalanchwok (**Fig. 1**). The strong earthquake on April 25, 2015 (7.8 M_w moment magnitude) originated at Barpak of Gorkha District and the largest aftershock with the magnitude of 7.3 M_w (United States Geological Survey) affected the building to great extent leading to the structural failure of the building. This building is an Ordinary Moment Resisting Frame (OMRF) covering an area of 888.31 sq.m.

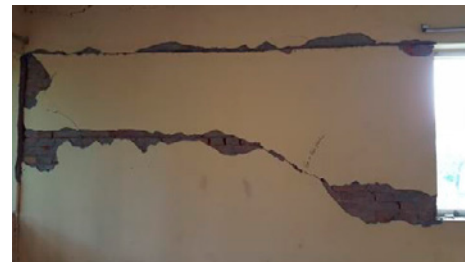
Fig. 7. Cracks seen in masonry infill wall.

During rapid visual assessment of the building, large numbers of cracks was seen in masonry infill walls and some columns had undergone structural failure as well.

Figures 7, 8 and **9** show both structural and non-structural damages as seen in the building.

During visual assessment cracks were seen in masonry infill walls. Therefore, wall repairing was carried out along with column jacketing. The walls with diagonal shear cracks were demolished as they were liable to collapse from the confining frame under the action of vertical load. Cement-sand grouting was done in parts where cracks do not span a long distance. In parts where cracks of greater depth and larger distance were detected grouting was carried out along with net plastering (**Fig. 17**).

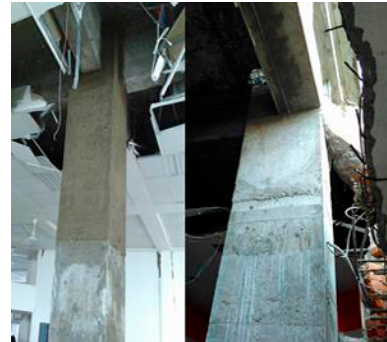
Fig. 16. Concrete jacking at Beam-Column joint, Kathmandu University Central, Dhulikhel.

All the columns of ground floor were found deficient in flexure during analysis, so all columns were retrofitted by reinforced concrete jacketing so that it was able to carry out its intended function (**Figs. 15 and 16**). For this purpose, guidelines for seismic evaluation and strengthening of existing reinforced concrete structures provided by Indian Standard Code IS 15988:2013 were followed. Similarly, the cracks in the wall were repaired by net plastering and grouting. Structural members like beams and slabs, if found failed, could also be retrofitted by considering viable retrofitting options.

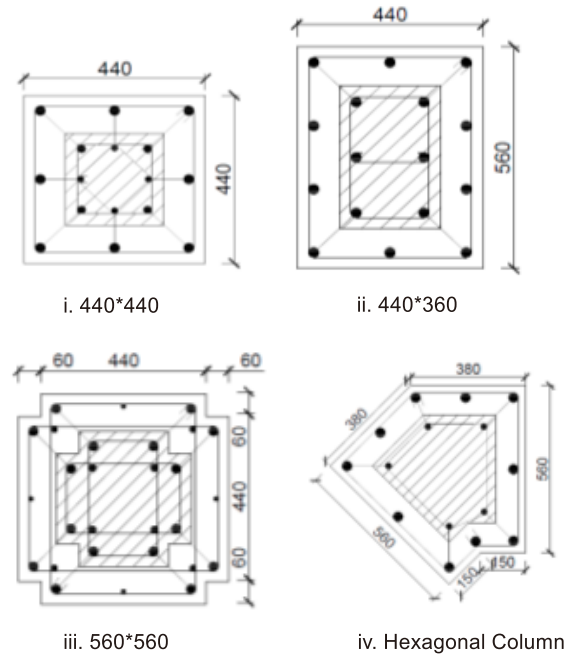
The required reinforcement was calculated as explained earlier and the arrangement of reinforcement is shown in **Fig. 20**.

Fig. 20. Columns after Retrofitting.
