Research Paper

Spatial distribution of coseismic mass movements by 2015 Gorkha Earthquake in six districts of Central Nepal

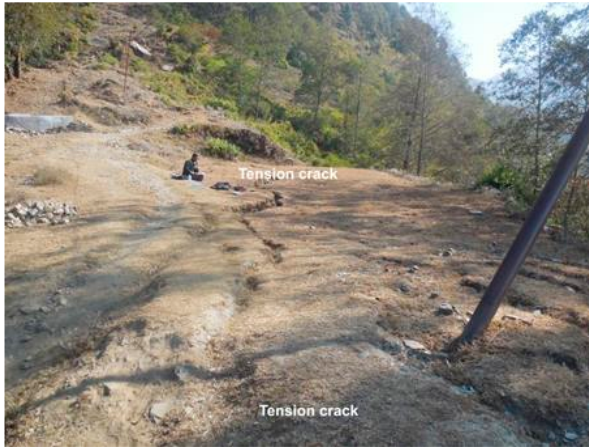
Fig. 3. Tension cracks at about 100 m NE of NTC mobile tower, Barpak. View to W.

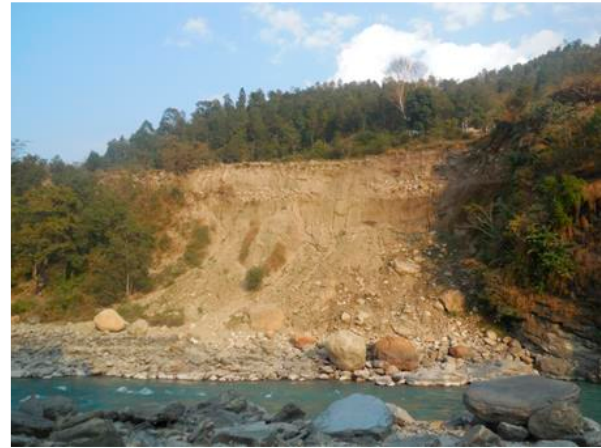
Fig. 4. Landslip on left bank of Budhi Gandaki River at Galane.

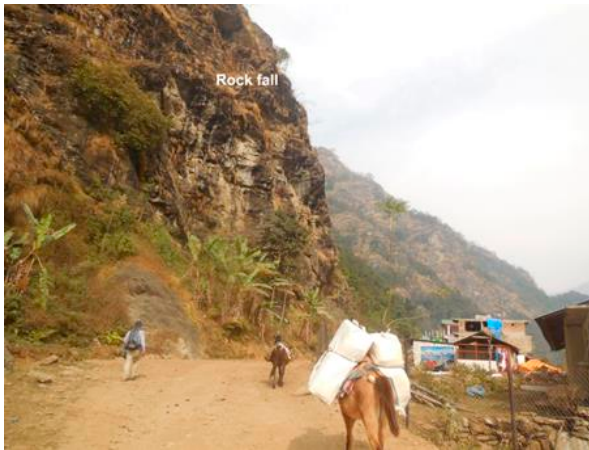
Fig. 5. Rock fall zone at Soti Bajar. View to N.

Soti Bajar of the Thumi VDC, where multiple extension joints are present in the rock cliff (**Fig. 5**) and about 10 houses are situated within its runoff zone. The cliff is about 50 m high and steeply (70-80 degrees) facing due east. At Soti Bajar, the Budhi Gandaki River is also undercutting its right bank by scouring about 10 m high alluvial terrace for a length of about 300 m. Some of the buildings are just a meter away from the cliff. Hence, they are under a high risk of failure, especially in the rainy season.

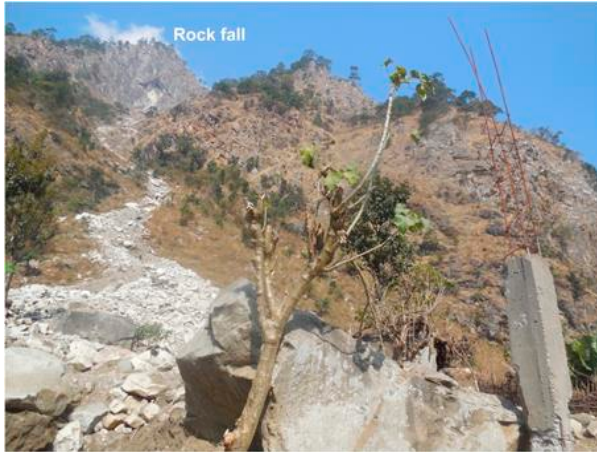
Fig. 7. Rock fall damaging a building at Khorlabesi. View to W.

At the village of Khorlabesi in the Uiya VDC, a debris flow has reached the banks of Budhi Gandaki River and damaged a few houses. The upper slope of Khorlabesi has highly jointed rock masses and the rock falls originating from that slope have destroyed several houses (**Fig. 7**).

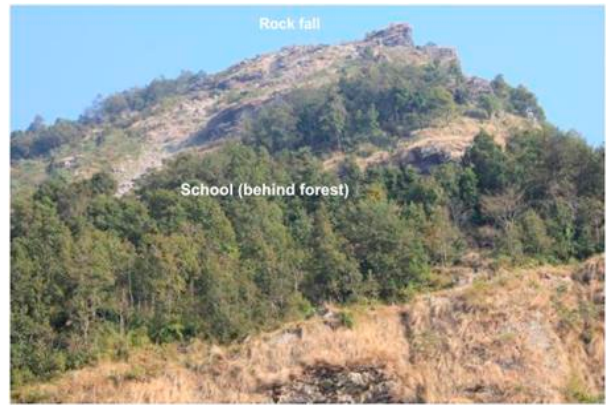
Fig. 8. The dip slope with a large failure reaching the school of Tawal. View to NW.

The Ri VDC is one of the largest in the Dhading District that was severely affected by the quake. Especially, its north part witnessed many failures. North of the school of Tawal, a large rockslide-rock fall (**Fig. 8**) occurred periodically. This slope failed at first during the

earthquake and then in the rainy season for several times. Its runout zone is about 150 m high, 200 m long, 200 m wide, and the accumulated debris is forming a cone near the toe is 5-15 m deep. The boulders from the failure can reach the school compound. Some large boulders (1-3 m) are scattered to the north of school, whereas some of them are resting just at the brink of school compound. Presently several wedge slides are active at the crown. A wedge slide – fall is also seen on another cliff, about 75 m east of the main debris cone. Some part of the openly fractured rock is overhanging and can come down in the next monsoon.

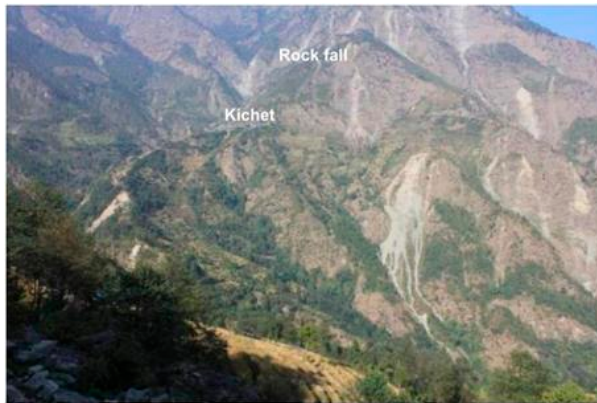
Fig. 9. A general view of Kichet from the southeast. Note many shallow sides and falls on steep rocky slopes. View to NW.

On the way to Tajumrang, a rock cliff is suffering from a wedge failure at the junction of two trails, where massive, cliff-forming, grey, pelitic quartzite and biotite schist are exposed. The rock is strongly lineated. Many shallow rockslides, debris slides, and rock falls are seen on the slope, where the village of Kichet is located (**Fig. 9**).

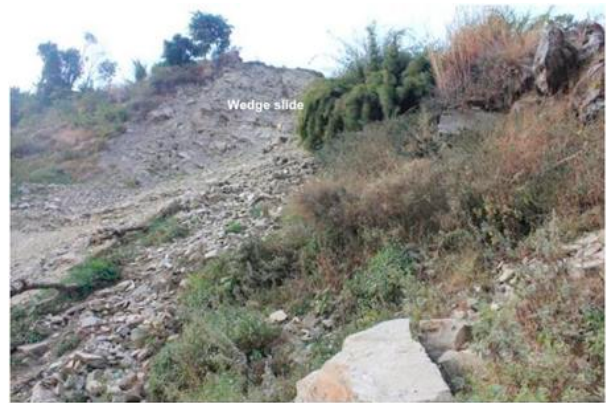
Fig. 10. A large wedge slide at Gangmrang. View to NW.

A very big rockslide devastated the village of Gangmrang, where all the houses have collapsed. Many tension cracks are seen in the trail below the abandoned village. The crown of landslide has reached the village in the form of a wedge slide (**Fig. 10**). The rock is represented by grey schist.

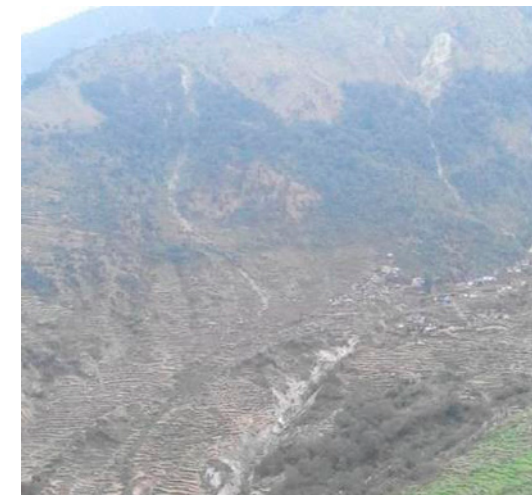
Fig. 12. Rockslide with gully erosion on Hindung village. Source: Soil Conservation Office, Dhading.

In the vicinity of Hindung, a few rockslides occur on the upper part of a west-facing hill slope. The runout from these failures can reach the village. Another rockslide is situated near the primary school of Hindung. There is one more rockslide just below the main village. An erosive gully (or runout), originating from the upper slide, passes through a stream and affects the village (**Fig. 12**).

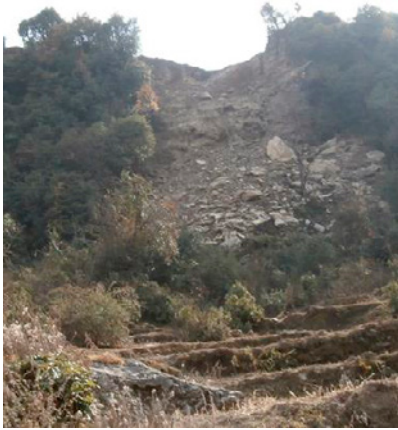
Fig. 13. Rockslide above Sertung village.

Two rockslides are located about 200 m southwards from the Sertung village, on the north-facing hill slope. Out of them, one is a reactivated slide and the other is a fresh failure with 1-2 m deep topsoil. Though the landslides lie mainly in the forest, both the crown as well as runout from them is in the paddy field. The failures affect the main settlement of Sertung, consisting of more than 200 houses. In the upper part of the slide, there are a number of tension cracks in the paddy field up to 10 m away from main scarp. The tension cracks record a lateral displacement of 60 cm and a vertical drop of 50 cm (**Fig. 13**). Presently, the flat area above the crown is dry, but it will be wet during the paddy cultivation in the rainy season. The natural slope below the slide is about 25 degrees; the slope on which the slide has developed is about 70 degrees.

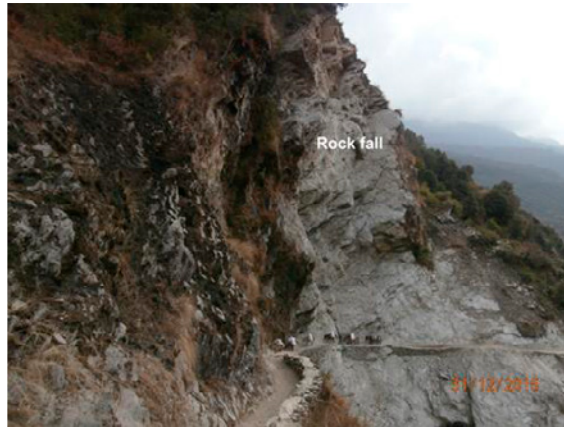
Fig. 14. Rock fall affecting the trail above Gobregau village.

A rock fall is observed on a barren land composing the west-facing uphill slope of the Gobregaun village in the Sertung VDC. The Borang-Sertung trail crosses the fall, which is about 30 m long and 20 m wide, and its failed slope angle is about 80 degrees (**Fig. 14**). The runout from the fall has travelled for more than 300 m and it may even reach a distance of 1000 m. Here, the bedrock consists of garnetiferous schist, the foliation of which strikes 285 degrees and dips at an angle of 45 degrees due north. The rock has three perfect joint sets.

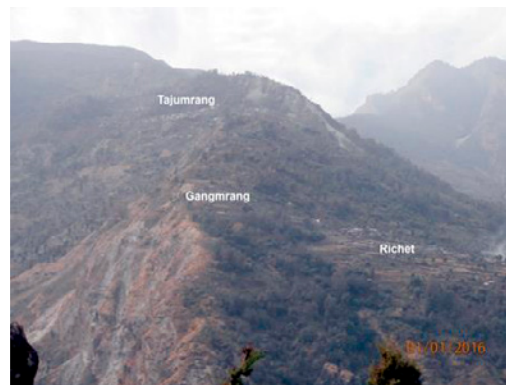
Fig. 16. Some large rock falls and rockslides at Richet and Tajumrang villages. View to W.

From the Kalmrang village lying on the left bank of the Ankhu Khola, a rockslide is observed on the opposite bank of the river, about 300 m above the village of Richet in the Ri VDC. The village is essentially north-facing and the constituent slope dips at an angle of about 40 degrees, whereas the failed slope is steeper (about 60 degrees). The village of Tajumrang is located on the eastern slope and is about 100 m away from the main landslide scarp. Between the main landslide scarp and settlement, there is a forest as well as a cultivated land. The landslide is 50-60 m long and 30-40 m wide. To the uphill side from the Ankhu Khola, towards Tajumrang, there is a large rock fall zone (**Fig. 16**).

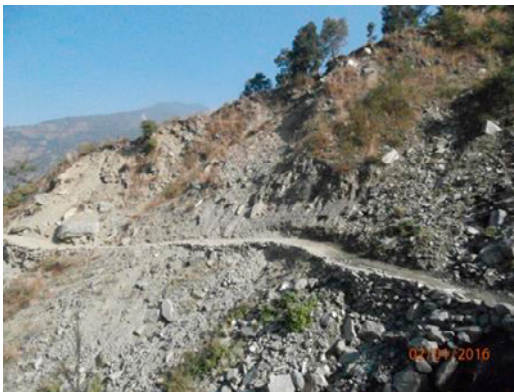
Fig. 17. Dharna colluvial slide affecting Dundure-Dhading Besi road.

At the Dharna village in the Dharkha VDC, an old reactivated rock fall – rockslide is observed. The slide is about 150 m long and 50 m wide. In it, the clasts are up to 1.5 m in size. The debris from the slide has travelled for about 500 m and reached the river. A road passes through the middle portion of the slide. The slope around the slide is covered by grass and forest. The landslide is saturated with water, as a stream is flowing through its central part (**Fig. 17**).

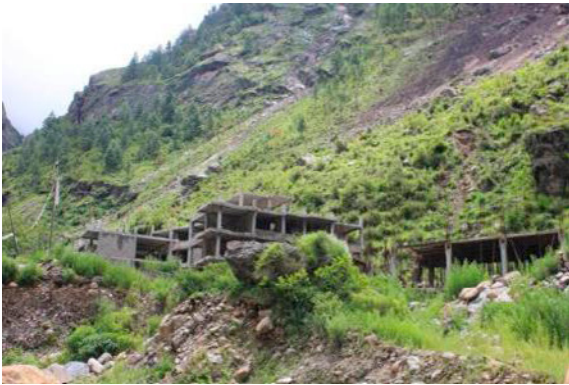
Fig. 19. Buildings of Rasuwa Gadhi Hydropower Project damaged by rock fall. View to E.

The office building construction site of the Rasuwa Gadhi Hydropower Project is located on the left bank of the Ghatte Khola and the Bhoté Koshi River. It is stretched along the foothill of a large rock cliff with talus cones (**Fig. 19**). This area suffered from severe rockslides and rock falls, which significantly damaged the five buildings under construction. Many large boulders and debris came down periodically during the main shock as well as aftershocks from about 400 m high cliff lying immediately southeast of the building site. Much of the material also came down when a series of rainfall events hit the area. The boulders destroyed roofs, columns, and ground floors of the buildings.

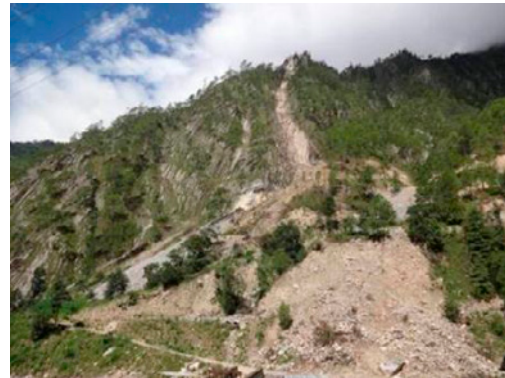
Fig. 20. Rock fall entering the area surrounding the valve chamber and severely damaged road on the talus cone below the portals. View to SW.

The earthen road leading to the two portals of valve chamber and access tunnel was severely affected by the earthquake and rainfall. The road was constructed on a wide colluvial and alluvial fan with large quartzite boulders. Presently, the road is severely damaged owing to its cut slope failure. Two portals are located within the rock fall zone from about 150 to 200 m above a rock cliff and gully (**Fig. 20**). Though most of the debris has already reached the base of the slope, about 25 % of it is still remaining there.

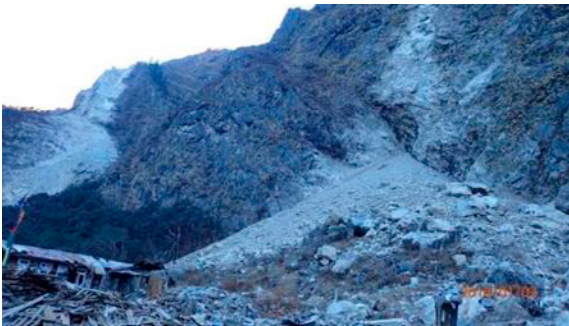
Fig. 21. Rock fall at Ghodatabela.

about 3011 m, rock falls and slides are very common and the area lies in a high hazard zone (**Fig. 21**).

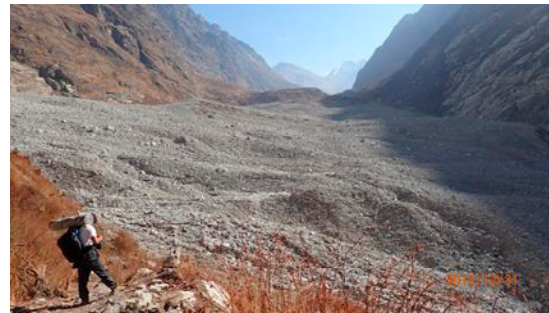
Fig. 22. Buried Langtang village. View to NE.

The Langtang village was located below a very steep ridge, and above it is a glacier towards the northwest and a large snow field right above the village. A mixture of

snow, ice, and debris, which originated at the snowfields on the slopes above Langtang, suddenly fell into the Langtang River as an avalanche and buried the village (Shrestha et al., 2016; Lacroix, 2016). The buried area occupies about 0.5 sq km. The extent of damage incurred in this area can be surmised by examining the buried Langtang valley and the river channel (**Fig. 22**). The wind blast during avalanching ripped and uprooted trees and aligned them in the direction of blow.

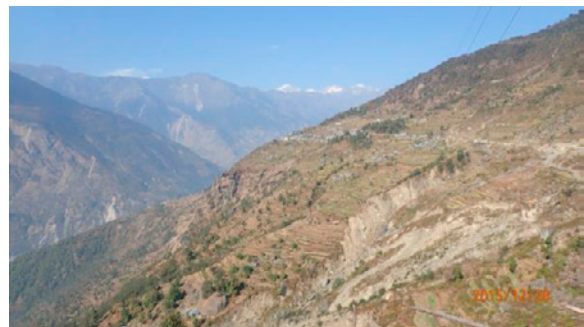
Fig. 23. Actively moving deep-seated landslide at Ramche. View to N.

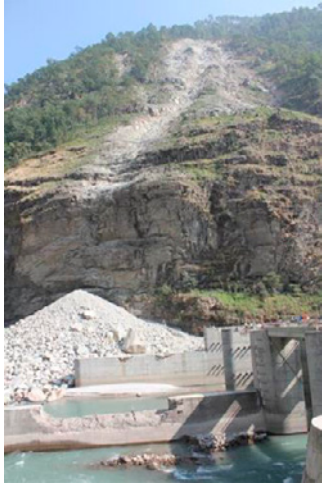
Fig. 25. About 150 m high rockslide-rock fall with a large talus cone on left bank of Trishuli River. View to E.

material has come down from about 100 to 150 m above the riverbed (**Fig. 25**). The upper part of the failed slope is steep (40 to 45 degrees) and its middle part is gentle (25 to 30 degrees). Then, there is a cliff of about 40 to 50 m height. The rock fall came mainly in the monsoon period.

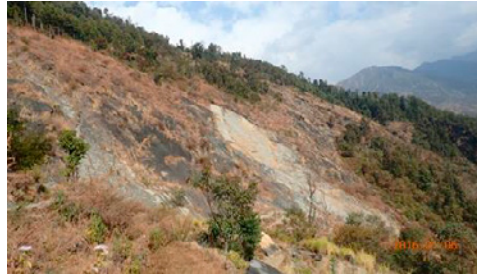
Fig. 26. Rockslide near Kaphali village. View to NE.

cultivated land situated in the vicinity of the crown. At the Kaphali village, a rockslide is damaging the cultivated land (**Fig. 26**). However, the settlement is not affected by the failure.

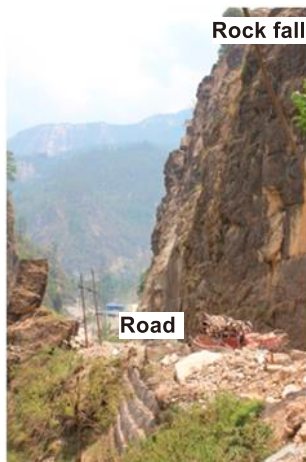
Fig. 28. Cliff south of Chaku, where Arniko Highway is suffering from rock falls. View to N.

rock cliff trigger rock falls or topples and frequently obstruct the Arniko Highway (**Fig. 28**) passing through the left bank.

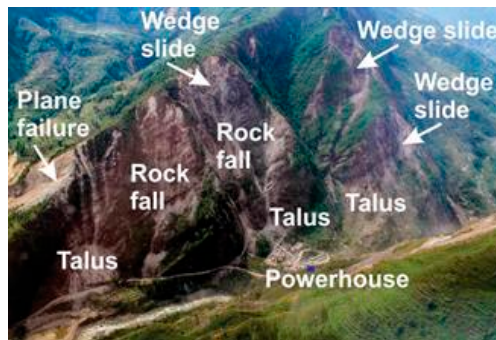
Fig. 29. Rock falls and shallow slides developed above the Upper Bhoté Koshi Powerhouse. View to SE.

There is a few hundred meter-high rock cliff (monocline) between the village of Khokundol and the Upper Bhote Koshi powerhouse (**Fig. 29**). The Khokundol Khola is flowing along the strike of bedrocks left bank has suffered from many dip-slope failures and wedge slides that have transferred to rock falls at the road level. These earthquake-triggered slides have originated from the upper edge of the slope.

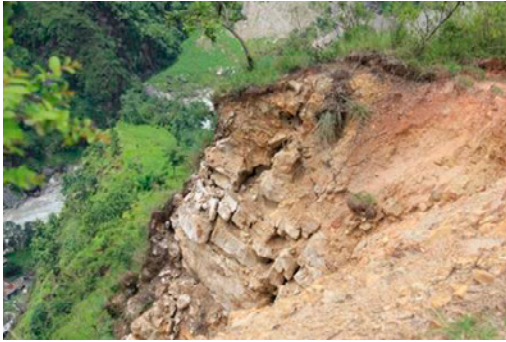
Fig. 30. Open joints in pale yellow to white calcareous quartzite exposed at the crown of the rockslide and rock fall zone lying about 300 m above the riverbed. View to NW.

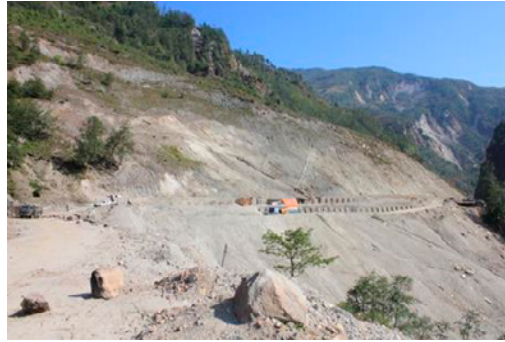
Fig. 31. Deep-seated landslide of Daklan affecting Arniko Highway. View to S.

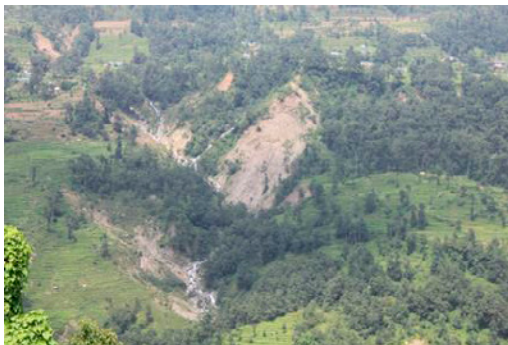
Fig. 32. Many shallow slides reactivated by the earthquake at Sundrawati, close to the Upper Tama Koshi Road. View to N.

The earthquake triggered shallow mass movements in the Tama Koshi watershed, especially between Charikot and Lamabagar. Most of them were similar to those observed near Sundrawati (**Fig. 32**). Like in other districts, the old soil slides and debris slides were not affected much by the earthquake. For example, a large debris slide at Km 10+500 m of the Upper Tama Koshi Road (**Fig. 33**) was insensitive to the quake. A weathered garnet schist is exposed on both ends of the soil slide. At this place movement was severe in the monsoon of 2012, and about 50 m length of road was damaged, as it was subsided for more than 5 m and shifted laterally for more than 12 m.

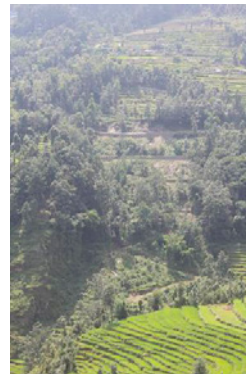
Fig. 33. A large soil slide at Km 10+500 of the Upper Tama Koshi Road. The slide was not much affected by the earthquake. View to W.

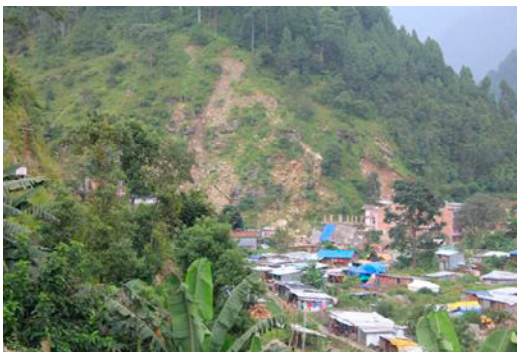
Fig. 34. Rock and debris falls from the south-facing slope of Singati. View to N.

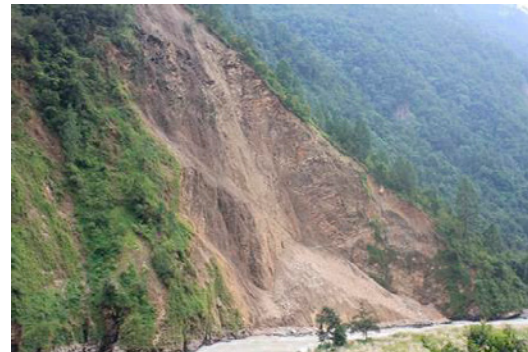
Fig. 35. Wedge slides and rock falls on the left bank of the Tama Koshi River, south of the Tinkhu Khola confluence. View to S.

slide lies on the left bank of the Tama Koshi River, south of the Tinkhu Khola confluence (**Fig. 35**). It is an old failure reactivated by the earthquake and subsequent monsoon rain. On the left bank of the Tam Koshi River, just upstream from the Gongar Khola, a long rockslide-rock fall forms a large talus deposit. It is an old slide reactivated by the earthquake.

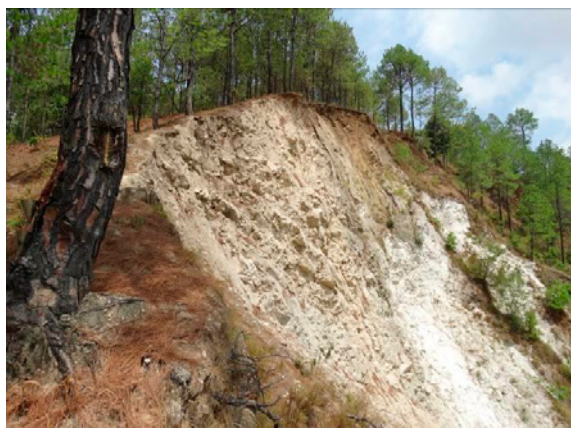
Fig. 36. Reactivated landslide at Pipaldanda. View to NNE.

About 150 m long, 10-15 cm wide, 0.5-2 m deep, and 10 cm vertically displaced tension crack was generated by the earthquake of 12 May 2015 in the gentle slope northeast of Pipaldanda. An old rockslide (**Fig. 36**) lies south of Pipaldanda and west of Gogane. Another tension crack is seen in the crown of the old slide consisting of residual soil and weathered gneiss. The crack is 5 mm to 30 cm wide. Most of it is an old crack, which was partly widened by the quake. In the nearby spur with gentle slope covered by pine forest, about 150 m long tension crack is developed in the residual soil and colluvium. The crack discontinues towards the east, i.e., near the old landslide scarp, but becomes extensive to the west. The main crack is 5 to 10 cm wide and has slipped by about 10 cm towards the downhill.
