Research Paper

Landslide dams and their hazard after the 25 April 2015 Gorkha Earthquake in Central Nepal

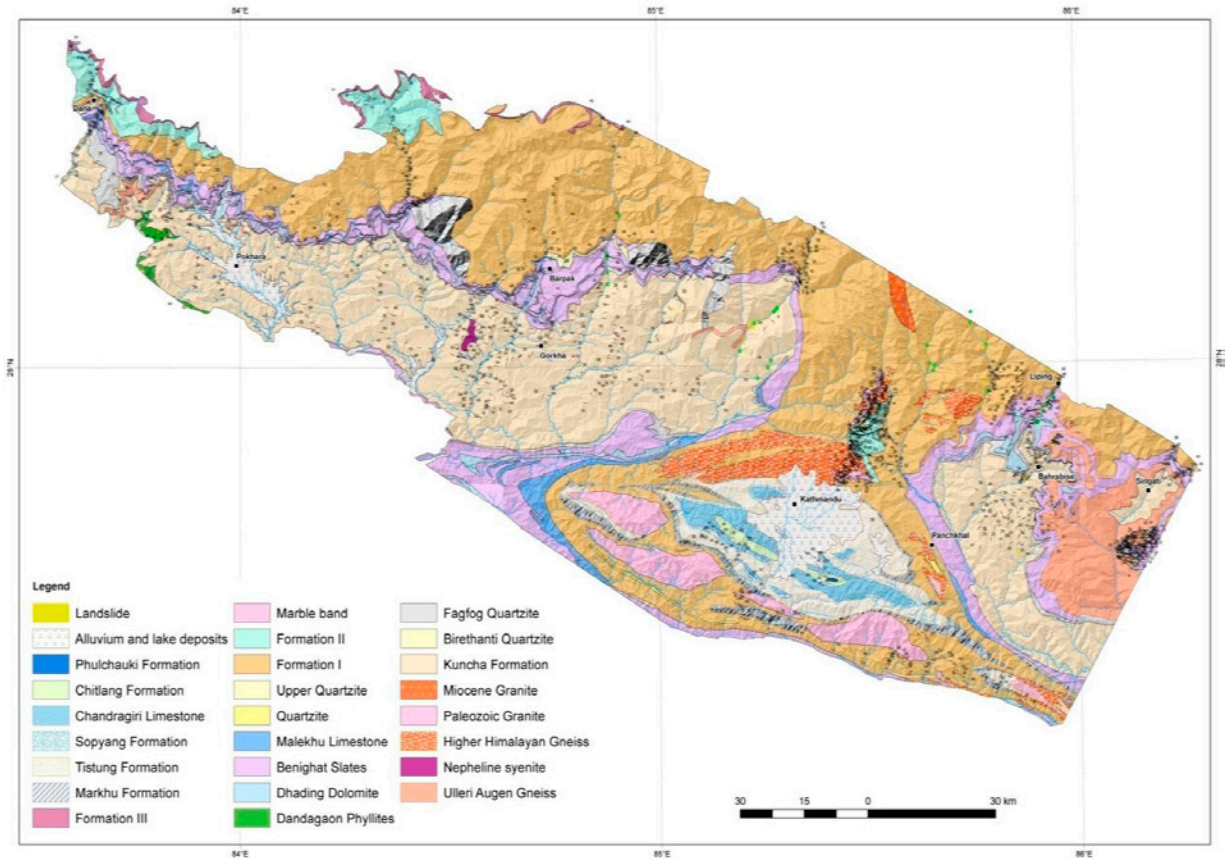
Fig. 1. Geological map of the Kali Gandaki – Tama Koshi area in Central Nepal (Modified from Colchen et al., 1986; Dhital, 2015).

The 25 April 2015 earthquake-affected area can be divided into the Lesser Himalayan Sequence, Higher Himalayan Crystallines, and the Tibetan–Tethyan Sediments (Dhital, 2015). These rocks have been classified into various formations (**Fig. 1**) and a short description of them is given below.

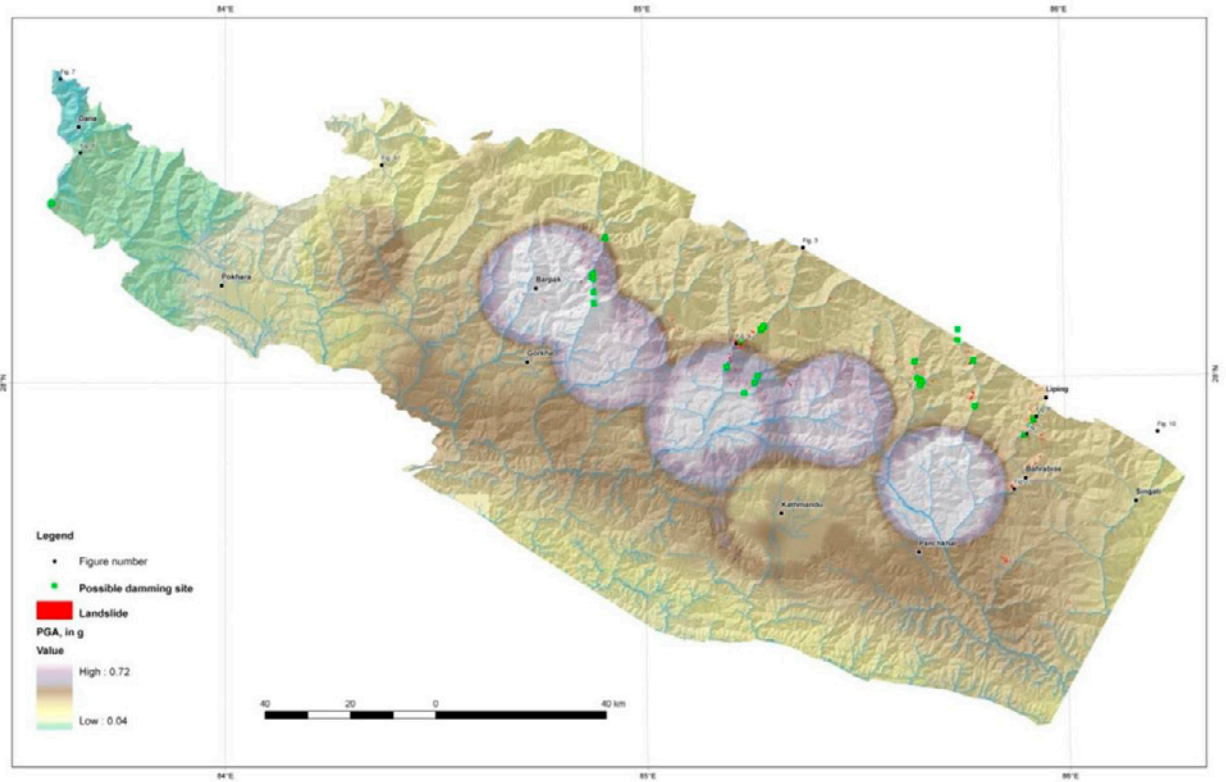
Fig. 2. Peak ground acceleration of the 25 April 2015 earthquake in the study area. Peak ground acceleration data source: USGS (2015). On the map are also shown major landslides and possible future damming sites together with locations of past landslide dams.

The Gorkha earthquake of 25 April 2015 (**Fig. 2**) triggered off more than 2000 landslides. Most of them were shallow and did not create many landslide dams. However a number of them partially blocked major rivers and such obstructions or constrictions were washed away by the floods during the rainy season.

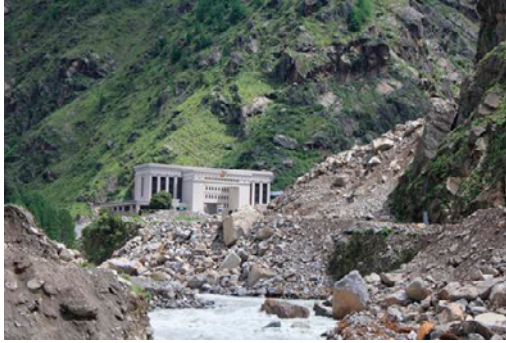
Fig. 3. Partially dammed Bhote Koshi River at the Rasuwa Gadhi check point in the Rasuwa District.

In the Rasuwa Gadhi area, a large rock fall – rock slide is observed on the right bank of the Bhote Koshi River, at the Nepal–China border (**Fig. 3**). The slide has partially blocked the flow and the debris is being gradually washed away by the river. A large number of shallow and long slides are seen on the right bank of the Trishuli River and in the Mailung Khola (**Fig. 4**). A few of them partially dammed the Trishuli River and were subsequently cleared off by the floodwater.

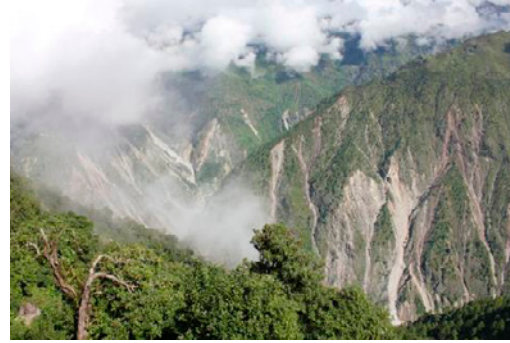
Fig. 4. Many rock falls, wedge slides, and plane failures in the Mailung Khola (left) and the Trishuli River (Right) south-west of Dhunche, opposite Ramche. The slides were triggered by the 25 April earthquake.

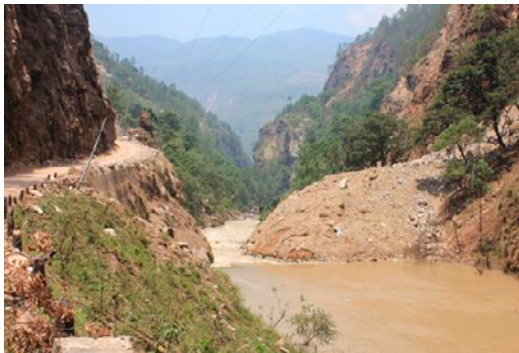
Fig. 5. Partially dammed Bhote Koshi River south of Chaku, Sindhupalchok District.

On the Arniko Highway, south of Chaku, a landslide has partially blocked the Bhote Koshi River (**Fig. 5**). Depending on the availability of the debris generated on the landslide, the material will continue to come to the river valley with a low probability of damming the river. Since the size of blocks in the debris is relatively small, complete damming seems improbable.

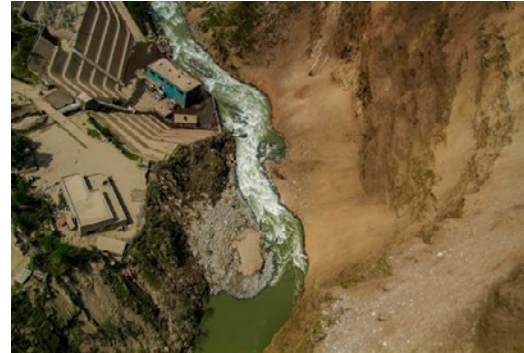
Fig. 6. Partially dammed Bhote Koshi River upstream from the Upper Bhote Koshi Powerhouse. Note extensive dust and talus on the right bank of the river.

The Bhote Koshi River opposite the powerhouse of the Bhote Koshi Hydropower Project was also temporarily (for a few minutes) dammed by rock and debris falls (**Fig. 6**). However, at present the channel is completely free of the dammed material.

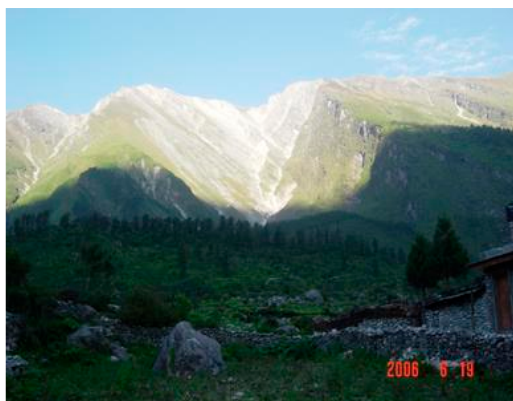
Fig. 7. Landslide of Kalopani that dammed the Kali Gandaki River several thousand years ago.

The huge rockslide of Kalopani (**Fig. 7**) was reported by many, including Baade et al. (1998). It occupies several square kilometres and has completely blocked the Kali Gandaki River. Subsequently the river cut a channel across the dam.

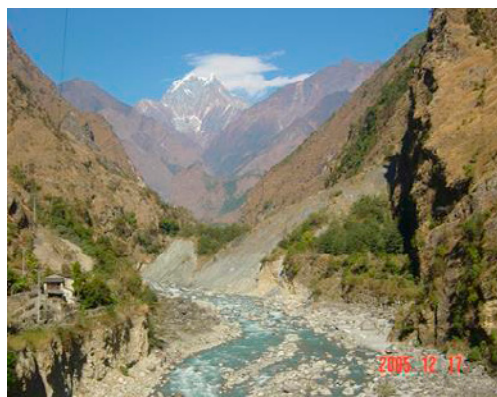
Fig. 8. Landslide dam of Tatopani in the Kali Gandaki River.

A landslide dam (**Fig. 8**) was formed in the Kali Gandaki River, downstream from Tatopani in 1998 (Völk, 2000). It lasted for about 72 hours and was overtopped by the river without any serious consequences.

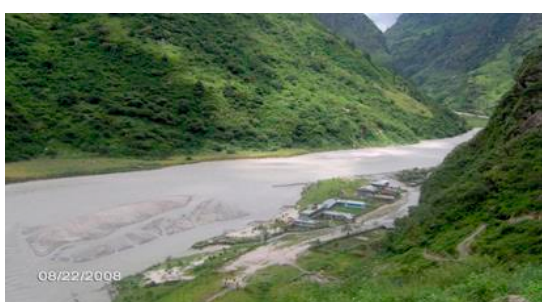
Fig. 9. Landslide dam of Tal Bagar in the Marsyangdi River.

The landslide dam of Tal Bagar in the Marsyangdi River (Weidinger, 2001). It is at least 1000 years old and the river has presently filled up the dam with sediments and it is flowing through it (**Fig. 9**).

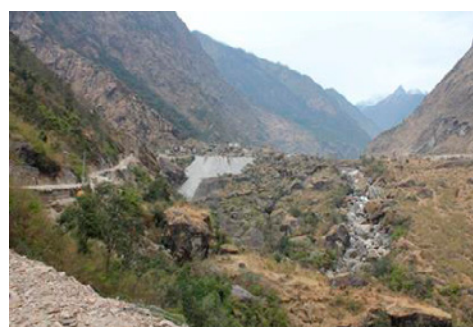
Fig. 10. Landslide dam of Tama Koshi at Lamabagar in the Tama Koshi River.

Another old landslide dam is observed at Lamabagar, in the Tama Koshi River (**Fig. 10**). It is several thousand years old (Uhlir, 1998) and presently, the river is flowing through the dam.

Rock type plays a major role in landslide damming. Generally, hard and resistant rocks with wide joint spacing create large blocks that cannot be easily transported by the river (**Fig. 10**). In such circumstances, if a rock fall or slide occurs from a steep and high slope, it may dam the river (**Figs. 8, 10, and 11**). On the other hand, a soft rock may be responsible for creating debris slides, large mud slides, debris flows, and mud flows, which can also dam a river. Sometimes alternating hard and thick bands with soft and thin bands create anisotropy in rock. In the Higher Himalayan region, quartzites and schists frequently alternate. Similarly there are alternating marble and schist bands as well as gneiss and schist bands of similar nature. In the Lesser Himalaya and the Tibetan-Tethys zone, phyllites are alternating with quartzites, sandstones are intercalated in shales and mudstones, limestones are found together with slates or shales. Hence, such conditions can favour a large rockslide or rock avalanche (**Figs. 10 and 11**).

River sinuosity plays a vital role in landslide damming. It is found that concave turns with steep banks suffer the most from frequent damming (**Fig. 10**). The ratio of river valley to active channel is another controlling factor of landslide dam formation and its longevity. River gradient controls landslide dam stability in many ways. Landslide dam volume and catchment area above the dam are considered the main parameters deciding the dam's stability (**Fig. 11**).

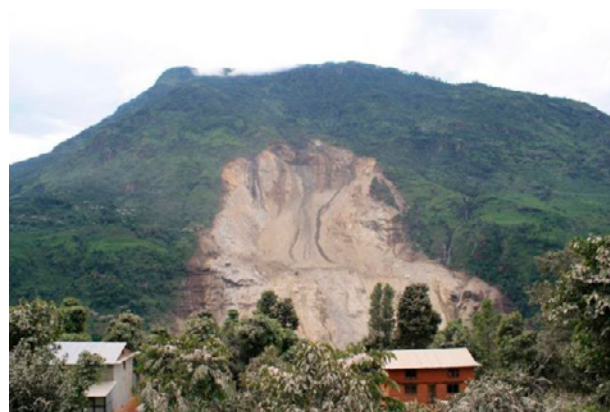
Fig. 11. Landslide of Jure that dammed the Sun Koshi River on 14 August 2014.

The Jure rockslide–rock avalanche (**Fig. 11**) occurred in the morning of 14 August 2014 and it lasted for about 2 months by souring the east part of the dam. This event destroyed the headworks of the Sun Koshi Hydroelectric Project and caused damage to a few houses of Khadichaur.

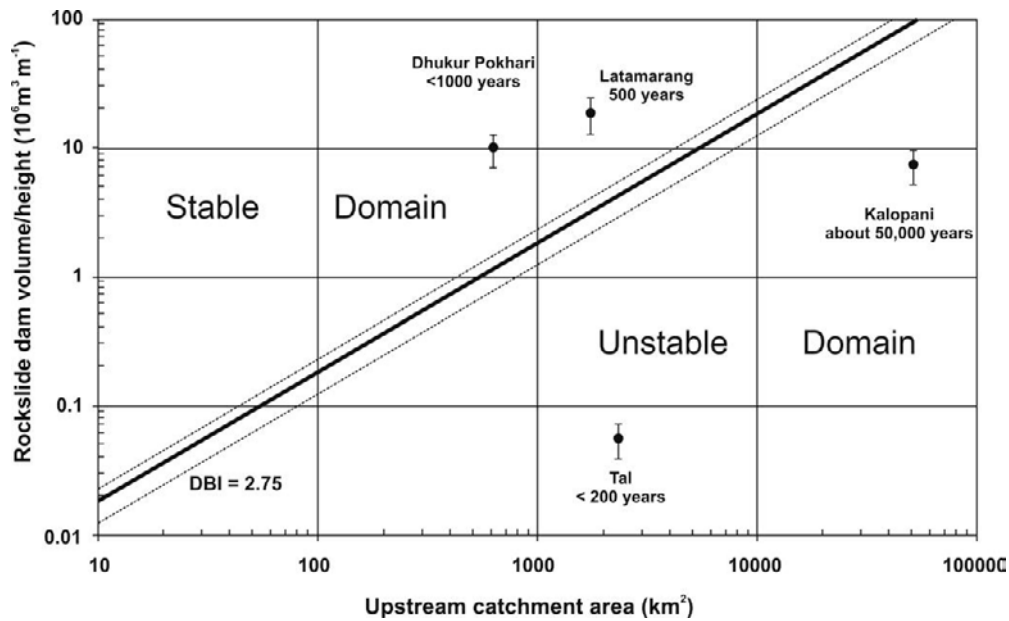
Fig. 12. Stability condition of rockslide dams based on upstream catchment area and dam volume (Modified from Weidinger, 2011).

Weidinger (2011) worked out a relationship between volume of three rockslide dams and one rock avalanche dam scaled by height versus upstream catchment area for natural river blockages in the Kali Gandaki and Marsyangdi River valleys of Nepal (**Fig. 12**). The plot was prepared using a dimensionless blockage index ($DBI=2.75$) of Ermini and Casagli (2003) for worldwide data separated into stable and unstable landslide dams, by taking the empirical relationship derived by Korup et al. (2006).
