Research Paper

Effects of surface geology and topography on the damage severity during the 2015 Nepal Gorkha earthquake

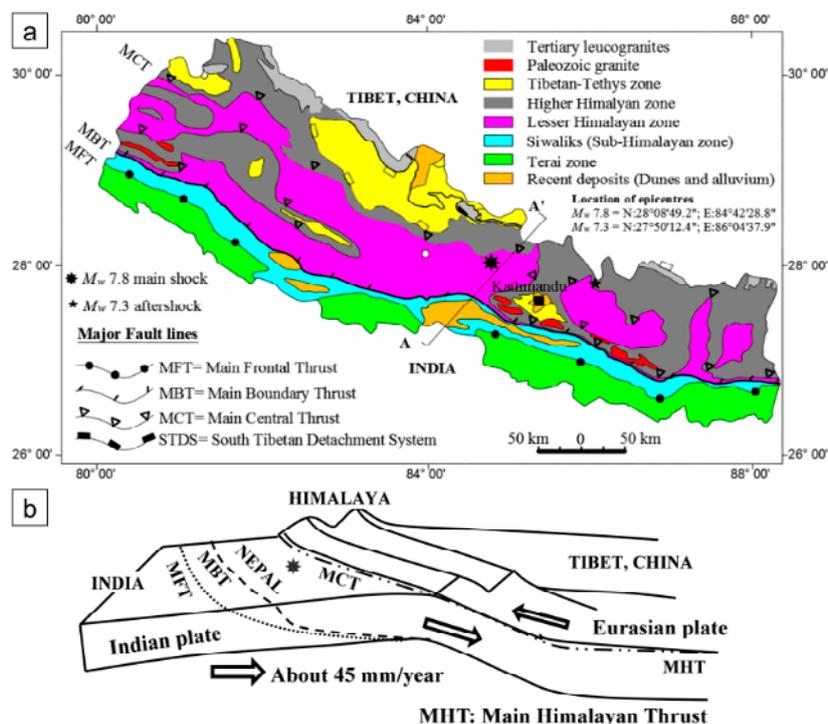
Fig. 1. (a) Tectonic zoning of Nepal with active faults (modified after Dahal (2006) and locations of the main shock and M_w 7.3 aftershock, and (b) motion and type of plate boundaries at the cross section A-A' (Sharma and Deng, 2017).

starting 40 million years ago. Nepal is situated in the center of the Himalayan concave chain and is rectangular in shape of about 900 km in the NWW-SEE and 130 to 260 km in N-S direction. The Himalayan arc, which is one of the most active seismic regions on earth, has caused numerous major earthquakes in past centuries (Bilham et al., 2001; Ambraseys and Douglas, 2004). **Figure 1a** shows the tectonic zones, major faults, and geologic map of Nepal. The 2015 Gorkha earthquake was the result of thrust faulting between the subducting India plate and the Eurasia plate to the north (**Fig. 1b**), where the Indian plate converges with the Eurasian plate at a rate of 45 mm per year towards the north-northeast (Copeland, 1997).

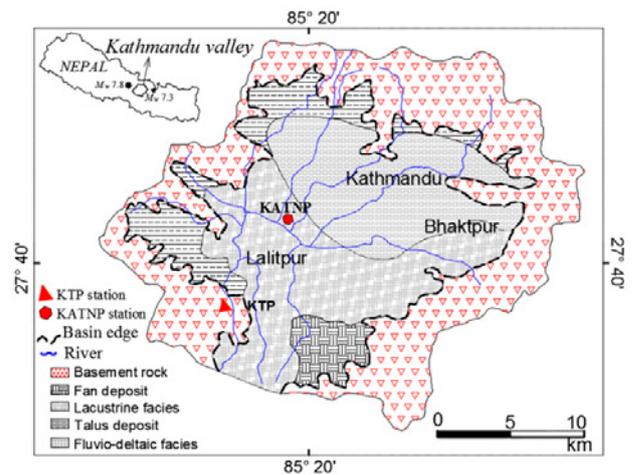
Fig. 2. Geological map of the Kathmandu Valley (modified after Sakai et al., 2002).

Figure 2 shows the geologic map of the Kathmandu Valley, where the majority of the observations in this studies are located. Geological study has shown that the Kathmandu Valley is an ancient lake deposit and is made of thick layers of clay, silt, sand, and gravel. The maximum thickness of the valley soil is 500-550 m at the center of the valley (Sakai et al., 2002). As shown in **Fig. 2**, the valley south soils consists of boulders and gravel with a clayey and silty matrix derived as debris flows from the southern hill, while marginal fluvio-deltaic facies (i.e., typical riverbed layered deposits of clays, silts, sand, and gravels) are found in the valley north, and the central basin consists of open lacustrine facies (e.g., thick organic mud, and the black clay). As the soil deposited in irregular layers, soil properties and basin thickness vary from place to place.

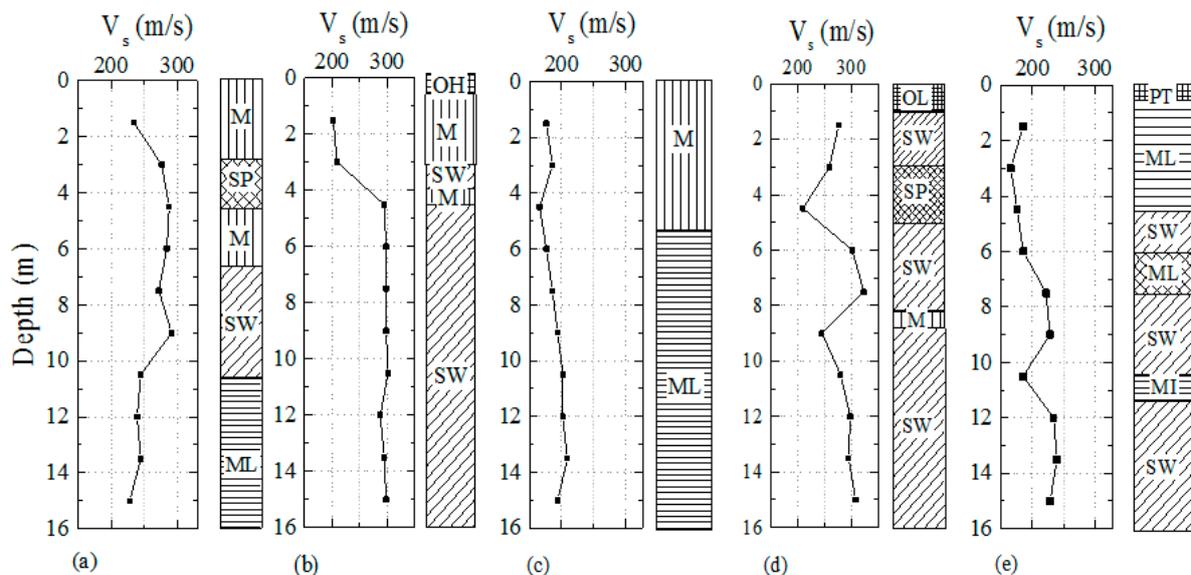
Fig. 3. Shear wave velocity (V_s) and soil classification at five locations in the Kathmandu Valley: (a) Baneshwar (BN), (b) Balkumari (BR), (c) Baudha (BD), (d) Dhapasi (DS), and (e) Budanilkantha (BT).

laboratory soil characterization. The SPT sites were chosen because they are readily available and near the liquefied or severely devastated areas. The sites are primarily located in regions of the fluvio-deltaic facies and the fan deposits. In the absence of geophysical tests, the shear wave velocity (V_s) was estimated through the correlation with corrected SPT values, proposed by JICA, for the alluvial deposit of the Kathmandu Valley ($V_s = 97 \cdot N^{1/3}$; $N = \text{SPT } N \text{ value}$) for all types of soils (JICA, 2002). According to this correlation, V_s varies from 150 to 350 m/s in the valley. Five representative borehole logs with the shear wave profile are presented in **Fig. 3**.

The site investigation showed that most soils in the Kathmandu Valley are grey to dark silty sand and clayey silt. Organic clay, fine sand beds and peat layers are common in the surface 1 m layer. The soil profiles at BN, BR, and DS (**Figs. 3a, 3b, and 3d**) show thick layers of

well-graded sands and silty sands that are susceptible to liquefaction. The soil profiles at BD and BT (Figs. 3c and 3e) show thick and interbedded sandy silts that have high liquefaction resistance. The low plasticity silt with some portion of gravel in underlying layer is found to constitute a PI of 15. However, the plasticity of 23 is found to be occurring in the medium clay slit. As per the grain size distribution in the study area, clays are dominant in most of the sites and a small portion of sandy facies is present in the northern part. The ground water table (GWT) was not determined at the time of site investigation. However, the Kathmandu Valley was in the dry season from March to June 2015, during which the city withdraws a large amount of groundwater; this drew down the GWT of the valley, except in the regions near major rivers.

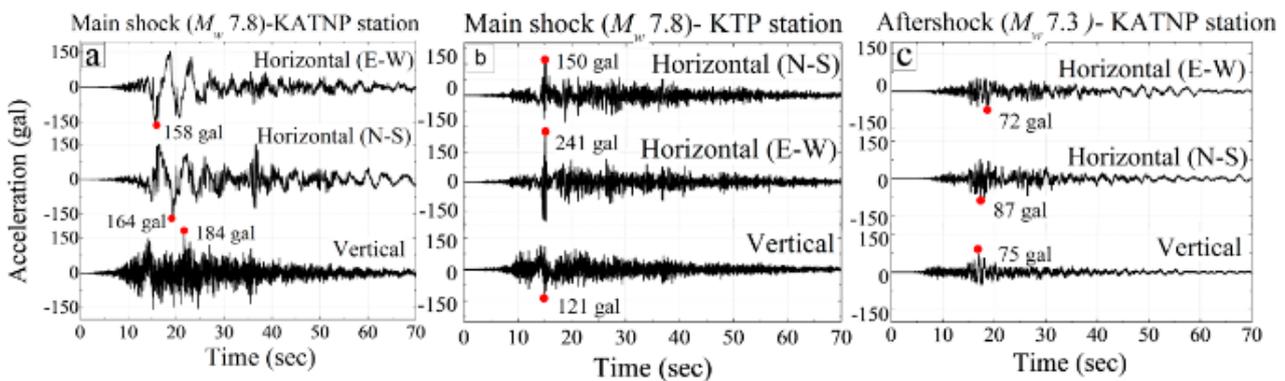
Fig. 4. (a) Accelerograms at KATNP for the M_w 7.8 main shock, (b) accelerograms at KTP (Takai et al., 2016) for the M_w 7.8 main shock, and (c) accelerograms at KATNP for the M_w 7.3 aftershock.

The E-W, N-S and vertical components of the accelerograms of the main shock at KATNP and KTP are shown in **Figs. 4a** and **4b**. **Figure 4c** shows the E-W, N-S and vertical components of the accelerograms of the M_w 7.3 aftershock at KATNP. The peak ground accelerations (PGA) of the main shock in horizontal direction are 164 gal (1 gal = 1 cm/s²) and 241 gal at KATNP (soil site) and KTP (rock site), respectively. Time histories in **Fig. 4a** show that the horizontal accelerograms at KATNP had long duration with conspicuous long-period oscillation at about 5 seconds while the period of horizontal accelerograms at KTP was less than 1 second. This long-period ground motion may be due to the response of the Kathmandu Valley basin. Although the long-period component is large, the shorter-period component (1 second to 2 seconds) is relatively small, resulting in a peak ground acceleration value of 184 gal in vertical directions at KATNP station. The PGA recorded at KATNP station did not exceed the PGA estimates with 10% probability of exceedance in 50 years from the recent regional seismic hazard studies by JICA (2002) and Ram and Wang (2011); however, it is speculated that the local site effects might have contributed to the significant amplification of the motions in Kathmandu Valley and thus make the effects of the earthquake more influential.

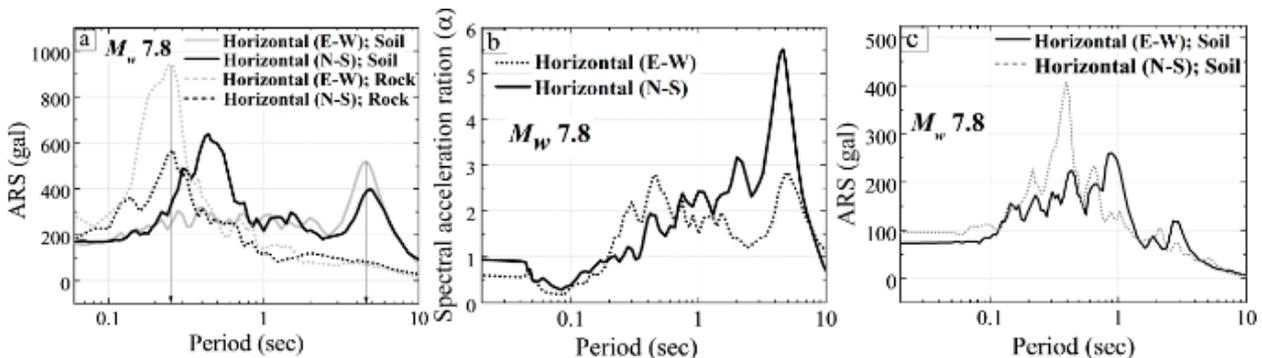
Fig. 5. (a) 5% damped acceleration response spectra (ARS) of the main shock motions at soil (KATNP) and rock (KTP) stations, (b) ARS amplification ratio of the main shock soil motions at KATNP with respect to the outcrop motion at KTP, and (c) 5% damped ARS of the M_w 7.3 aftershock motions at KATNP.

The 5% damped acceleration response spectra (ARS) of the main shock at KATNP and KTP are compared in **Fig. 5a**. It is seen that both N-S and E-W components at KTP have a peak at 0.25 seconds while the N-S component at KATNP has two prominent periods at 0.47

s and 5 s and E-W component has one peak at 5 seconds. The acceleration records at soil site (KATNP) are broadband and contain the long-period components at 5 s. The features of the ground motions are the result of the effects of the thick, soft sediment in the valley, where the KATNP was built upon. The horizontal components of the main shock and aftershock show the similar characteristics when the period is less than 1 second (**Figs. 5a** and **5c**). In contrast with horizontal components of main shock at KATNP, aftershock components do not show the peaks at 5 seconds. The peaks at about 5 seconds of the main shock components at KATNP may be attributed to the main shock sources rather than the local site effects.

To understand the site effect on the main shock motions, spectral acceleration ratios (KATNP/KTP) of the two main shock motions, presented in **Fig. 5b** for each horizontal component, represent the amplification effect of the deep alluvial soil on the ground motion. It is shown that the ground motions at the KATNP site were strongly influenced by the local site condition at long periods. These spectral ratios reveal that spectral response at the soft soil site is amplified by a factor varying between 1.5 and 4.5 compared to the rock site in the period range of 0.3 seconds to 5.0 seconds. The fundamental periods of the heavily damaged residential buildings and heritage structures on the alluvial basin in Kathmandu Valley fall into this range. **Figure 5c** shows the 5% damped ARS of the aftershock at KATNP. N-S components of aftershock at KATNP has a peak at 0.35 seconds while the E-W components at 1 second. Both E-W and N-S components of main shock have the secondary peaks at about 5 seconds whereas the aftershock components do not show

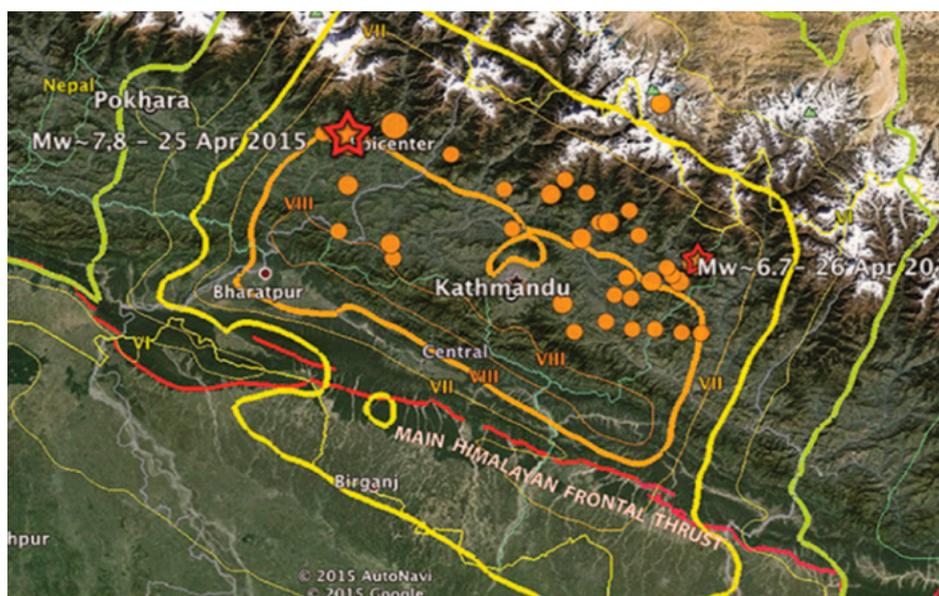
Fig. 6. Isoseismal map for the 2015 Gorkha Nepal earthquake (USGS, 2015).

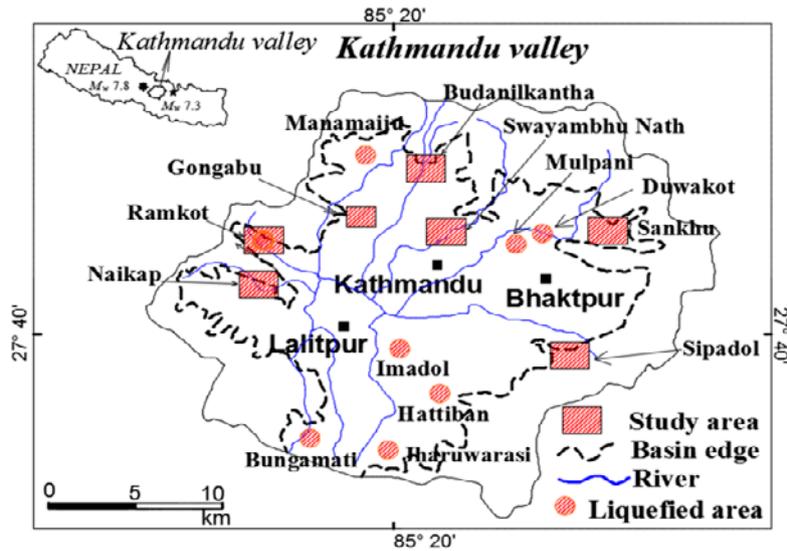
Fig. 7. Locations of the study areas for local site effects and liquefaction.

Figure 7 shows the areas selected to investigate the effects of local soil characteristics on the structural damage of buildings. The case histories in Gongabu and Machhapokhari, along the Bishnumati River where maximum damage to RC buildings occurred, are particularly of interests for local soil effect investigation. The geological map of Gongabu and Machhapokhari show that both areas lie on recent (Holocene) alluvium soil. The recent alluvium near the river mainly consists of sand and silt, with a shallow ground water table, typically 1.5 m to 3.0 m from ground surface. The standard penetration test (SPT), N values are mostly lower than 15. From the preliminary study of the Gongabu and Machha Pokhari site, it is indicated that the soil is very soft (Holocene alluvium) and water logged, which can amplify the seismic wave and therefore increase the severity of the damage to buildings.

The destruction of building structures supported on shallow foundations in Ramkot, Naikap and Sipadol (locations labeled in **Fig. 7**) could be interpreted as local site amplification, because most of these structures were constructed on loosely compacted fill. The organic soft fill was originated from the cut of adjacent hill as shown in **Fig. 9**. The fill was not compacted enough to achieve high density and strength of filled soil. On the contrary, many building structures on the hill top were not damaged as severely as the structures on the fill because the intact hill soils were generally stiff and thus the shaking amplification may not be significant. **Figure 9b** illustrates the schematic diagram of the land preparation for houses in Kathmandu Valley. **Figure 10** shows the performance of a RC building, which is designed for earthquake resistance, developed on loosely compacted fill. This highlights the importance that local site effects need to be considered in design.

When looking at the damage distribution caused by the Gorkha earthquake, one can easily notice severe damage along the basin edges of the Kathmandu Valley. **Figure 7** shows several severely damaged towns within the valley. Towns such as Duwakot, Kapan, Manamaiju, Budhanilkantha, Jorpati, and Sankhu located at the edge of the valley basin were severely affected (Sharma and Deng, 2016) as compared to other old towns with many non-engineered masonry buildings, such as Asan and Patan located in the center of the Kathmandu Valley. On the other hand, most of the old structures were destroyed and new RC structures were severely damaged in the towns near the basin edge (**Fig. 24**). The observed damage distribution and high intensity of the ground shaking near the basin edge clearly demonstrated the influence of the basin-edge effect.

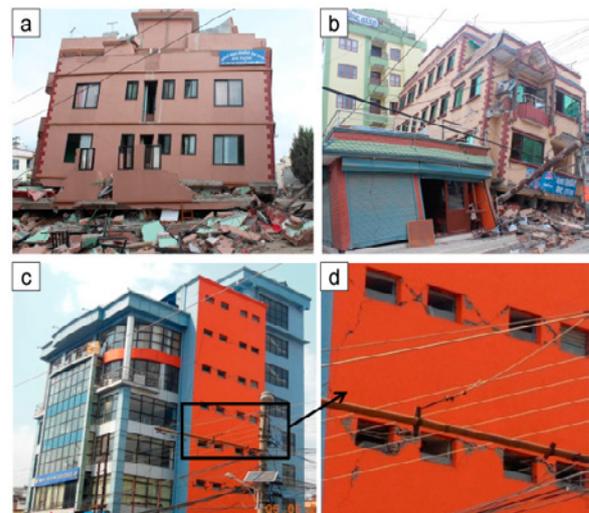
Fig. 8. Damaged buildings at (a) Gongabu (N: 27.738114°, E: 85.307635°), (b) Machhapokhari (N: 27.735511°, E: 85.305340°), (c) Newly constructed building at Tripureshwar, Kathmandu along the Tukucha River and (d) severe diagonal cracks on the wall (N: 27.691972°, 85.316163°).

Figures 8a and 8b show typical building failure at Gongabu and Machha Pokhari. Similar cases of local soil effects can be found along the major river channel in the Kathmandu Valley. **Figure 8d** shows sever cracking on the wall of a well-engineered, newly constructed building at Tripureshwar along the Tukucha River (**Fig. 8c**). It also may be inferred that soil amplification of lower frequency ground motion along major rivers in Kathmandu caused greater damage to buildings, probably due to double resonance effects (resonance at 0.25 seconds and 4.5 seconds; **Fig. 5a**) (Graves, 1996).

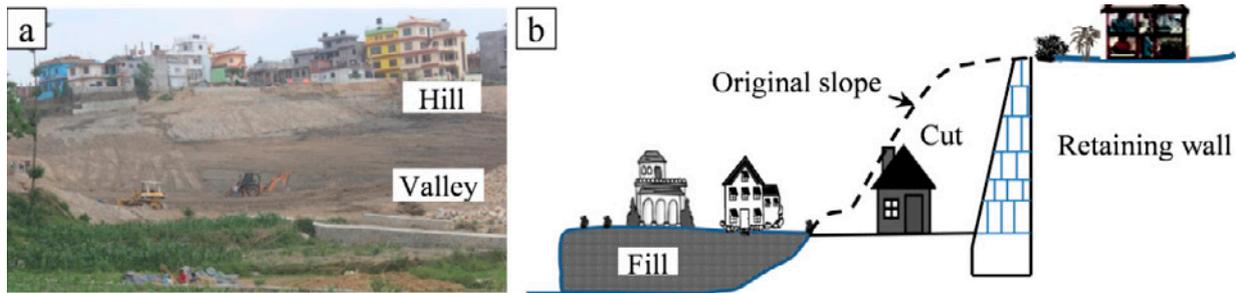
Fig. 9. (a) Earthwork activities for housing construction in the Kathmandu Valley (N: 27.698884°, E: 85.366282°), and (b) schematic diagram of the cut and fill. Building structures on the hill were considered intact (Sharma and Deng, 2017).

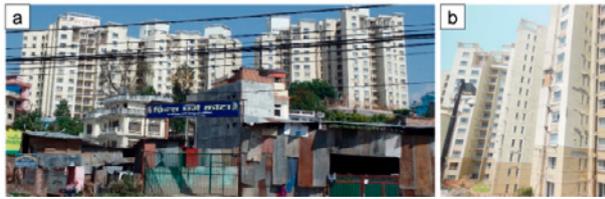
Fig. 11. (a) Park View Horizon apartment (N: 27.739762°, E: 85.324410°) was severely devastated by the main shock due to the basin effect, and (b) close view.

Although newly constructed high-rise apartment buildings are considered as a well-engineered building type in Nepal, severe cracks were found on many infill walls of this type of buildings. It was found that out of 15 newly constructed high-rise apartment buildings in Kathmandu Valley, 11 were severely affected by the earthquake. Figure 11 shows a 16-storey, apartment complex, Park View Horizon, which exhibited many major cracks along its height. Non-structural burnt bricks were used as the infill material, which led to a significant increase in weight. In contrast to a well-engineered high rise apartment, old and poorly constructed residential buildings around the apartment were found intact (Fig. 11a).

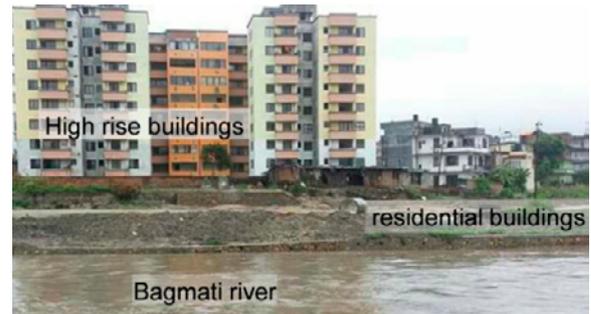
Fig. 12. High rise building at Buddhanagar, Kathmandu (N: 27.682565°, E: 85.329619°).

Another case that highlights the soft soil effect is the newly constructed high-rise building in Buddhanagar, Kathmandu, as shown in Fig. 12. The high-rise building is located in between several old masonry and non-engineered RC buildings. The high-rise buildings were well engineered while the residential houses (RC or masonry) are old and poorly constructed; however, the apartment suffered from more severe damage than the old short buildings. This case history shows that the effect of long period ground motion due to newly deposit sediments

along the Bagmati River exacerbated the destruction of tall RC buildings that have long predominant periods.

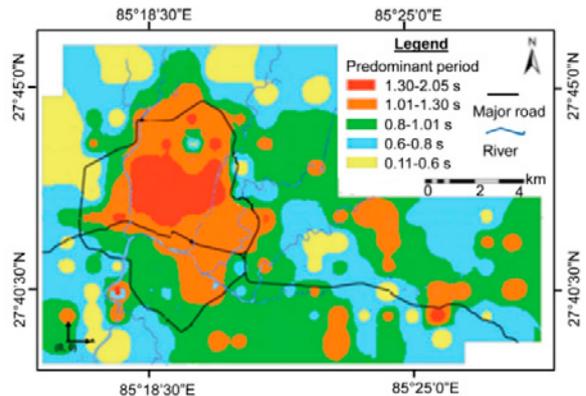
Fig. 13. The contour map of predominant period of ground of the Kathmandu region (Paudyal et al. 2012).

13. These predominant period contours provide some valuable information which can be roughly correlated with the period of the damaged structures. Failure of the Dharahara tower, a 203 feet tall unreinforced masonry tower (**Fig. 14**), could also be related to the long-period dominance in the central region (1.30 seconds to 2.05 seconds).

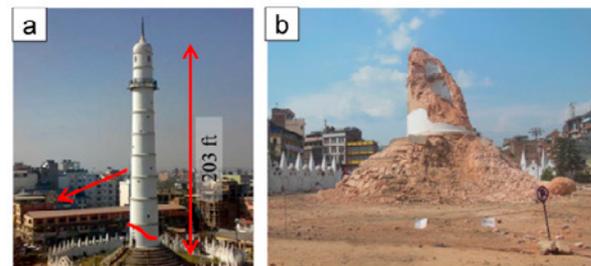
Fig. 14. (a) Dharahara tower before earthquake, and (b) base of Dharahara remaining after earthquake (N: 27.70082°, E: 85.31249°).

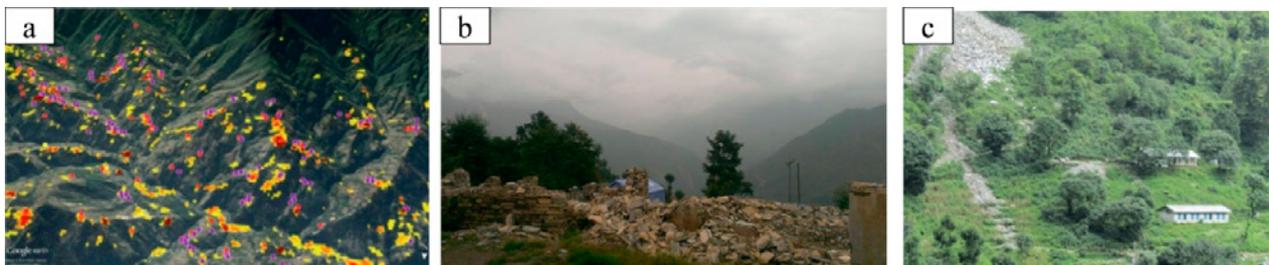
Fig. 17. (a) Ridge-top damage interpreted from satellite image decorrelation before and after the main shock (ARIA/JPL-Caltech), (b) a completely destroyed school on the hill top (N:27.837392°, E:85.854154°), and (c) an intact school at the hill valley near the school on the hill top (N:27.804319°, E: 85.913725°) (Sharma and Deng, 2017).

Figure 17a shows the damage distribution (source: ARIA/JPL-Caltech 2015) of building in the hilly areas of Nepal. Red and yellow represent completely damage and partially damage buildings respectively. It is shown that the severe damages are aligned with the ridge lines. **Figures 17b and 17c** compare the seismic performance to two similar schools building constructed in the same era (about 50 years ago) near the epicenter of the M_w 7.3 aftershock. The school building in the nearby valley performed very well, while the school building located on the top of a hill was completely demolished. The distinctive performance of the school buildings could be explained by the ridge effect. The collapse of the building on the hill top was attributed to the ground motion amplification by the hill.

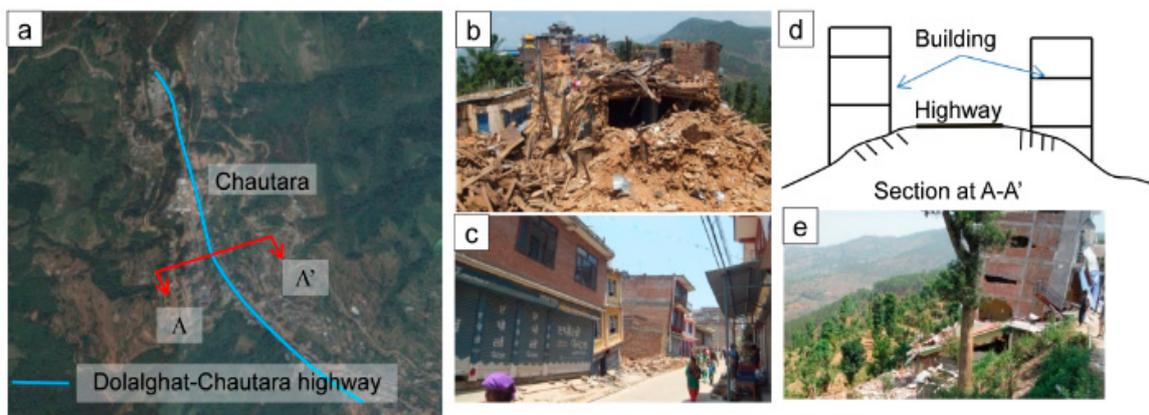
Fig. 18. (a) Chautara on the top of ridge (N: 27.776336°, E: 85.712683°) (b) schematic cross-section about A-A', (c) severe damage of the buildings at Chautara, (d) and (e) damage on buildings located on slope ground.

Chautara town is one of the places that suffered the most severe damages during the earthquake (**Fig. 18**). The town is located along Arniko highway on the mountain ridge (**Fig. 18a**). The damage to the Chautara town (**Figs. 18b, 18d and 18e**) was very severe though it is far from the epicenter and earthquake fault. The reason can be the amplification of narrow mountain ridge. The field investigations in Chautara also show that a majority of the damaged buildings, mostly mid-rise reinforced concrete (RC) moment-frame systems, were located on steep slopes along the Arniko highway (**Figs. 18d and 18e**). In contrast,

building with the same structural characteristics located on flat ground did not suffer much damage.

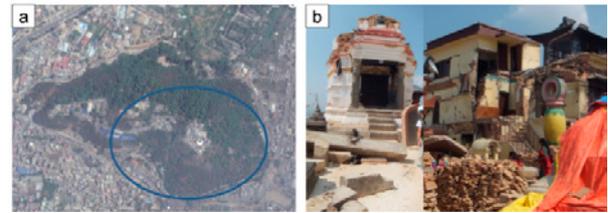
Fig. 19. (a) Swayambhu Nath, a small hill in the center of Kathmandu Valley, and (b) severely destructed buildings (N: 27.714980°, E: 85.290401°) at the hill top of Swayambhu Nath.

Ridge effects were also observed in the Kathmandu Valley. Building damage was specifically concentrated at the top of an isolated hill at Swayambhu Nath as shown in **Fig. 19**. The location of the hill is labeled in **Fig. 7**. It was noticed that the shake intensity was so high at the hill top that many buildings at the top were severely destructed or destroyed (**Fig. 19b**). On the contrast, buildings in the lowland surrounding Swayambhu Nath were not significantly damaged.

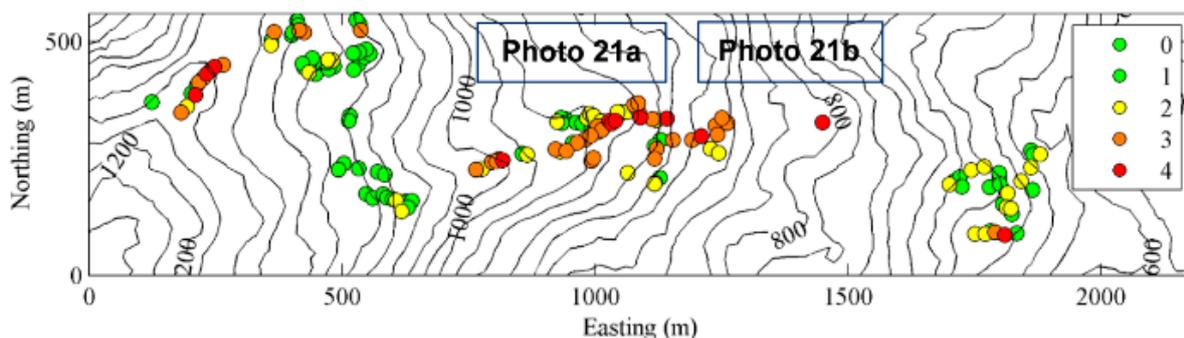
Fig. 20. Damage scenario in mountainous area with the contour map (N: 28.088225°, E: 84.542748°) (Parajuli and Kiyono, 2015).

A damage survey of the structures in rural areas, focusing on the topographic effect on structural damage, had been completed a few months after the Gorkha earthquake. The site for the survey was chosen in the Harmi VDC, Gorkha district, about 17 km southwest from the epicenter of the Gorkha earthquake 2015. A contour map of the surveyed area was developed as shown in **Fig. 20**. A total of 149 structures in the strip of a small mountain slope were studied and ranked in the range of damage index from 0-5. Structures were also categorized as small, medium and large based on their floor level and plinth area. Structures having less than 45 m² plinth area are categorized as small, where up to 75 m² and more are taken as medium and large respectively. Heavily damaged structures with damage grade 5 were not spotted but grade 4 structures were 6%, similarly 24% of structures fall in damage grade 3 and grade 2 each. A maximum, 38% of the structures in the study area had damage grade of 1 along with no damage or minor damage structures with grade 0 were at 8%. It was found that most of the

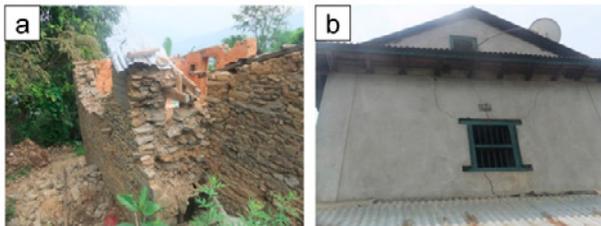
Fig. 21. (a) Stone masonry building, a residential house collapsed on the ridge line and (b) cracks on the wall of the building located on the ridge line.

structures in ridge line suffered more damage than those located in the slopes (**Fig. 21a**). When we only consider the structures located in the local ridge line, a total of 52%, 15%, 19%, 52% and 14% of the structures categorized with damage grade of 1, 2, 3 and 4. There were not any structures having grade 0 in ridge line. Structural system of all the structures were similar, with almost the same source of materials. When we look at the differences between similar structures, but having different damage grades, we found two major reasons for reducing the damage level. One of the major reasons was cement plaster/pointing in the main wall. Almost all of the structures with cement plaster were not heavily damaged. Those structures had enormous cracks, however did not collapse, as like the one shown in **Fig. 21b**. This study of a small village clearly highlights the topographic (ridge) effects on the damage severity of the structures (Parajuli and Kiyono, 2015).

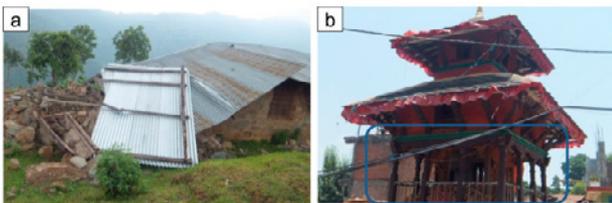
Fig. 22. (a) School on the top of hill at Harmi, Gorkha (N: 28.089571°, E: 84.542719°) (b) temple on the top of hill at Chautara (N: 27.774824°, E: 85.715495°).

In Nepal, school building and temples are often constructed on hilltops. Many of these structures located on the top of hills were destructed (**Fig. 22**), which can be attributed to topography amplification effects.

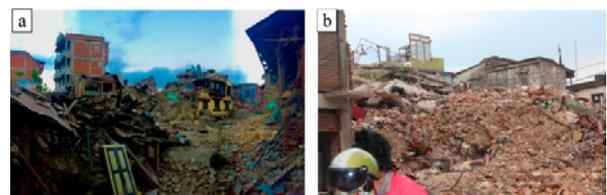
Fig. 24. Severe damages of buildings at (a) Sankhu (N: 27.513595°, E: 85.329142°) and (b) Balaju, Kathmandu (N: 27.735512°, E: 85.301820°).

Severe damages were observed adjacent to basin edges around the Kathmandu Valley after the main shock and subsequent aftershocks. This is evidence that basin edge effects had an impact on the performance of buildings because of the geological features of the Kathmandu Valley. The increase of the amplification when compared to the case of horizontal layering in the valley center may be a factor of 5 to 10. The motion amplification also depends on the velocity contrast between the layers and the geometry of the basin (Iyisan and Khanbabazade, 2013).

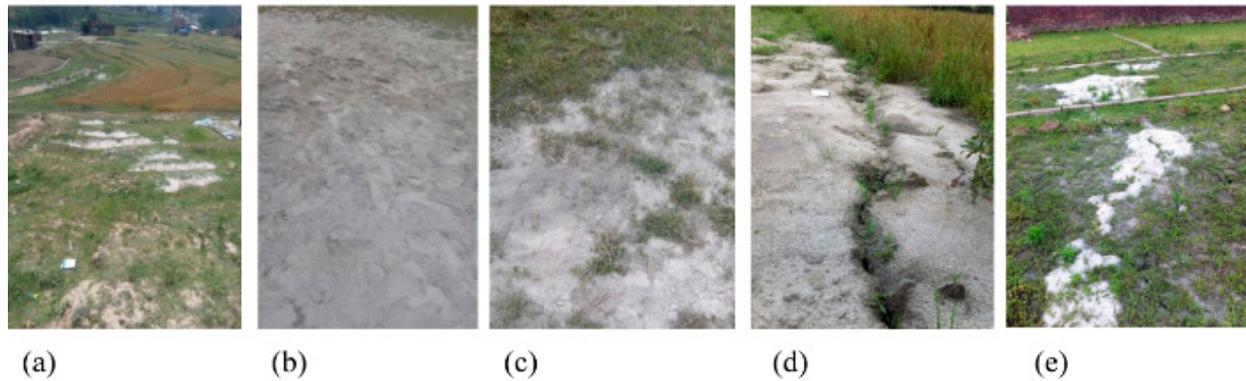
Fig. 25. Liquefaction along the basin edge of Kathmandu Valley (a) Ramkot, Kathmandu, (b) Manamaiju, Kathmandu, (c) Duwakot, Bhaktpur, (d) Bungamati, Lalitpur, and (e) Mulpani, Bhaktpur.

Liquefaction triggered by the 2015 Gorkha earthquake appears to be fairly limited and localized (Subedi et al., 2016; Sharma, 2016). The localized areas where liquefaction was observed are Manamaiju, Ramkota, Bungamati, Jharuwarasi, Hattivan, Imadol, Mulpani and Duwakot (**Fig. 7**). Most of liquefied sites are either within or on the edges of the Kathmandu Valley. These are regions likely to be more vulnerable to liquefaction due to basin edge effect; however, liquefaction potential analysis of the liquefied areas is needed to get into real scenario. **Figure 25** shows some examples of liquefaction occurred along the edge of Kathmandu basin.
