Research Paper

# Liquefaction during the Kumamoto Earthquakes on April 14 and 16, 2016

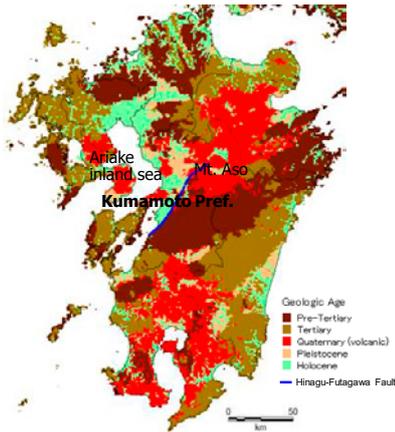
**Fig. 1.** Surface geology of Kyushu (Wakamatsu et al., 2005) and the Hinagu-Futagawa Fault (The Headquarters for the Earthquake Research Promotion, 2016)

**Figure 1** shows a geological map of Kyushu, the southernmost of the four major Japanese islands. Kumamoto Prefecture, which was the earthquake-stricken area, is located at the center of Kyushu. The land features of Kumamoto Prefecture are characterized by Mt. Aso (1,592 m in height), an extensively active volcano located in the east, pre-tertiary mountain ranges running along the SW-NE direction in the south, and the Holocene, extending to the western areas facing the Ariake inland sea.

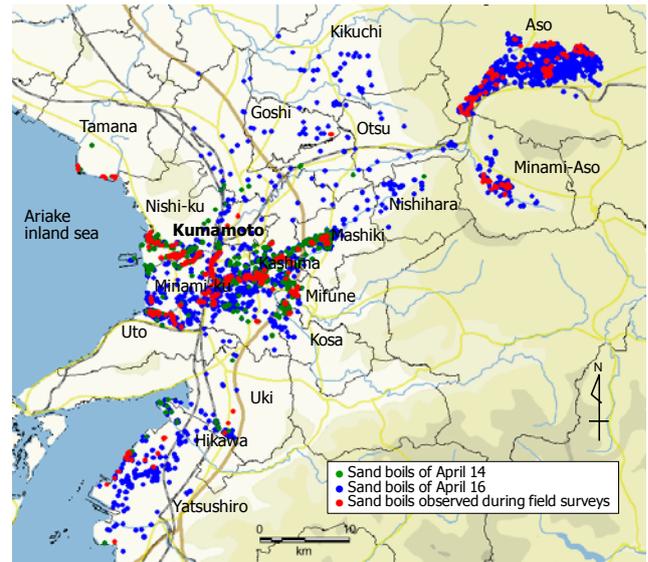
**Fig. 2.** Liquefied sites during the 2016 Kumamoto Earthquake

**Figure 2** shows the distribution of the liquefied sites during the Kumamoto earthquake. The red dots in **Fig. 2** represent the sites where sand boil deposits were observed in our field reconnaissance surveys during April 28 to May 1, May 11 to 12, and May 21 to 22. The green dots show liquefied sites induced by the foreshock on April 14, and the blue dots show the liquefied sites additionally generated by the main shock on April 16. The sand and water boiling occurring at the sites, shown in the green and blue dots, were identified through the interpretation of satellite images from Google Earth taken immediately after the foreshock, and high-resolution aerial images taken immediately after the main shock on April 16 (Geospatial Information Authority of Japan, 2016), respectively. Namely, the green points were confirmed before the main shock on April 16 occurred. Comparing the two sets of images taken on April 15 (shots of the April 14 foreshock were taken on April 15) and April 16, the size of the sand boil deposits from the April 15 shots were enlarged in the April 16 shots, as shown in **Figs. 3(a)** and **3(b)**, thus implying that the liquefied sites during the foreshock were repeatedly liquefied during the main shock on April 16.

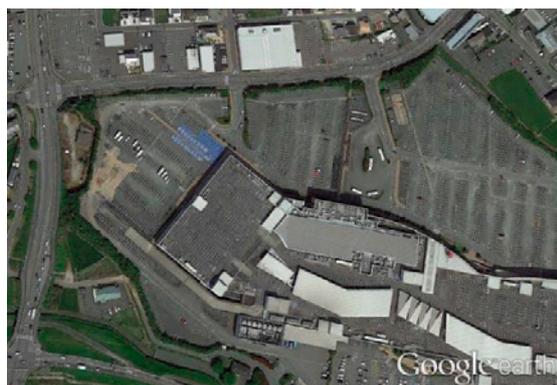
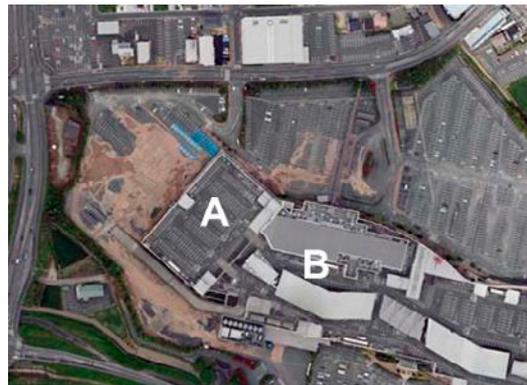
(a) After the foreshock on April 14 (Source Google Earth of April 15)

(b) After the main shock of April 16 (Geospatial Information Authority of Japan, 2016). Building A and B with spread foundation were settled due to liquefaction.

**Fig. 3.** Sand boiling at a shopping mole in Kashima-machi (32.739032N, 130.741351E)

Liquefaction occurred mainly in a slightly elevated area by filling in low and wet back marsh in accordance with the land readjustment project between 1983 and 1998. It should be additionally noted that a shopping mall near Midorikawa River, shown in **Fig. 3**, was built on backfilled land after gravel mining to a depth of approximately 10 m in 1989.

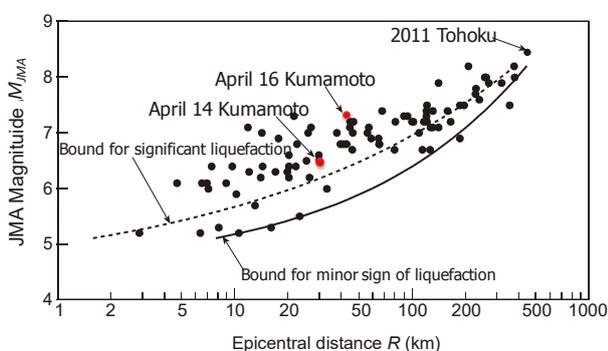
**Fig. 4.** Epicentral distance to farthest liquefied sites,  $R$ , in km for Japan Metrological Agency Magnitude,  $M_{JMA}$

**Figure 4** shows the empirical relationships between the earthquake magnitude,  $M_{JMA}$ , and epicentral distance,  $R$ , to the farthest liquefied sites derived from 87 Japanese earthquakes used to estimate the maximum extent of liquefaction in a susceptible area during an earthquake (Wakamatsu, 2011). The values of  $M_{JMA}$  versus  $R$  for the

sites of liquefaction caused by the foreshock and main shock are plotted in **Fig. 4**. Both distances are within the limiting boundary for significant liquefaction given by Wakamatsu (2011), which indicates that the maximum extent of liquefaction during the foreshock and main shock of the Kumamoto earthquake were not large in relation to the earthquake magnitude, when compared with past Japanese earthquakes.

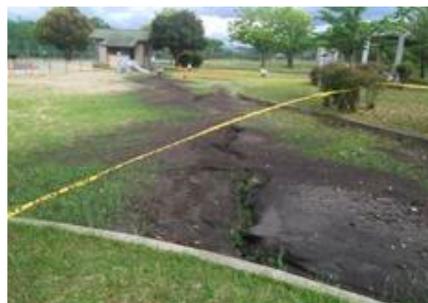
**Fig. 5.** Fissure ejecting black sand along former river (Kojima Park, Nishi-ku, Kumamoto City, 32.776476N, 130.635140E)

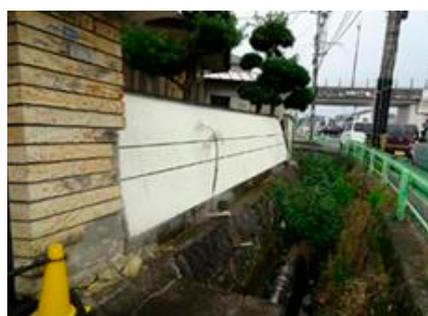
**Fig. 6.** Tilted wall due to liquefaction (Chikami, Minami-ku, Kumamoto City, 32.770945N, 130.692849E)

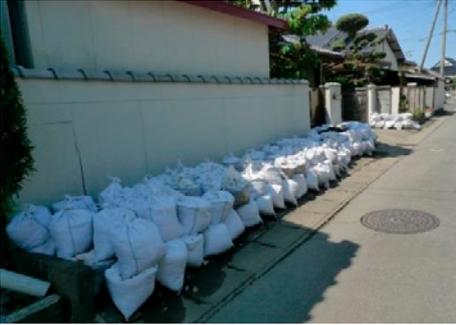
**Fig. 7.** Sandbags refilled with 25 kg sand boil deposits removed from a 4 meter-deep well. The number of sandbags reached 320 in total (8 ton in weight) (Chikami, Minami-ku, Kumamoto City, 32.769953N, 130.691958E)

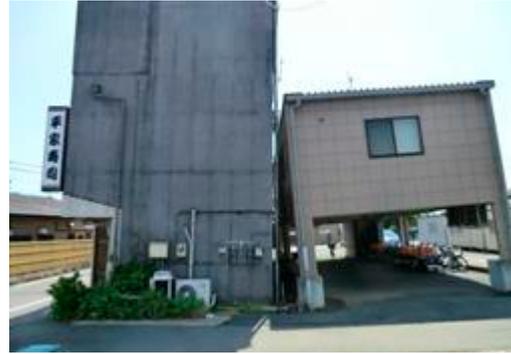
**Fig. 11.** Tilted buildings (Karikusa, Kamamoto City, 32.760014N, 130.682909E).

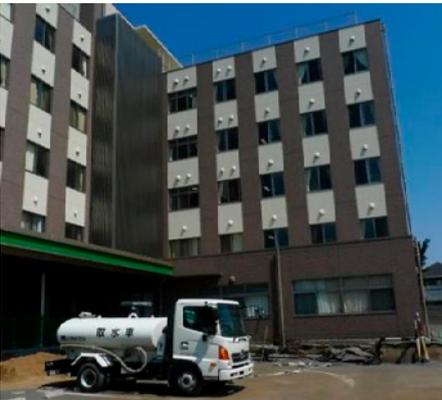
**Fig. 8.** A five-story building constructed three years ago lifted because of a 1-m ground subsidence (Chikami, Minami-ku, Kumamoto City, 32.769215N, 130.691603E)

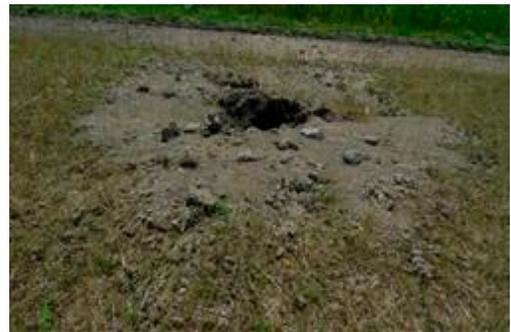
**Fig. 12.** Sand and gravel boil deposits. Maximum diameter of the gravel was 15 cm (Jin, Mifune-machi, 32.719221N, 130.770320E)

In contrast, sand boil deposits with fine and large gravel were found in the Midorikawa drainage basin, and in Jin, Mifune-machi, gravel with a maximum diameter of 15 cm was ejected from farmland, as shown in **Fig. 12**. In the reclaimed land along the Ariake inland sea, sand boil deposits with shell fragments were observed, as shown in **Fig. 13**, which indicates that the marine sand deposits liquefied.

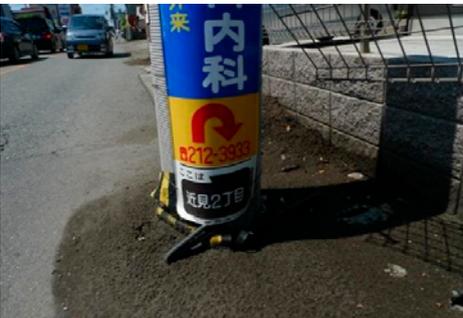
**Fig. 9.** An electric pole settled by more than 1 meter (Chikami, Minami-ku, Kumamoto City, 32.765147N, 130.687960E)

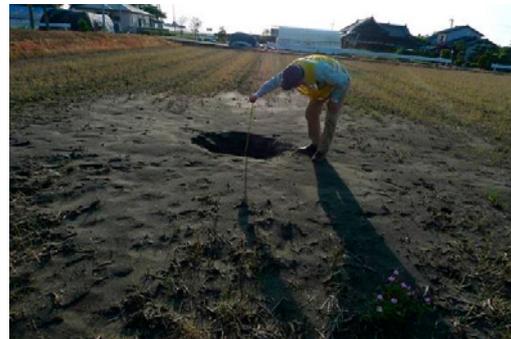
**Fig. 13.** Sand crater with a 110cm-diameter and 60cm-depth (Sasahara-machi, Uto City, 32.720672N, 130.611326E)

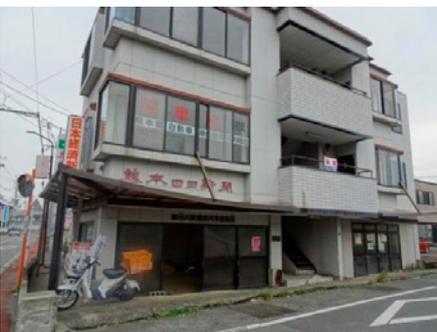
**Fig. 10.** A three-story building settled approximately by 50 cm (Karikusa, Minami-ku, Kumamoto City, 32.759882, 130.683249)

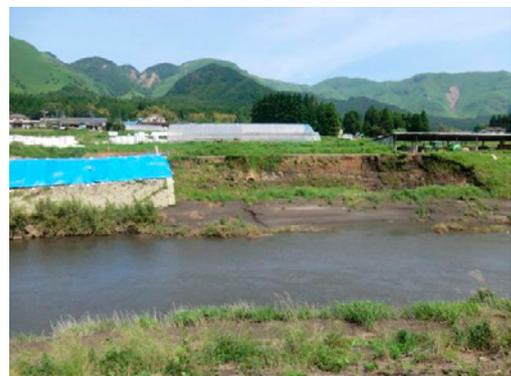
**Fig. 14.** Collapsed levee of the Kurokawa river and sand boils at the foot of the levee (Akamizu, Aso City, 32.926322N, 130.991291E)

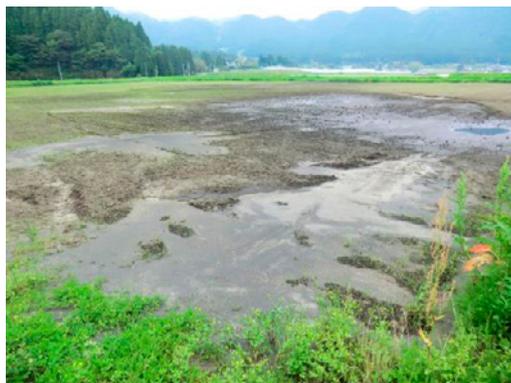
**Fig. 15.** Sand boils in farmland (Okura, Aso City, 32.980056N, 131.083809E)

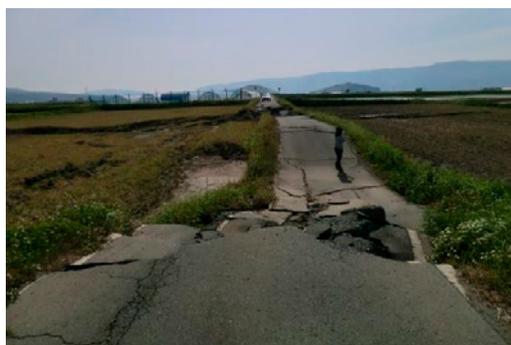
**Fig. 16.** Two-meters of settlement and lateral displacement of a farm road. Length of the settlement was approximately 50 m (Yakuinbaru, Aso City, 32.949986N, 131.084916E).

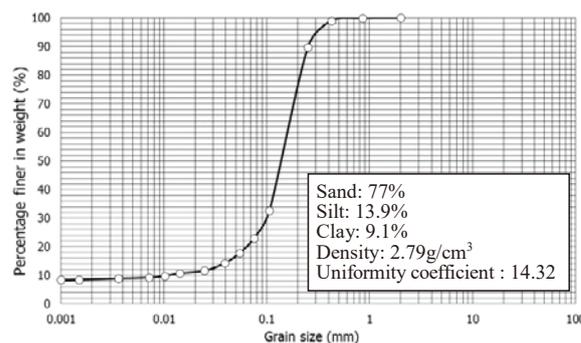
**Fig. 19.** Cumulative grain size distribution curve for sand boil deposit taken in Chikami, Minami-ku, Kumamoto City

Most of the sand boil deposits in the Shirakawa drainage basin appear to be secondary sediments of pyroclastic materials from Mt. Aso, known as “Yona,” which are carried down by the rivers (**Figs. 5, 9 14,** and **15**). The typical grain size distribution of the sand boil deposit of Yona is shown in **Fig. 19**. To determine the grain size distribution, a soil sample was taken from sand boils in a well approximately ten days after the main shock by the owner of the well, as shown in **Fig. 7**, in Chikami, Minami-ku, Kumamoto City. The soil is classified as fine sand having a soil particle density of 2.79 g/cm<sup>3</sup> and a uniformity coefficient of 14.32, with a composition of 77.0% sand, 13.9% silt, and 9.1% clay.

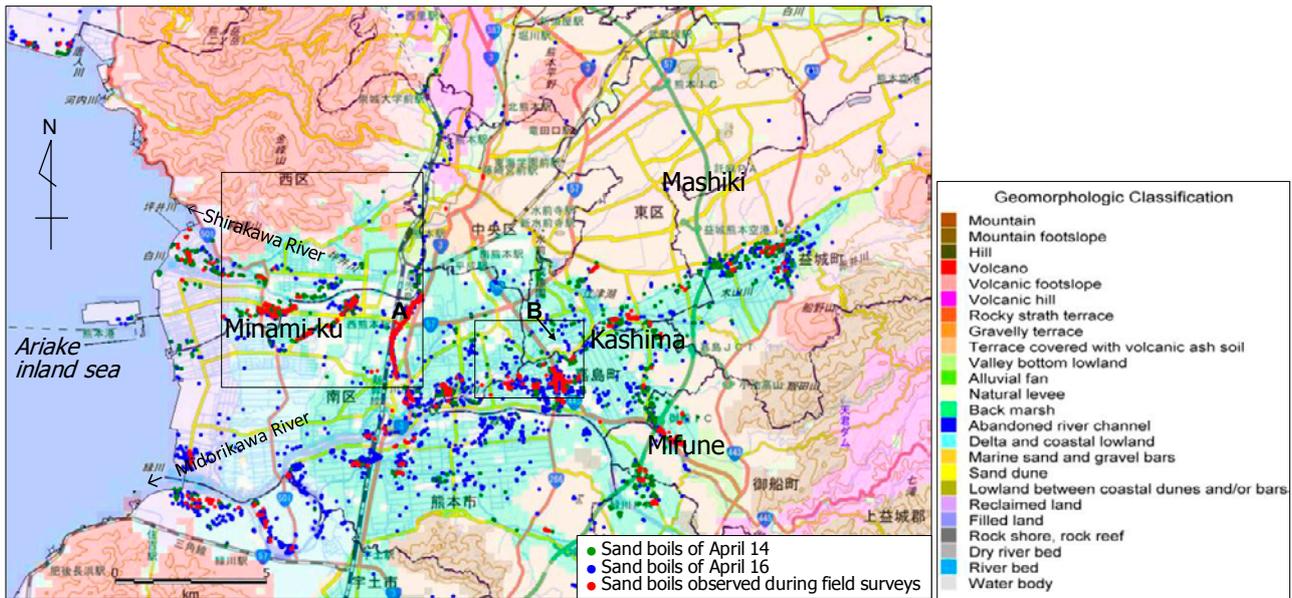
**Fig. 17.** Geomorphologic land classification map in Kumamoto Plain superimposing liquefied sites

**Figures 17** and **18** show engineering-based geomorphologic land classification maps (7.5-arc-second JEGM) for the Kumamoto Plain and Aso region with superimposed liquefied sites, respectively. This type of map is used nationally for various kinds of hazard mapping in Japan (Wakamatsu and Matsuoka, 2013). Here, the land mass was classified into 24 geomorphologic units, as shown in the legend. Two major rivers flow across the Kumamoto Plain: Shirakawa River, which originates in Mt. Aso, and Midorikawa River, which originates in Mt. Sanpou-zan in the southeastern region of Kumamoto Prefecture.

Kumamoto Plain, the liquefaction is distributed in the flood plain, including the natural levee, back marsh, and former river channel, and in reclaimed land along the coast, whereas the liquefaction in the Aso region is distributed in the flood plain of Kurokawa River and in an alluvial fan located at the skirt of Mt. Aso.

Minami-ku, which is in the southern district of Kumamoto City, is located on the left bank of the Shirakawa River, as shown in **Fig. 17**. Long belt-like liquefied sites appeared along a small irrigation stream in Minami-ku (**Fig. 24**). Examples of the damage occurring in this area are shown in **Figs. 6 through 11**. The stream appeared to be a trace of a former large river channel; however, no land depression feature of the former river course was found. In addition, no large river was shown on older maps compiled around the years of 1605, 1650, 1700, 1838, or 1901.

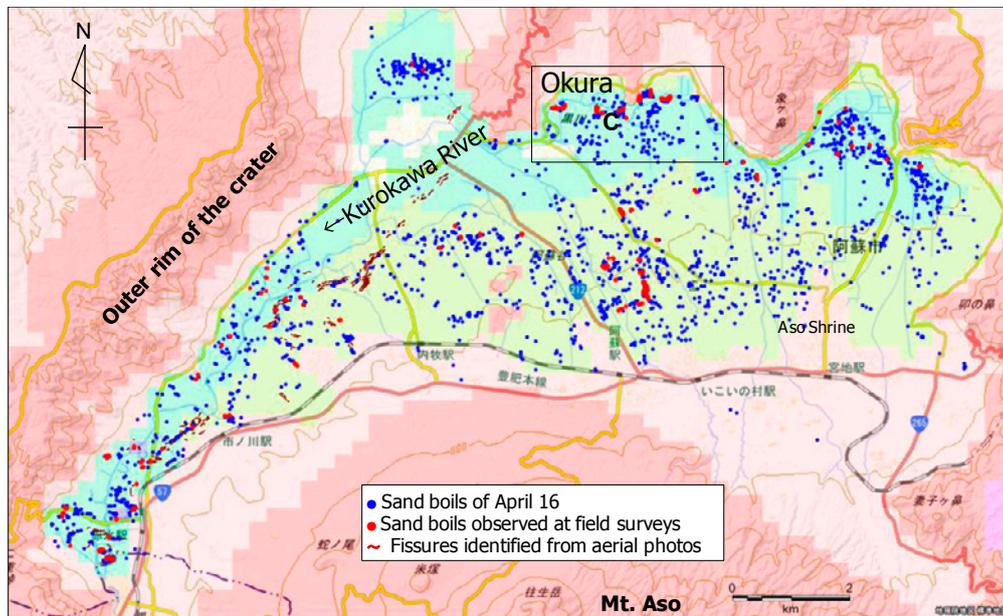
**Fig. 18.** Geomorphologic land classification map in Aso City superimposing liquefied sites (Explanation for geomorphologic land classification is the same as Fig. 17)

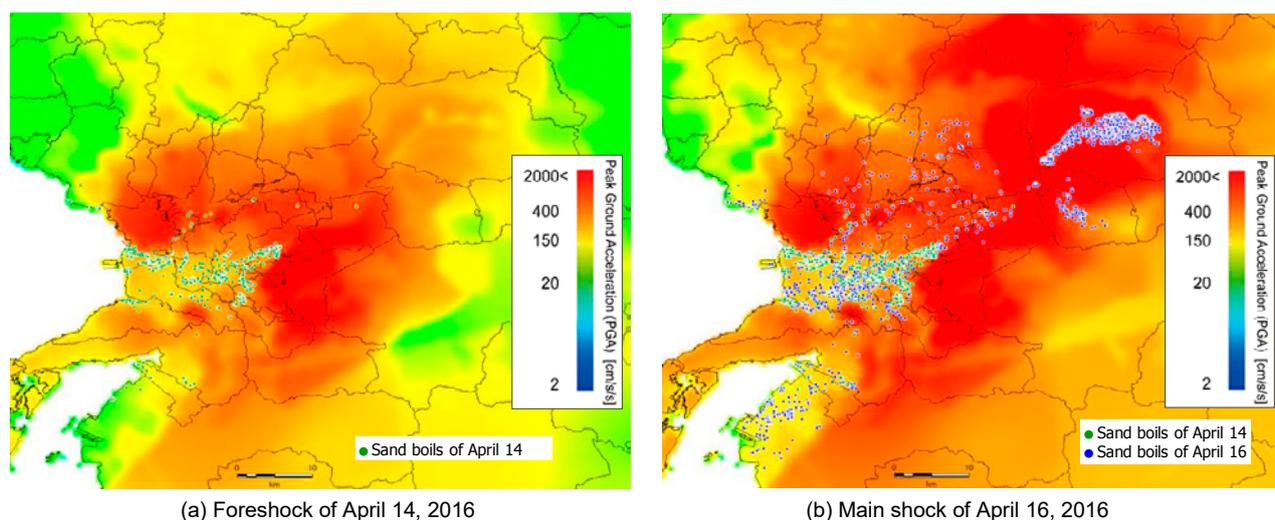
**Fig. 20.** Distribution of estimated peak horizontal ground acceleration and liquefied sites

**Figures 20(a)** and **(b)** show the distributions of the estimated peak ground acceleration (PGA) with a 250-m spatial resolution for the foreshock on April 14 and the main shock on April 16, respectively, superimposed with the liquefied sites during both shocks. The PGA for each 250-m grid cell was estimated based on a spatial interpolation procedure using the strong ground observation records (Matsuoka et al., 2015). The amplification factor of the PGA (Midorikawa et al., 2008) was calculated using the average S-wave velocity ( $V_{s30}$ )

of the ground (Matsuoka et al., 2006) obtained from the 7.5-arc-second JEGM, which was used to estimate the acceleration on soft rock ( $V_{s30}$ , equal to 600 m/s). The spatial interpolation was then applied to determine the acceleration distribution on soft rock using a simple kriging, assuming a prior trend component, because the underlying random function model is the sum of the trend and residual components (Kawasaki Laboratory, 2008). The trend component (deterministic function) is assigned for the attenuation relation obtained on soft rock. Furthermore, the distribution of the PGA on the ground surface was calculated by multiplying with an amplification factor in the 250-m grid cell units.

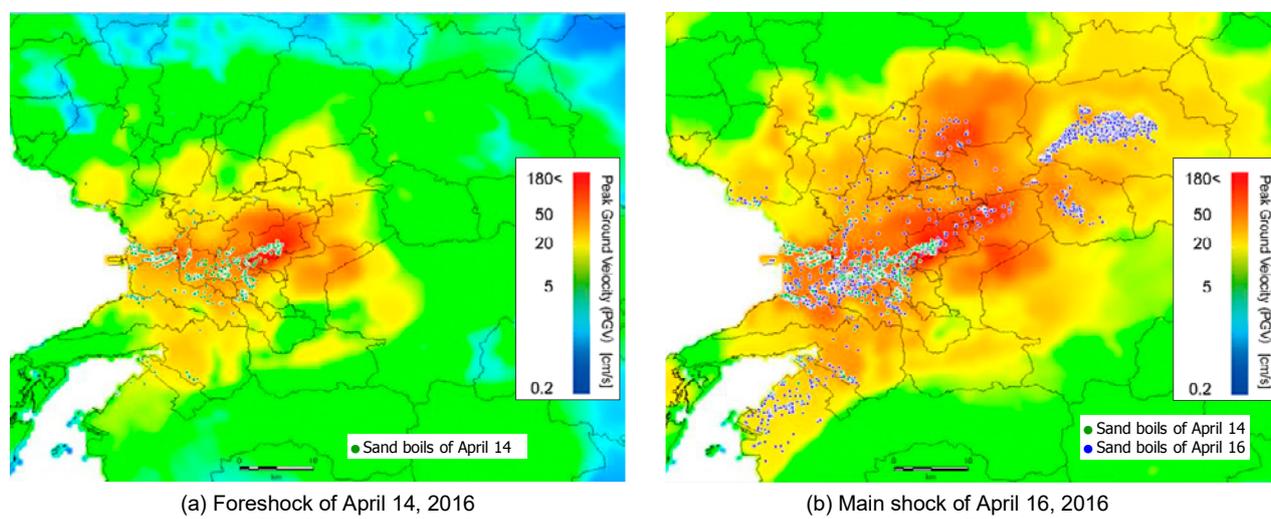
**Fig. 21.** Distribution of estimated peak horizontal ground velocity and liquefied sites

**Figures 21(a) and 21(b)** show the distributions of the estimated peak ground velocity (PGV) calculated in the same manner as the PGA for the foreshock and main shock, respectively, superimposed with the liquefied sites during both shocks.

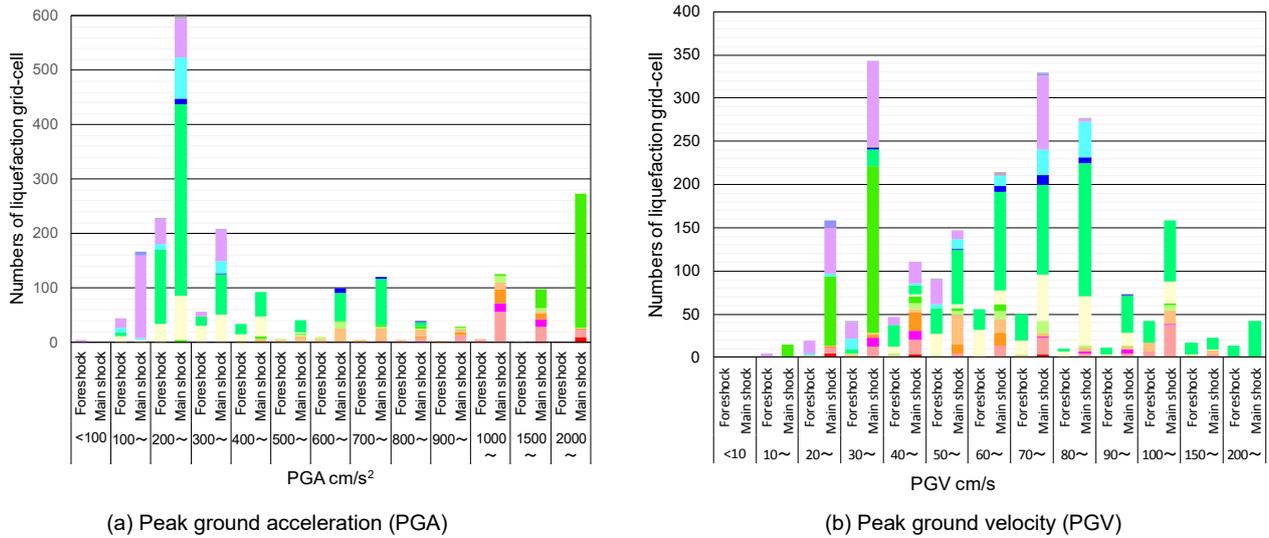
**Fig. 22.** Relationship between the number of liquefied grid-cells and levels of the intensity of ground motion for different geomorphologic units (Colors of the bar chart represent geomorphologic unit shown in the legend of Fig. 17)

The relationship between the number of liquefied grid-cells, and the PGA and PGV, was investigated with respect to the geomorphologic land classification, as shown in **Figs. 22(a) and 22(b)**, respectively. It can be seen from the figures that liquefaction during the foreshock was induced when the estimated PGA and PGV exceeded approximately  $100 \text{ cm/s}^2$  and  $20 \text{ cm/s}$ , respectively; however, during the main shock, liquefaction was induced by a lower PGV of  $10 \text{ cm/s}$ . The number of liquefied grid-

cells in back marsh is large, which is apparently due to the back marsh occupying a greater part of the Kumamoto Plain and Aso region. In contrast, the number of grid-cells in filled land, which is considered to easily liquefy, is remarkably low because the area of filled land is limited around Kumamoto Port.

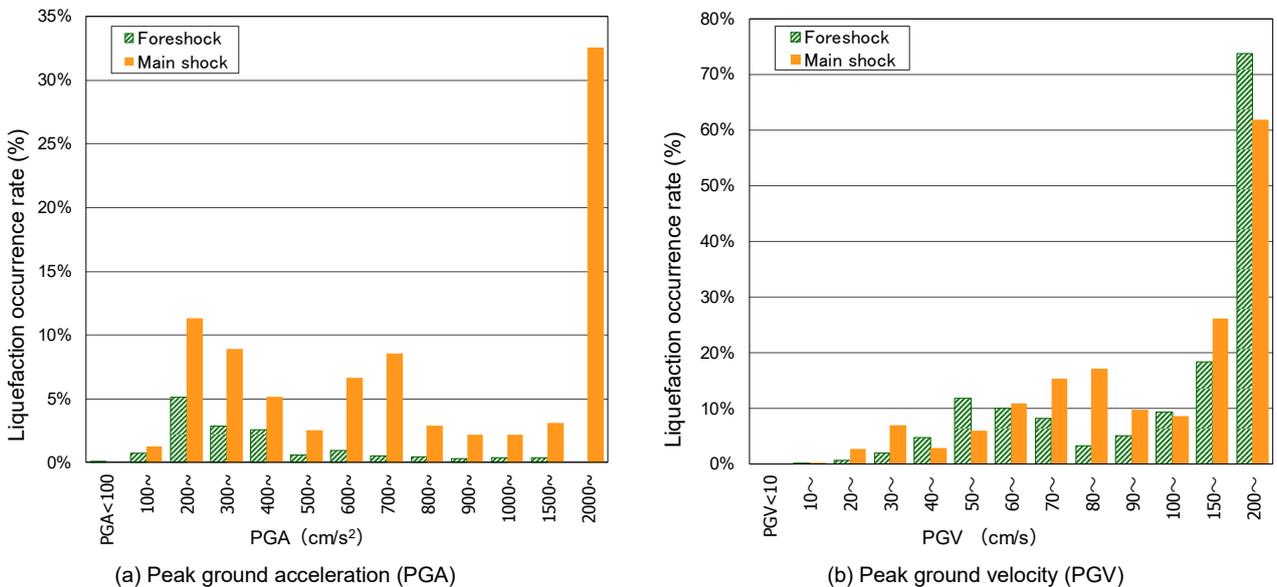
**Fig. 23.** Relationship between the liquefaction occurrence rate and levels of the intensity of ground motion for the main shock and foreshock

**Figures 23(a)** and **23(b)** show the relationship between the liquefaction occurrence rate (number of liquefied grid-cells divided by the total number of grid cells) and the PGA and PGV levels, respectively, for geomorphologic units composed of Holocene deposits for the foreshock and main shock. It can be seen from **Fig. 23(a)** that the liquefaction occurrence rates for the main shock are remarkably higher than those for the foreshock for all PGA levels. The cause of this is thought to be the ground approaching a liquefied state during the foreshock, and easily liquefying owing to the lower intensity of the ground motion.

The rate of liquefaction is very low when the PGA is under 100 cm/s<sup>2</sup>, but is relatively high when the PGA

ranges between 200 cm/s<sup>2</sup> and 700 cm/s<sup>2</sup>, and a decrease with an increase in the PGA exceeding 800 cm/s<sup>2</sup>. However, the rate rises sharply again when the PGA exceeds 2000 cm/s<sup>2</sup>. Comparing **Fig. 22(a)**, geomorphologic units where liquefaction occurred in a range of PGA of between 200 and 700 cm/s<sup>2</sup> correspond to back marsh, natural levee, and delta regions, which are composed of soft soil. In contrast, the geomorphologic units where a range of PGA of between 800 and 2000 cm/s<sup>2</sup> correspond to the units which are composed of stiff soil such as volcanic footslope and volcanic hill. The PGA exceeded 2,000 cm/s<sup>2</sup> correspond to units composed of relatively hard soil, such as an alluvial fan, respectively.

In contrast, liquefaction was induced when the PGV exceeded 20 cm/s, and the rate gradually increased with an increase in the PGV level regardless of the geomorphologic units, as shown in **Figs. 22 (b)** and **23(b)**. The trends in **Figs. 22** and **23** seem to imply that the PGV is a more appropriate index for evaluating the liquefaction potential for a wide area, although further investigations

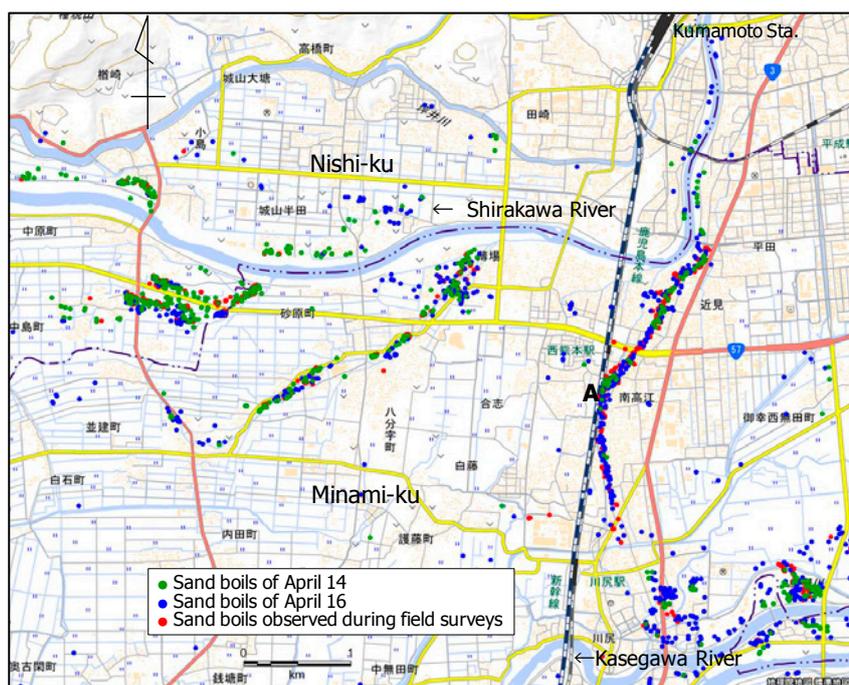
**Fig. 24.** Liquefied sites in Minami-ku, Kumamoto City

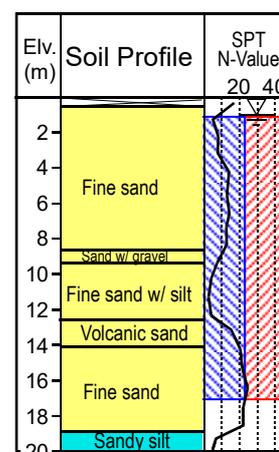
**Fig. 25.** Soil profile and SPT N-value in Hiyoshi, Minami-ku at Point A in Fig. 24

**Figure 25** shows the soil profiles and SPT N-value at point A, shown in **Fig. 24**, where significant sand boiling and differential settlement of the buildings occurred during both the foreshock on April 14 and the main shock on April 16, indicating loose fine sand consisting of “Yona” with very high-water content that is continuously present from near the ground surface to a depth of 8.5 m. The ground water level is at 1.0 m below the ground surface.

Using the simplified procedure to evaluate the factor of safety ( $F_L$ ) against liquefaction, as presented in the Specification for Highway Bridges (Japan Road Association, 2002), sand layers from a depth of 1.0 to 17 m were found to be potentially liquefiable (i.e., with  $F_L \leq 1.0$ ), as indicated by the blue and red colors in **Fig. 25**. For the evaluation, maximum horizontal accelerations of 355  $\text{cm/s}^2$  for the April 14 shock and 394  $\text{cm/s}^2$  for the April 16 shock at the ground surface (PGA), as indicated in **Fig. 20**, were adopted. The evaluation results for both shocks agree well with the actual performance of the ground, i.e., the thick liquefiable layer under the ground surface may have caused significant sand boiling and liquefaction-induced damage to homes during the foreshock and main shock.

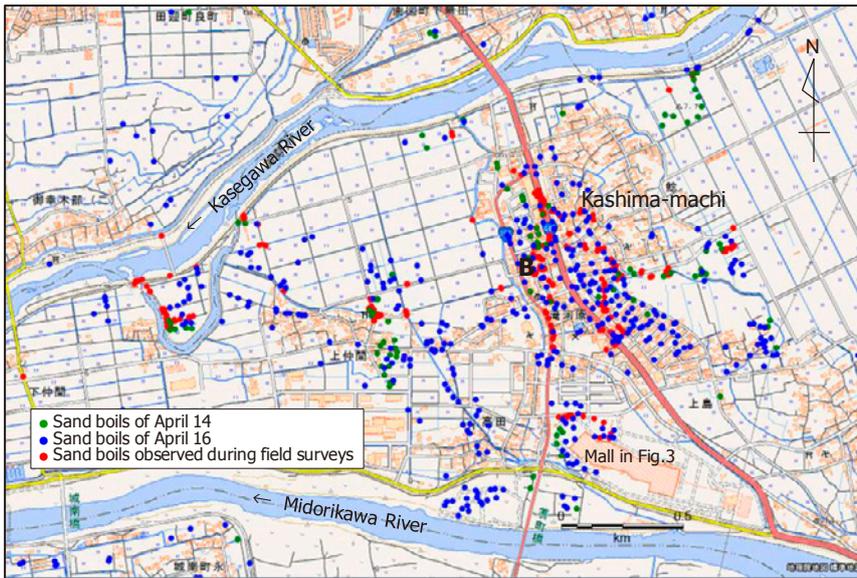
Fig. 26. Liquefied sites in Kashima-machi

The town of Kashima-machi lies in the center of the Kumamoto Plain, and sand boils were densely observed in the area between Kasegawa River and Midorikawa River, as shown in **Fig. 26**; however, the impact on the buildings was lower compared with in Minami-ku, as described in section 6.1. The area between the rivers is

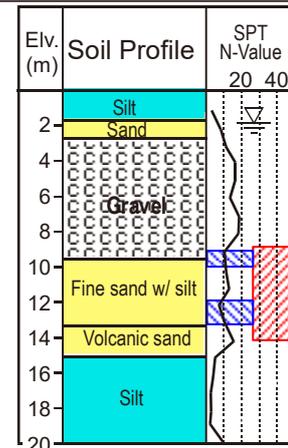
Fig. 27. Soil profile and SPT N-value in Kashima-machi at point B in Fig. 26

**Figure 27** shows the soil profile and SPT N-value at point B in **Fig. 26**. The sand beneath the ground surface was unexpectedly very thin at approximately 1 m. The soil from 3 m below the ground surface is a 6.7-m-thick gravelly soil with SPT N-values of approximately 20, which in turn overlies a 5.6-m-thick sandy soil layer with SPT N-values of around 10. The ground water level is at 2.4 m below the ground surface.

Using the simplified procedure to evaluate the  $F_L$  against liquefaction, sandy soil layers from a depth of 9 to 13 m were found to be potentially liquefiable for the April 16 shock, as indicated in red in **Fig. 27**; however, the liquefiable layers for the April 14 foreshock were thinner than for the April 16 main shock, as indicated in blue. For the evaluation, a PGA of 249  $\text{cm/s}^2$  for the April 14 foreshock and a PGA of 263  $\text{cm/s}^2$  for the April 16 main shock, as indicated in **Fig. 20**, were used. The evaluation results for both shocks agree with the actual ground performance, i.e., significant sand boiling occurred during the main shock on April 16, but had a minor impact on the foundation of a single-family home, and sparse sand boiling occurred during the foreshock on April 14.

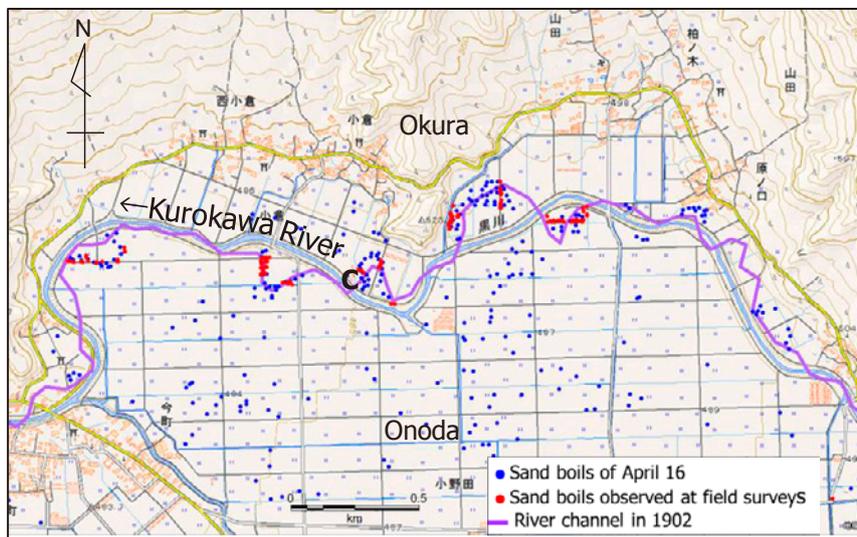
Fig. 28. Liquefied sites in Okura, Aso City

Aso city is located approximately 40 km northeast of the Kumamoto Plain, and includes Mt. Aso, which is one of major active volcanoes in Japan. Liquefaction in the city was generated only from the main shock on April 16 within the caldera between Mt. Aso and the outer rim of the crater. In Okura, in the northern district of Aso, numerous sand boiling sites were observed along the former bent river channel, as shown in Fig. 28.

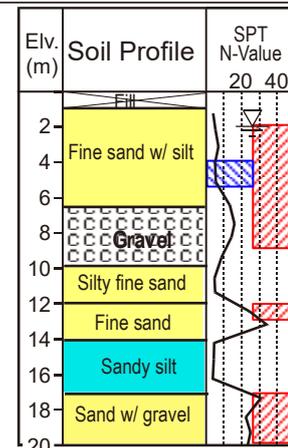
Fig. 29. Soil profile and SPT N-value in Okura, Aso City at point C in Fig. 28

Figure 29 shows the soil profile and SPT N-value at point C, shown in in Fig. 28. A loose fine sand with silt assumed to be “Yona” lies from the ground surface to a depth of approximately 6 m. A 3.6-m-thick layer of sand and gravel with SPT N-values of around 10 lies beneath the sand. The ground water level is at 1.95 m below the ground surface.

Using the simplified procedure to evaluate the  $F_L$  against liquefaction, it was determined that sand and gravel layers are present from a depth of 2 to 9 m, and a 1-m- thick sand layer at a depth of 12 m was found to be potentially liquefiable from the April 16 shock, as indicated in red in Fig. 25; however, the liquefiable layers for the April 14 shock were only 2 m in height at a depth of 4 m, as indicated in blue. For the evaluation, a PGA of 183 for the April 14 shock and a PGA of 669  $cm/s^2$  for the April 16 shock, shown in Fig. 20, were used. The evaluation results for both shocks agree with the actual ground performance, i.e., significant sand boiling occurred during the April 16 shock, but negligible sand boiling occurred during the April 14 shock.
