Research Paper

Deformation and failure characteristics of Volcanic soil at landslides site due to the 2016 Kumamoto Earthquake

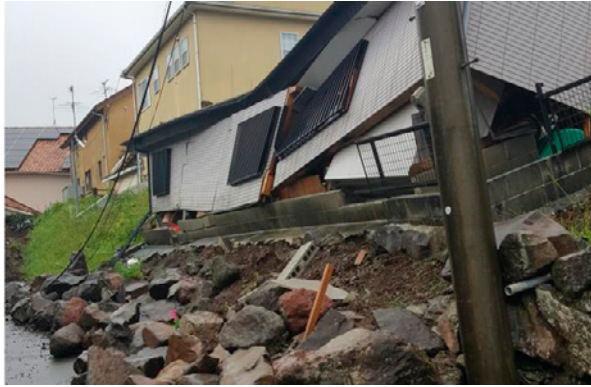
Fig. 1. Houses damages due to subsidence.

chain of earthquakes occurred in Kumamoto prefecture, Japan. It was a series of earthquakes, including a magnitude 6.5 MW foreshock and 7.0 MW main shock called the 2016 Kumamoto Earthquake. These chain of events demonstrated the impact of the earthquake on infrastructures, houses (**Fig. 1**), bridges (**Fig. 2**), roads (**Fig. 3**), and other engineering properties and even loss of lives. During the earthquake, seismic subsidences, widespread landslides, slope failures, debris flows, and liquefactions were observed in Kumamoto prefecture and its vicinity. The landslides occurred on steep as well as

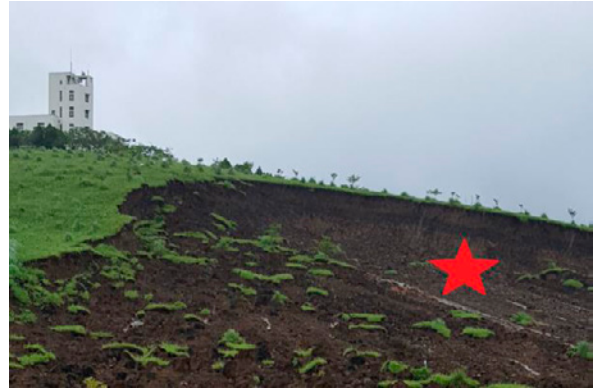
Fig. 4. Location of sampling sites, Aso Caldera, Kumamoto Prefecture, Japan.

on gentle slopes even though landslides rarely occurred on gentle slopes. One of the landslides is located close to Aso Volcanological Laboratory of Kyoto University as shown in **Fig. 4**. The slope has a gentle inclination (10 to 15 degrees) as reported by Kochi et al. (2017). It has many volcanic soil deposits with distinct colors. All of the deposits were failed other than the deposits below Orange colored deposits. They scattered in big and small lumps except the Orange colored deposit which crumbled as shown in **Fig. 5**. Therefore, the authors suspect that

The soil was collected using steel tube samplers as shown in Fig. 7, at a ground depth of 5 m at the scarp in landslide sites near the Kyoto University Volcano Research Center, as shown in Fig. 4. The collected samples were then assumed to be undisturbed even though some disturbing effects were suspected during the collecting process despite no visible damage by the process. After the undisturbed samples were tested, they were reconstituted and then tested as disturbed samples. In order to differentiate them from other volcanic soils in the Aso area, the soil samples were named as Orange soil in this research.

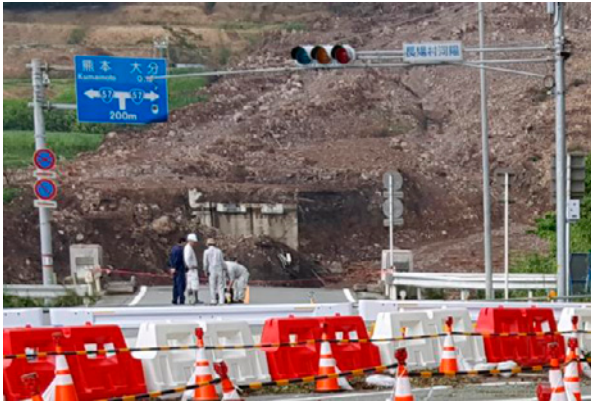
Fig. 2. Bridge collapse and landslide.

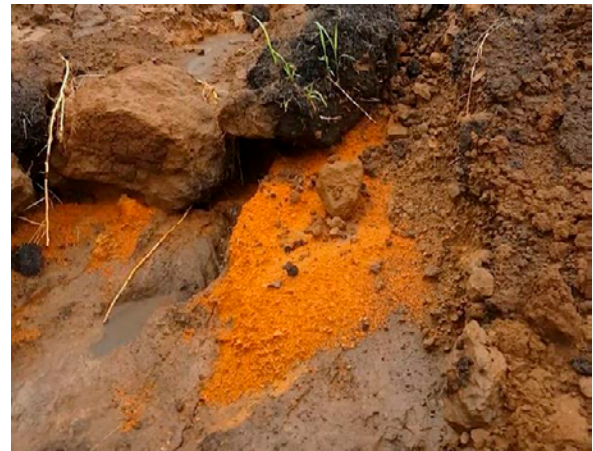
Fig. 5. Volcanic soil deposits after landslide.

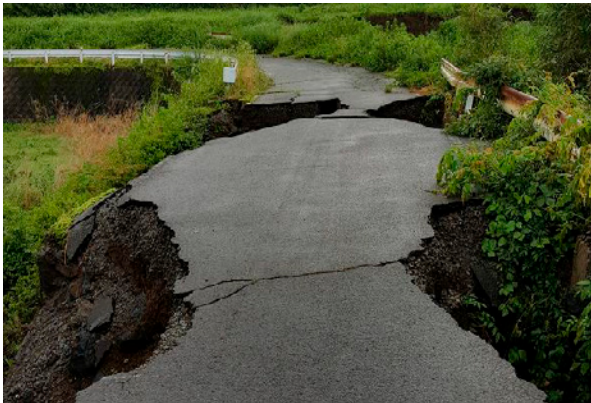
Fig. 3. Damages to road.

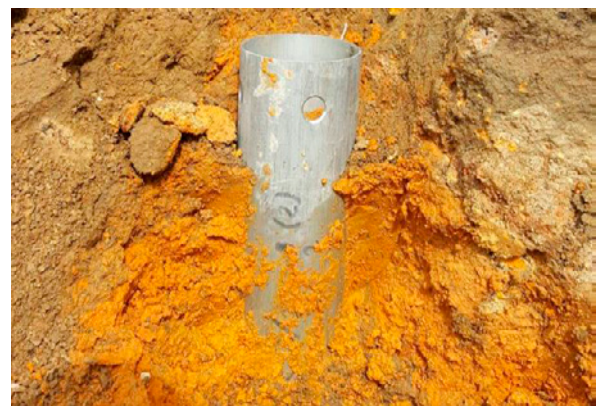
Fig. 7. Collecting volcanic soil using steel tube sampler.

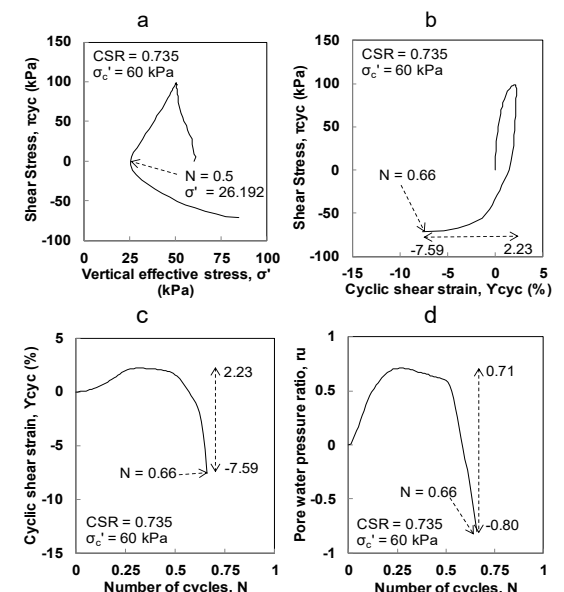
Fig. 15. Response of the undisturbed Orange soil samples in undrained cyclic triaxial test (CSR = 0.735, $\sigma'_c = 60$ kPa): (a) effective stress path, (b) shear stress versus shear strain, (c) shear strain versus number of cycles, and (d) pore water pressure ratio versus number of cycles.

The undisturbed sample under CSR = 0.735 shows the flow type failure behavior, pore water pressure ratio = 0.713, and fast development of cyclic shear strain. This occurred due to the shear stress amplitude being greater than half of the maximum deviatoric stress of the soil. The investigated samples exhibit cyclic mobility behaviours except that with CSR = 0.735, revealing that the undisturbed samples were less susceptible to flow type failure in cyclic loading under the confining stress 60 kPa except if the double shear stress amplitude exceeds the maximum deviatoric stress.

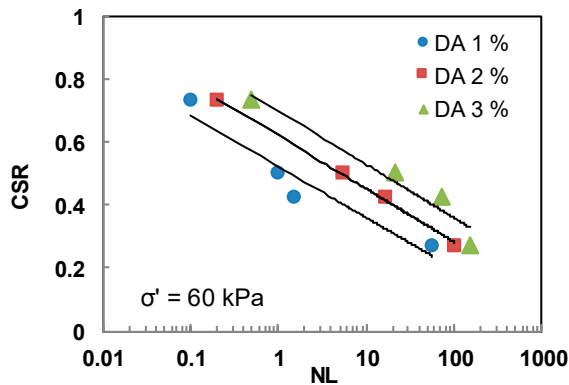
Fig. 16. Liquefaction susceptibility of Orange soil.

To cause a 5% double amplitude axial strain of Orange soil in 20 cycles, cyclic stress ratio of 0.50 was required as shown in Fig. 16. This occurred because the plasticity index of the soil is high, as shown in Table 2 and the shear strength being 2.5 times higher than the confining stress means that the soil is strong enough to bear the cyclic load even though the shear stress amplitude equals the confining stress.
