Research Paper

Analysis of liquefaction of volcanic soil during the 2016 Kumamoto Earthquake based on boring data

K. Ogo¹, H. Hazarika², T. Kokusho³, D. Matsumoto⁴, S. Ishibashi⁵ and W. O. Sumartini⁶

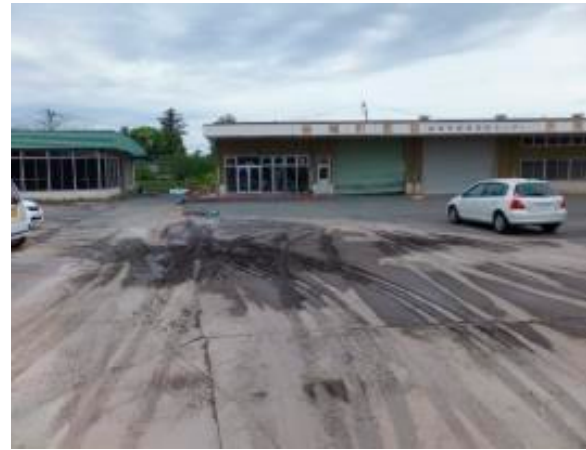
Fig. 2 is a picture taken during the reconnaissance survey at a parking lot of JA (Japan Agricultural Cooperatives Group) office of Mashiki Town, where major building damage was observed due to the strong motion. Although many traditional Japanese style houses were damaged due to the strong motion, very few damage of liquefaction-induced settlement of national and prefectural roads and upliftment of manhole were observed.

Fig. 2. Sand boiling at a parking lot of JA-Kamimashiki

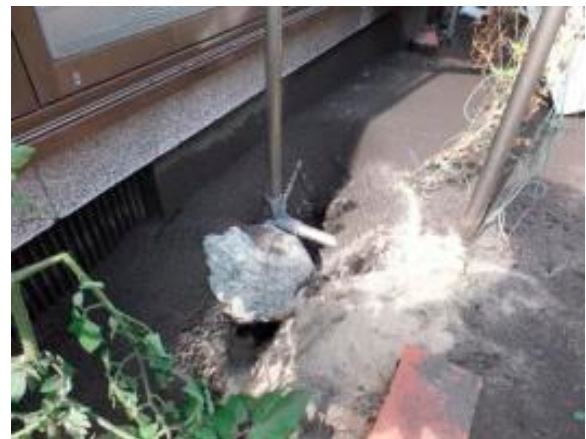
Fig. 3. Sand boiling in a house in Minami ku, Kumamoto

The Minami ward of Kumamoto city experienced liquefaction widely and intensively. Most of the damages were observed in the areas such as old river channel and floodplain. The Minami ward also includes the area developed by reclamation of an old river channel, where intense liquefaction were observed. **Fig. 3** is damage due

to ground subsidence observed in a residence in Minami ku, Kumamoto city. Sand boils were observed around this area and turned out to be black in color indicating volcanic soils.

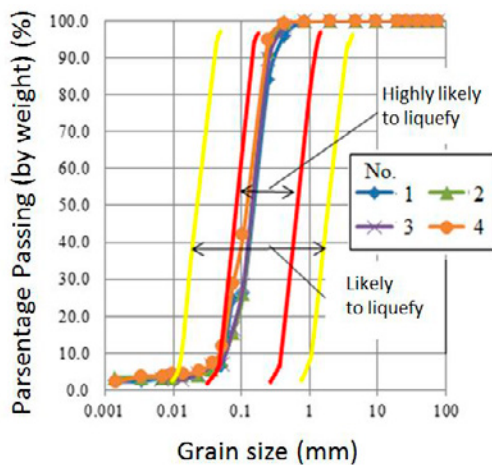
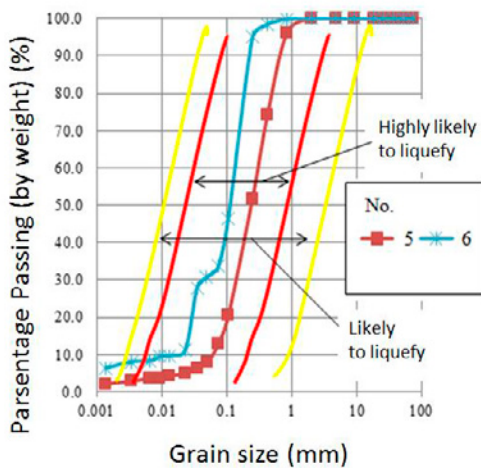
(a) $U_c < 3.5$

(b) $U_c \geq 3.5$

Fig. 5. Grain size distribution and possibility of liquefaction

Table 1 shows the list of collected samples in the site investigation after the Kumamoto Earthquake. Sample no. 1, 2, 3, 5 and 6 are taken from the sand boiling immediately after the earthquake, and no. 4 is sampled later from the nonliquefied riverbank to conduct a cyclic triaxial test. According to the result shown in **Fig. 5**, every distribution curve looks similar, and mainly consists of fine sand and medium sand. The results are compared with the criteria in Technical Standards and Commentaries for Port and Harbor Facilities in Japan. All the distributions are said to be highly likely to liquefy. According to Table 2, the particle density of ejecta is around 2.7 g/cm³, which is relatively heavy in comparison with other sands. However, we also tested the maximum and minimum density of sample no. 5. The maximum dry density was 1.53 (g/cm³) and the minimum dry density was 1.19, which was smaller than other soils.

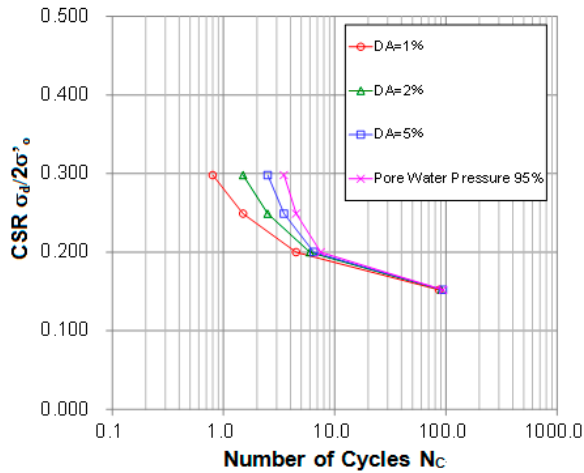
Fig. 7. Stress ratio-number of cycle relationship

density becomes 1.3 g/cm³, according to the natural condition. The specimen dimension is 10 cm in height and 5 cm in diameter. 50 kPa of confining pressure is used during the consolidation and loading. According to **Fig. 7**, the value of CRR, cyclic resistance ratio at 20 cycles of loading, is 0.179. Generally, loose sand with the CRR less than 0.2 is likely to liquefy (Ishihara, 2017). Therefore, the specimen is vulnerable for liquefaction.
