Research Paper

Catastrophic Debris Flows in Kazbegi Mountain Area, Georgia – Use of Available Free Internet Information as a Source to Generate Conceptual Engineering Geological Model

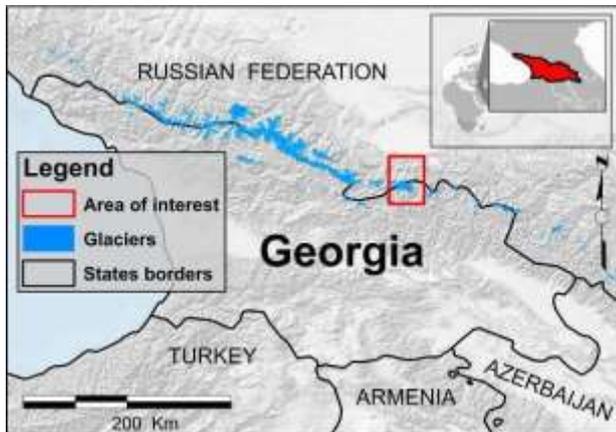
Fig. 1. Location of the area of interest Sources:DEM – USGS 2019, glaciers – GLIMS 2019

This paper discusses how much valuable information for the generation of conceptual engineering geological model is freely available from the Internet with respect to debris flow / mud flow hazards using the Kazbegi Mountain area in Georgia (**Fig. 1**) as an example.

The following section presents information obtained through the use of the Internet for the Kazbegi Mountain area (**Fig. 1**) in relation to debris flow / mud flow hazards.

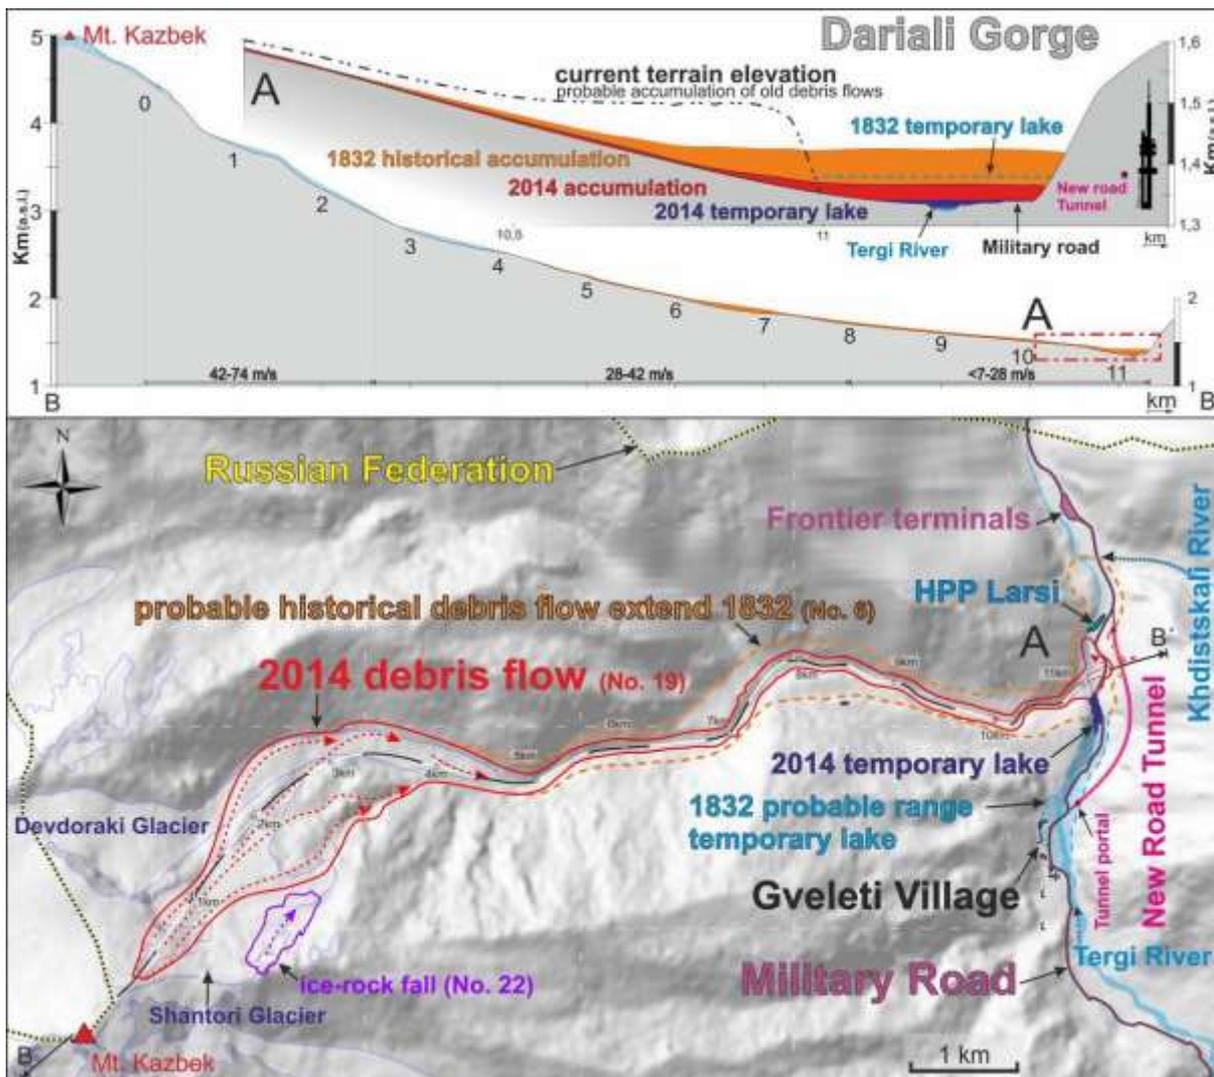
Fig. 2. Upper part: Schematic cross section of the 2014 Dariali debris flow with estimated velocity in each part of the flow. Inset: Detailed cross section of debris flows accumulation area (A). Lower part: Map of the 2014 Dariali debris flow (Hydroelectric Power Plant Larsi is within the hazard area, in extreme events new road tunnel portals can be also endangered). Source of DEM: USGS 2019, Source of glacier: GLIMS 2019

Calculations and geodynamic characteristics of the phenomenon from 2014 are discussed in Drobyshev (2018). The scarp area of the glacier is at an altitude of approximately 4,000–4,550 m a.s.l, with the glacier toe descending to 2,550 m a.s.l. Massive dacite rock and ice block of about dimension of 550 m x 350 m x 40 m and up to 5 million m³ (Fig. 3) travelled along the rock surface on a slope >40°.

The speed of debris flow (May 17, 2014) was estimated up to 200 km / h (Drobyshev, 2018). After falling on the mountain glacier, the mass of ice and rock disintegrated, energy was transferred to the loose sediments that were saturated by melted water and the

Floods are regularly (seasonally) repeated in these high mountain conditions and are one of the chief factors stimulating the geodynamic processes in the valley floor that are documented in **Fig. 8** (river bank erosion, landslides, rock falls, debris flows). The time-lapse image (**Fig. 4**) demonstrates the destructive activity of the Tergi River in the Dariali Gorge at approximately one-year intervals. It is clear from **Fig. 4** how changes of debris flow accumulation represent additional geological hazard by reorganizing non-consolidated clastic sediments, which may be further transported downstream during floods. Currently, a new road tunnel bypassing this risky gorge is in the operation (**Fig. 2**).

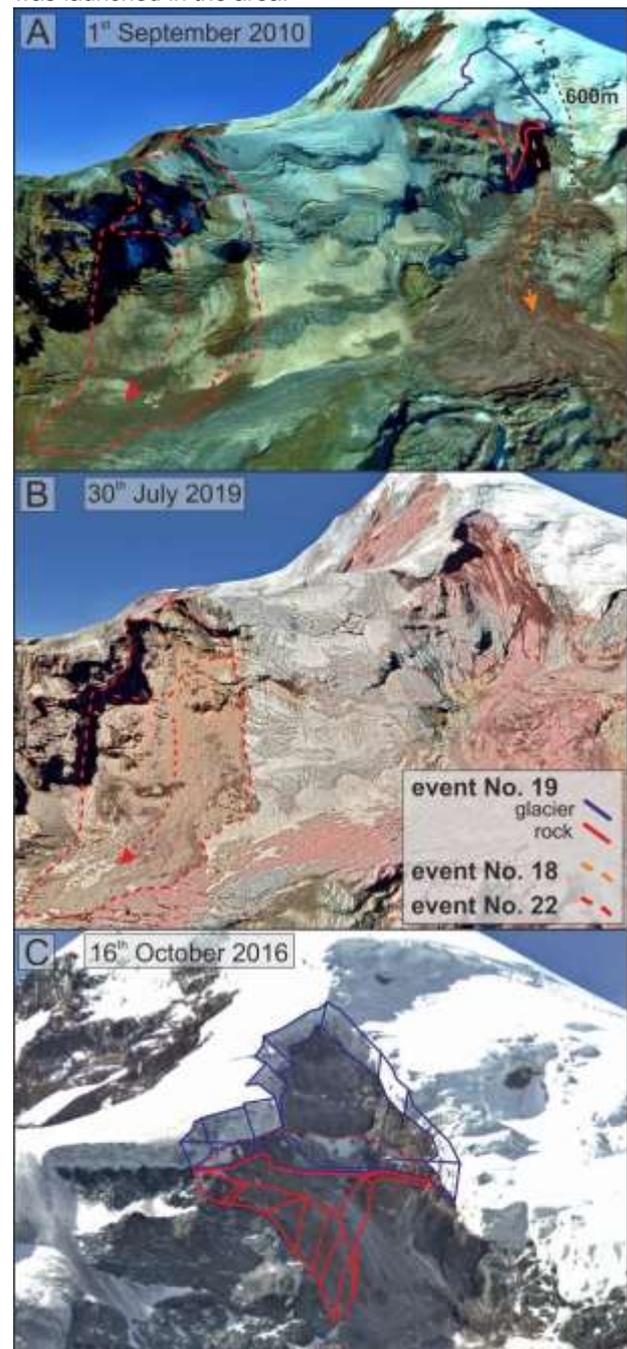
Fig. 3. Ice-rock fall area on the northwest slope of the Kazbek Mountain. 3A: 2010 Satellite image from Google Earth with drawing of collapse area from 2010 and 2014 (phenomenon No. 19, in Fig. 8 and Table 1). 3B: 2019 Satellite image from Google Earth with drawing of collapse area No. 22 in Fig. 2 and Table 1. 3C: Image from monitoring camera from 2016 with visualization of the glacier and rock block which fell down in 2014 (<https://www.geopraevent.ch>)

The ice–rock fall at the very similar source area of debris flow from 2014 at an altitude of 4,180 m a.s.l. occurred in 2010. The block covered approximately 730 thousand m² at a distance of 2.6 km (Dokukin, 2015). The assumed scarp area is indicated in **Fig. 3**. By comparing satellite images of January 9, 2010 and July 30, 2019 (Image CNES / Airbus from Google Earth in

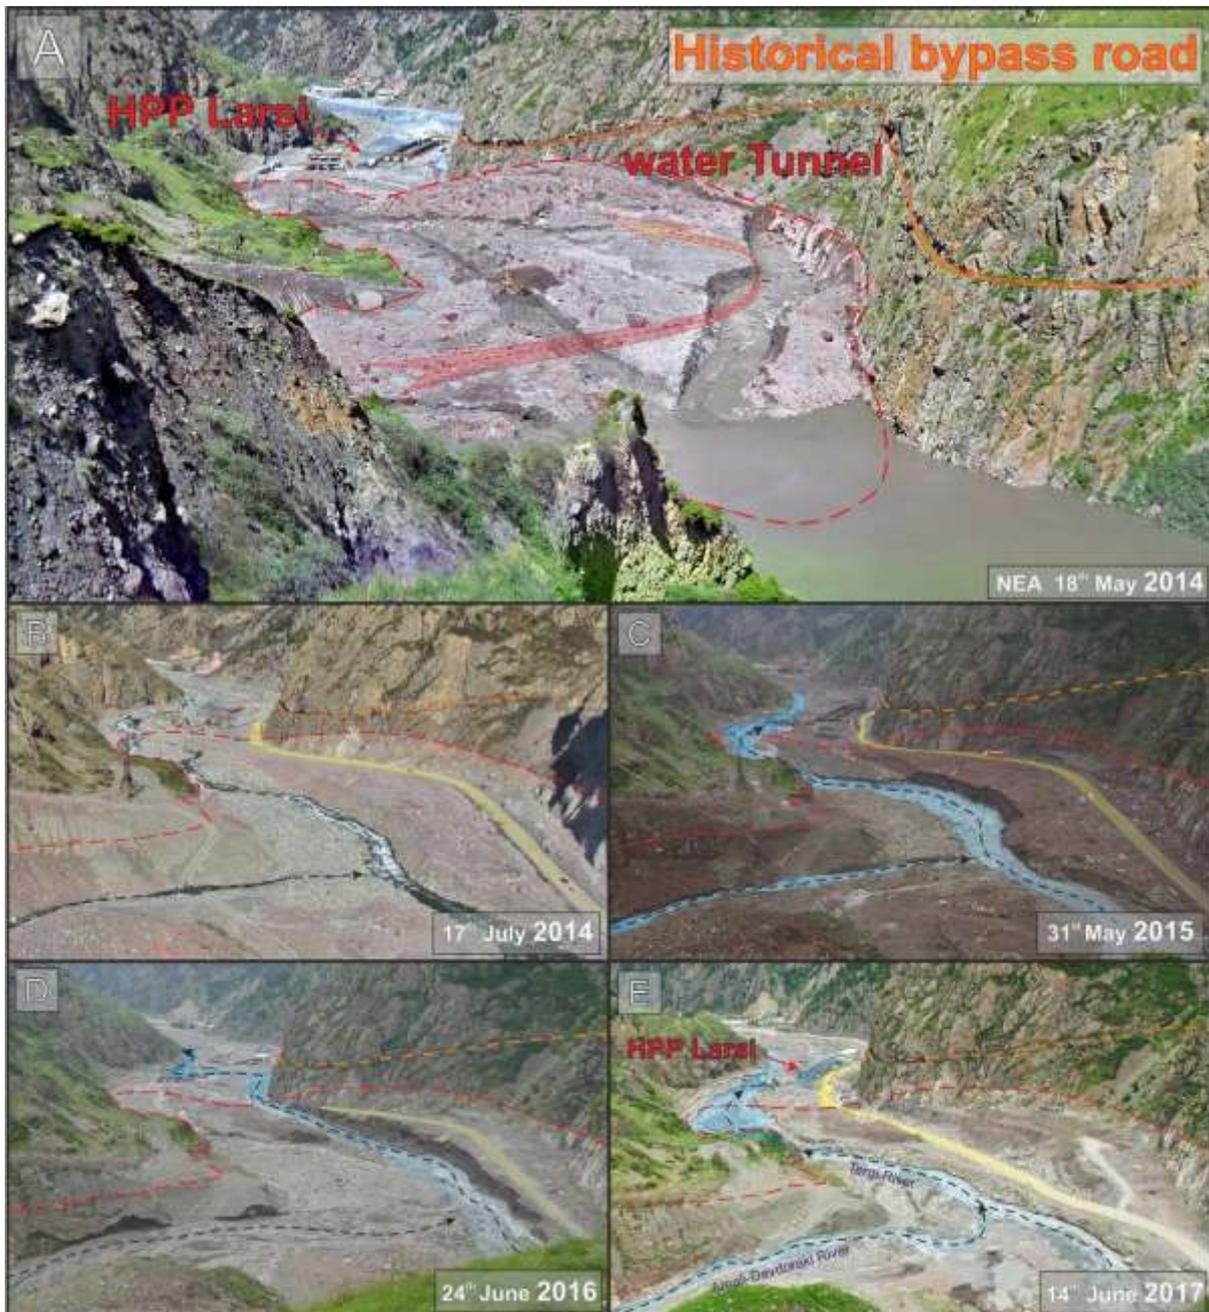
Fig. 4. Time-lapse images of accumulation area of the debris flow in Dariali Gorge in approximately year intervals (red line is distribution of the accumulation from 2014, orange line is bypass road created after debris flow 1832 – probable distribution of the accumulation). 4A: Dariali Gorge day after the event 2014 (NEA), 4B: new road (Vit Baldik), 4C: advancing river bank erosion (Petr Kycl), 4D: new road was destroyed by river bank erosion and HPP Larsi was damaged again (Vit Baldik). 4E: new road and HPP Larsi in operation (Martin Dostalík)

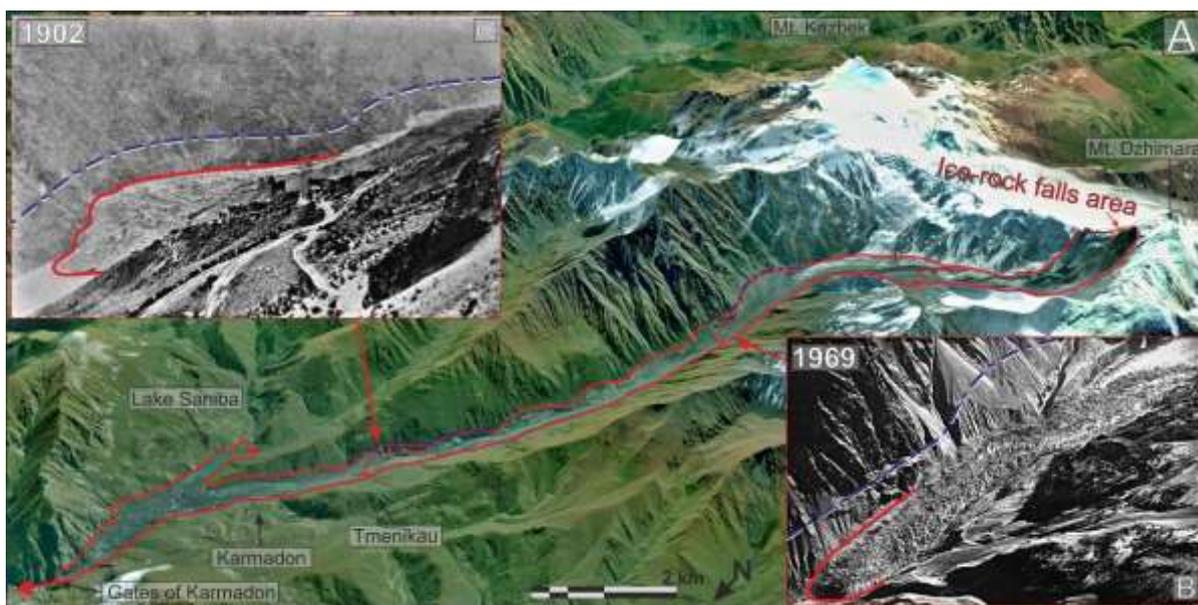
Fig. 5A: Kolka debris flow trace with ice-rock falls zone on the northern slopes of Dzhimara Mountain, transport area with meandering flow character and accumulation area on the Gates of Karmadon, 5B: Historical photo of earlier documented glacier surge on 1969 when glacier extended over 4,600 m in a 6 month (foto O. V. Rototaeva), 5C: Historical photo of earlier documented ice-debris flow 1902 (Photo from archive of North Ossetian Museum of Local Traditions, Rototaev et al., 1983)

On September 20, 2002, the whole Kolka Glacier separated from its bed and caused an exceptional debris flow that seriously affected the valley of the Genaldon. River and destroyed the Russian village of Karmadon (**Fig. 5A**).

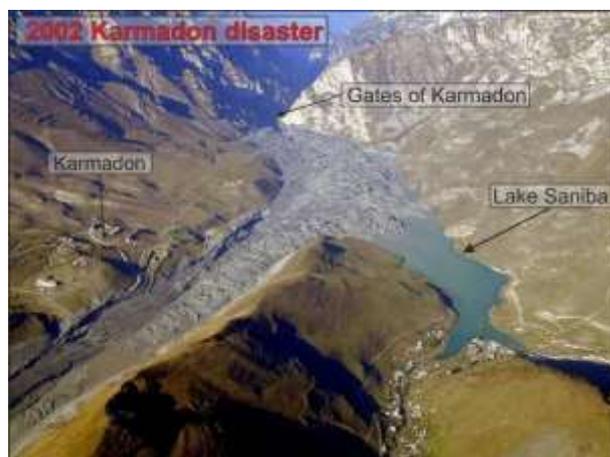
Fig. 6. Accumulation area of the debris flow in Karmadon valley from, October 6, 2002 (by Igor Galushkin In Evans et al., 2009).

The catastrophic debris flow caused by the Kolka Glacier in 2002 is one of the most important documented events of its kind in the world. It is the largest catastrophic debris flow documented in the mountain glacial environment in the historic era of the northern slope of the Caucasus Mountains, Russian Federation. This event is exceptional with a volume of material transported up to 130 million m³ with extreme speeds of up to 250 km / h. The affected area was 12.7 km², including the area of the initial rock fall, the narrow transport channel of the Genaldon River, the accumulation area in the Karmadon depression, and the zone of continued movement downstream in the Giseldon Valley. The 3.6 km long accumulation in the Karmadon depression (1,150–1,350 m a.s.l.) was spread over an area of 2.1 km² immediately after the disaster (**Fig. 6**). Subsequently, another smaller rock fall in the source area was documented, and on August 12, 2004, a smaller debris flow occurred. The original riverbed was blocked until spring 2007 (Chernomorets, 2007). In the valley, 13 temporary dammed lakes formed, the number of which was later reduced to 4, and their volume are being further reduced. The volume of water in the largest lake Saniba (**Fig. 6**) was artificially reduced by 5% in 3 years (Chernomorets, 2007).

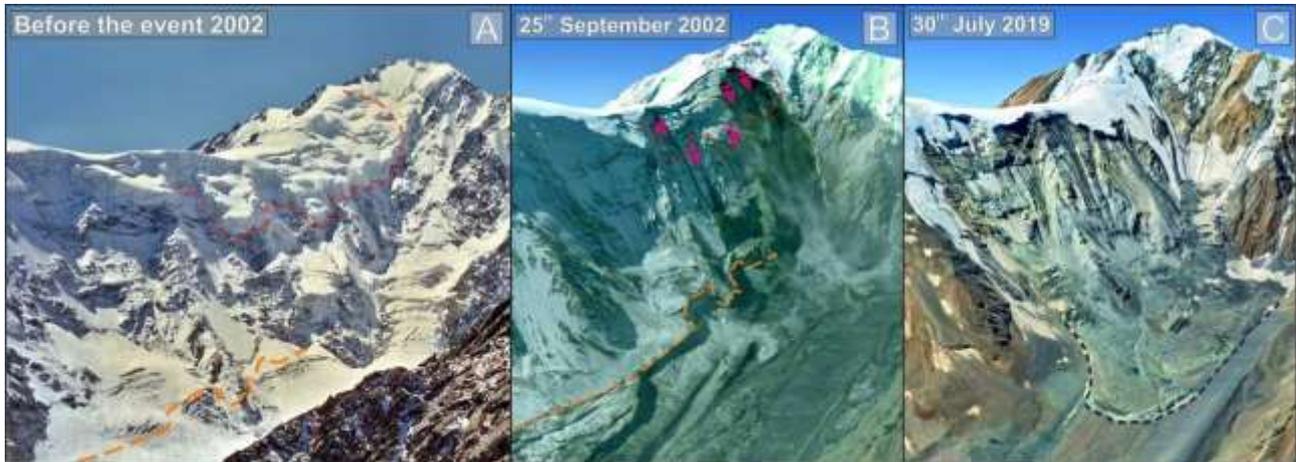
Fig. 7. Ice-rock fall zone on the northern slopes of Dzhimara Mountain. 7A: Photo of hanging glaciers (red dotted line) (Drobyshev, 2006), 7B: Google Earth satellite image from September 25, 2002 after event and probably active fumaroles (hot exhalations – in violet colour). 7C: Google Earth with satellite image from July 30, 2019 presenting self-regenerating Kolka Glacier (black dotted line)

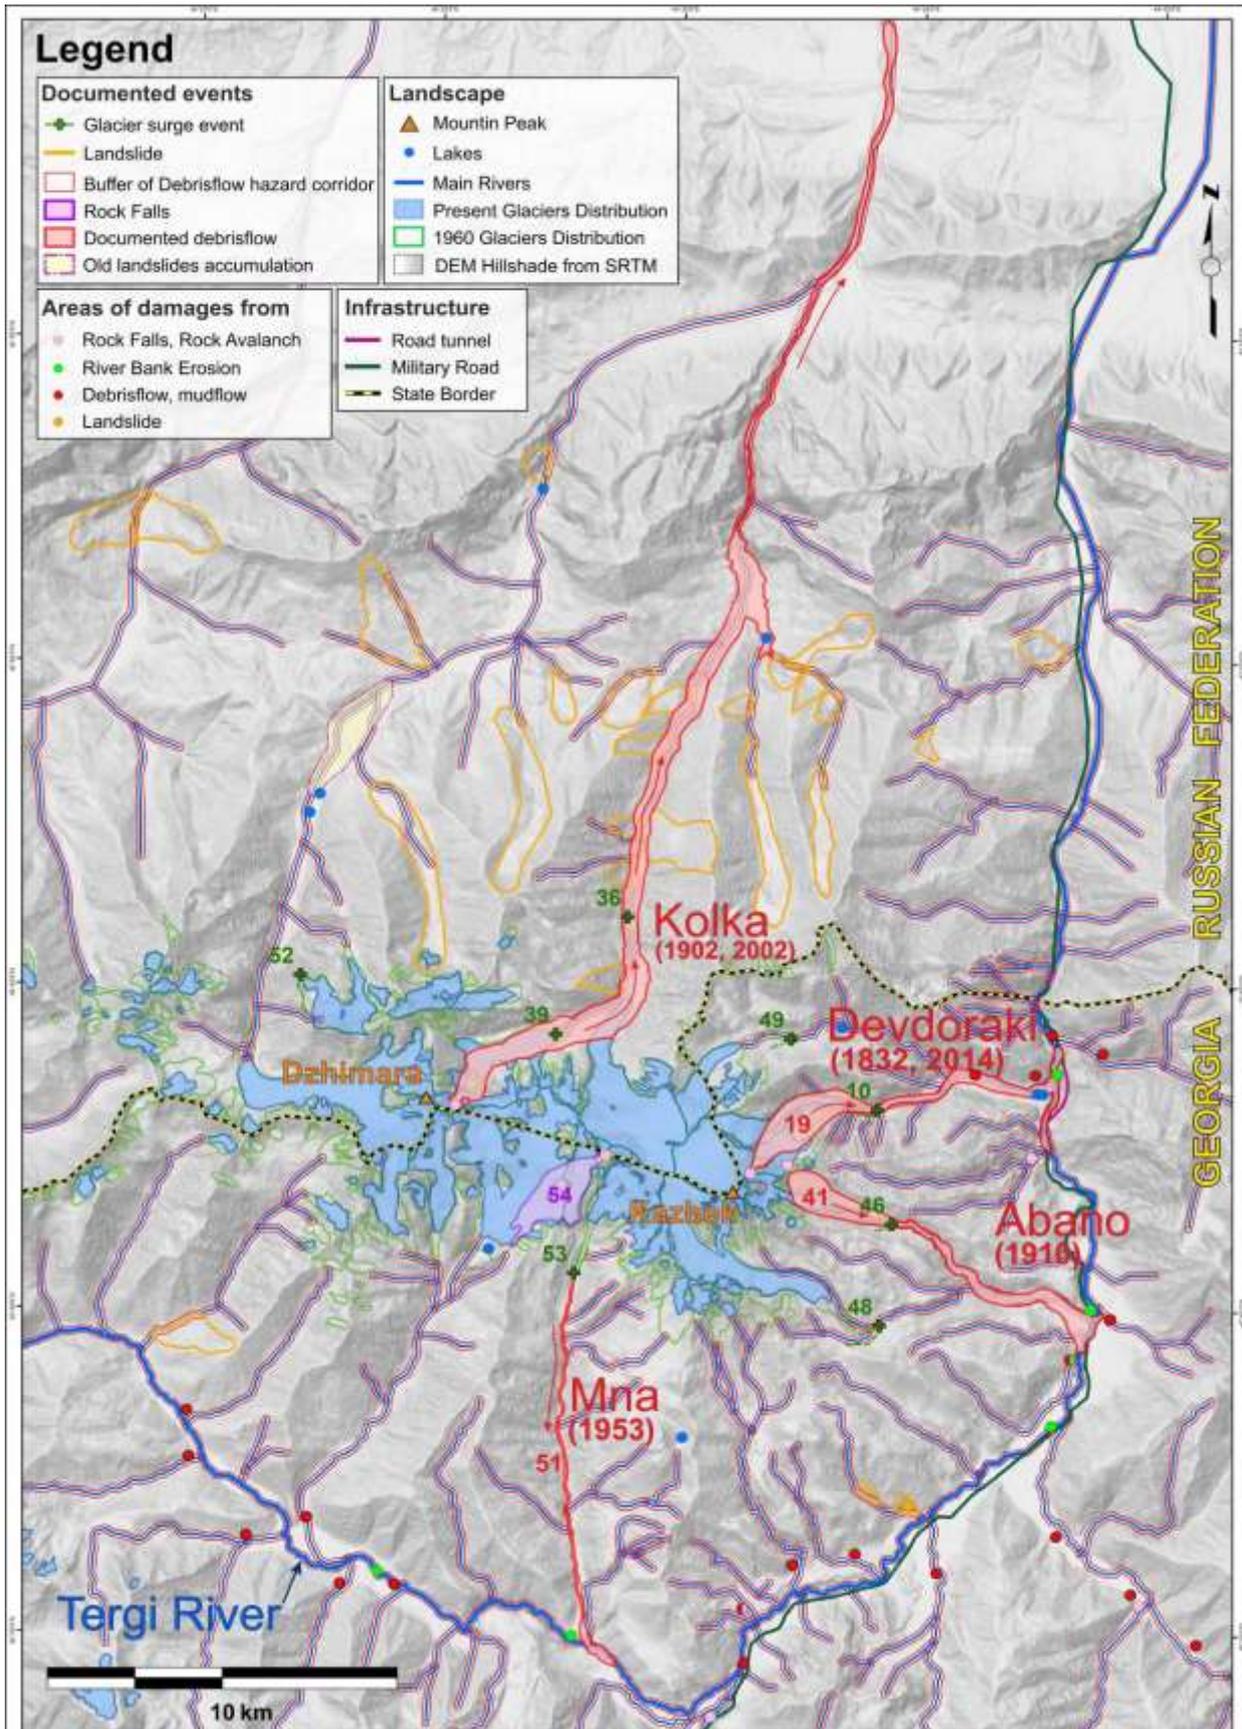
Fig. 8. Simple engineering geological hazard map. The main valleys with debris flow hazard were highlighted with a red buffer. The numbers on map is connected to the spreadsheets where are information about the events. The model can be more refined according to the type of slope movement or according to the type of initiating factor etc. Sources: DEM - USGS 2019, Present glacier – GLIMS 2019 and 1960 glaciers distribution – military topographic map 1:50 000 (ID: k_38_42_v)

The available archive information discussed in the previous chapters is presented graphically in **Fig. 8**. From **Fig. 8**, the occurrence of the recorded and described debris flows of Devdoraki, Kolka and Abano Glaciers is well defined with the approximate areas affected by these phenomena being marked. It is especially dramatic event of Kolka (2002) where its length extends more than 30 km. High hazard of these areas is visible from **Fig. 8**, when the source area is often very far from the locations that are catastrophically affected by these events. Unfortunately, these hazards are often not fully understood by the public.

Integral parts of the conceptual engineering geological model are **Tables 1, 2** and **3**, which complement **Fig. 8**. These tables present a brief overview of historically recorded devastating geodynamic hazards in the area with an emphasis on debris flow / mud flows related to glacier activity.

On the basis of a comprehensive evaluation of archival Internet data, documented or anticipated occurrences of debris flows / mud flows origins and runouts have been marked on **Fig. 8**. Based on these data, a conceptual engineering geological model has been generated in the form of a preliminary simple hazard map usable for first discussions of geological questions in urban planning in order to avoid urbanization in vulnerable areas. Measures other than eliminating urbanization at vulnerable areas are usually ineffective in preventing damage or financially out of the reality. However, if there are cases when construction cannot be

Low uncertainty is connected with the mechanism of slope movement, as the hazard map on Fig. 8 was prepared for debris flow / mud flow phenomena. Higher uncertainty can be expected in terms of causes (triggers). One possible scenario of triggering mechanism as a part of conceptual model is presented in Fig. 9.

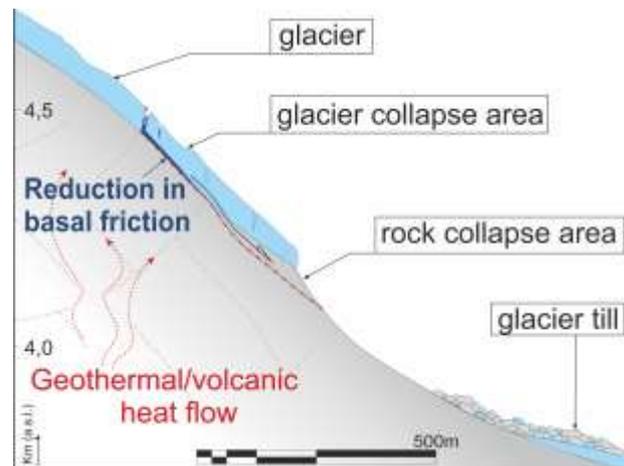
Fig. 9. One of possible scenarios of triggering mechanism for debris flow events in the area - fall of the glacier due to reduction in basal friction induced by geothermal volcanic heat flow.
