Research Paper

Evaluation of Rock Slope Deterioration Based on Granite and Schist Rock Slopes

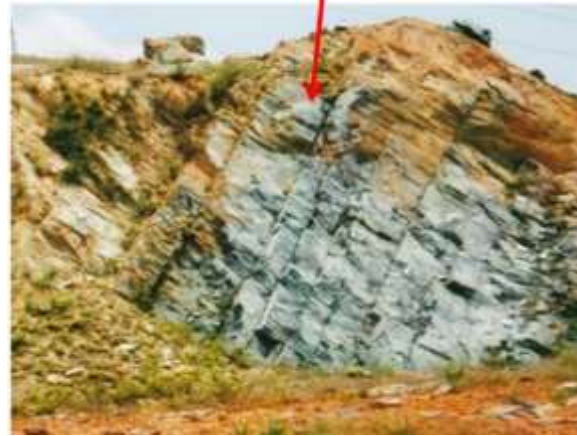
cut slope was cut in steep stage with the slope angle 60° to 80° in the direction of 100°N. It was a Granite cut slope with grade weathering I to grade III. The color was partially discoloration and the texture of the rock remains. The material from this site was hard and unbreakable by hand. Most were superficial indent with ringing sound.

Fig. 1. Granite cut slope in Kajang SILK Highway at location 2.961250°N, 101.719436°E

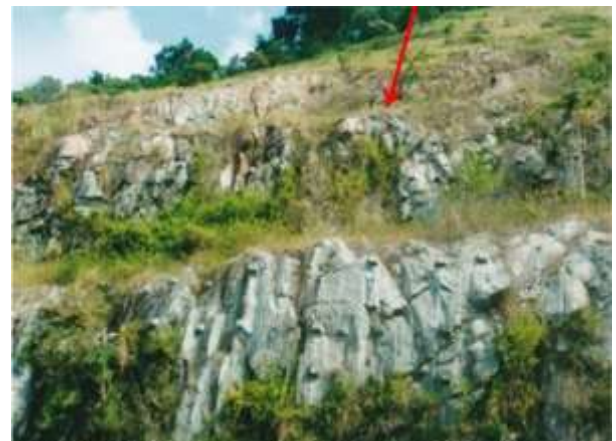
The area was a *Phyllite-Schist* cut slope with grade weathering II to grade III located at Putrajaya at location 2.961250°N, 101.719436°E (**Fig. 2**). The color was partially to completely change and the texture of the rock remains. The material was strong and firm. Most were superficial indent with ringing sound.

Fig. 2. *Phyllite-Schist* cut slope in Putrajaya at location 2.994701°N, 101.832291°E

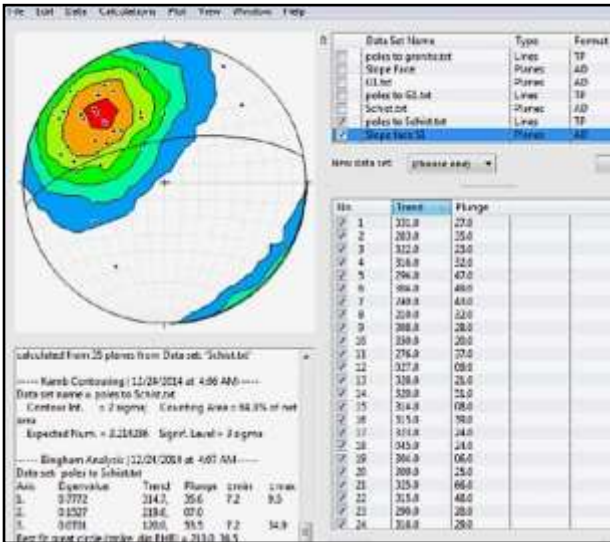
Fig. 4. Stereographic projection of Phyllite-Schist rock slope facing 350°N at Putrajaya

Scan line method was used to conduct the discontinuity surveys. These discontinuities are predominantly in the form of joints which is generally tight, with planar to slightly undulating surface. The measurement of the distance was about 30 m to ensure that the survey representing the measurement is continuous over the distance. Geological mapping was applied to create an overview layout through the perspective of geology by utilizing stereographic projection. Three types of failure occurring in the study areas namely toppling failure, wedge failure and plane failure were observed. The stereographic projection of Granite rock slope at Kajang, Selangor showed that the slope will experience plane and wedge failure based on 73 data measured on site and scan line method discontinuity survey (**Fig. 3**). The stereographic projection of Phyllite-Schist rock slope at Putrajaya facing 350°N showed that the slope will experience toppling and wedge failure based on 36 data measured by scan line method and discontinuity survey (Figure 4). From the results obtained, most chainage of the slope were not stable.
