EFFECT OF BASE REINFORCEMENT ON THE BEHAVIOR OF EMBANKMENT OVER SOFT SUBSOIL

C. W. Yang[1], J. C. Chai[2], N. Miura[3] and Y. S. Ye[4]

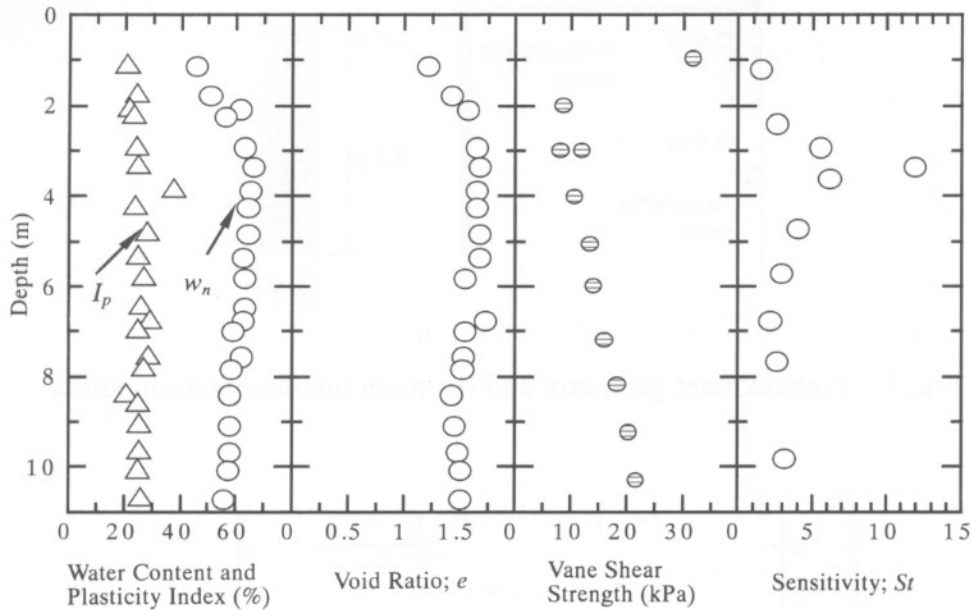
Fig. 1   Index and mechanical properties of subsoil

shown in Fig. 1, which indicates that a weak zone is in a depth of 2 m to 6 m. The top crust is in an overconsolidated state due to weathering and aging. Below 2.0 m, the soil is in a normal to slightly overconsolidated state with an overconsolidation ratio (*OCR*) of 1.04~1.07.

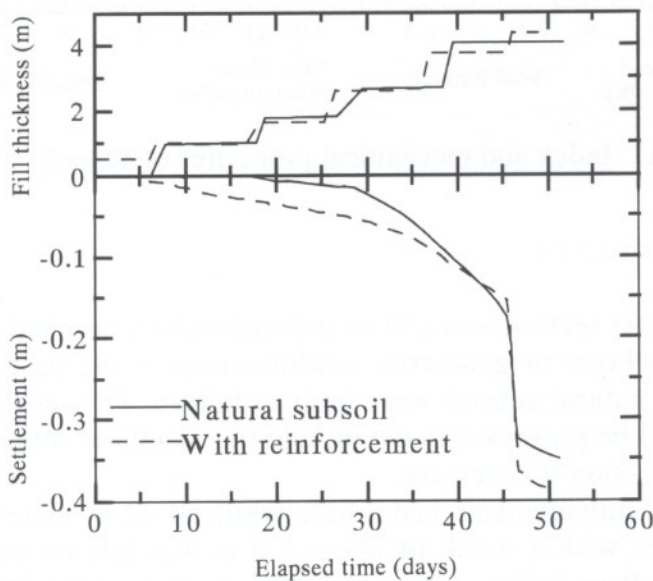
Fig. 3   Surface settlement versus elapsed time curves

(1) Surface settlement: The measured surface settlement-time curves under embankment centerline together with embankment construction histories are shown in Fig. 3. Following observations can be made from the figure. (a) Before fill thickness exceeded 2.0 m, the settlement was small. The top crust is stiffer and when the surcharge load was less than the yielding stress of the crust, the crust limited the subsoil deformation. (b) When the embankment approaching failure-state, the settlement was rapidly increased due to lateral distortion of the subsoil. (c) Just before failure-state, the geotextile reinforcement slightly reduced the settlement rate. It can be partially explained as that the combination of geotextile (strong in tension) and top

crust (strong in compression) strengthened the effect of the top crust.

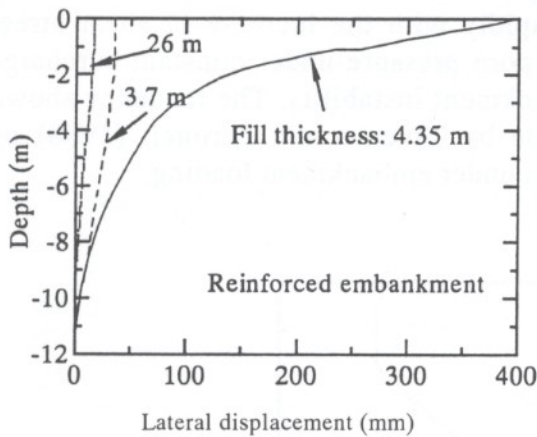
Fig. 4   Lateral displacement profiles

(2) Lateral displacement: At the time of writing this paper, only the lateral displacement data for geotextile reinforced embankment are available. The lateral displacement profiles of reinforced case are given in Fig. 4. It indicates that the lateral displacement was small before the fill thickness reached the 4.35 m (failure occurred). Figure 5 gives the variation of the ratio of lateral displacement/settlement with embankment fill thickness. This case history also clearly indicates that when the embankment approaches failure condition, the lateral displacement/settlement ratio increased rapidly. The results support the proposal made by Matsuo and Kawamura (1977).

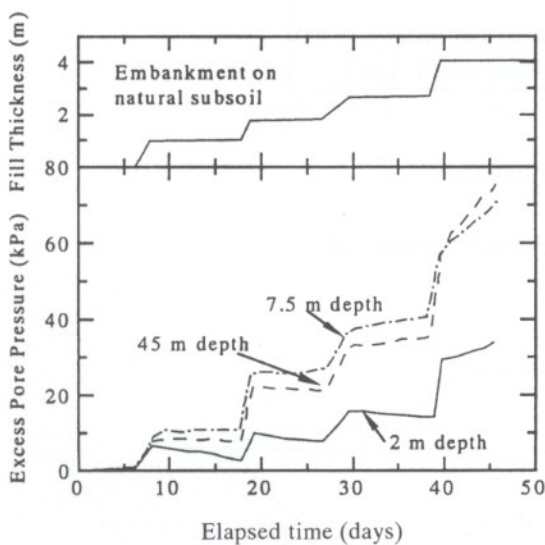
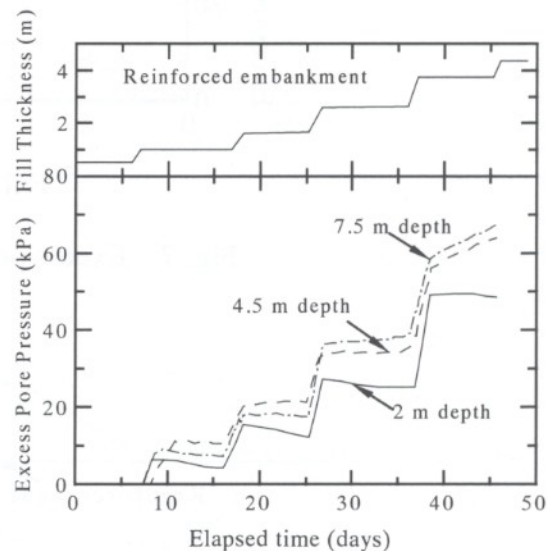
Fig. 6   Excess pore pressure variation

(3) Excess pore pressures: Variations of excess pore pressure at 2.0 m, 4.5 m, and 7.5 m depths are given in Figs. 6 (a) and (b) for with and without reinforcement cases, respectively. When fill thickness was less than about 3.0 m, at rest period between two load increments, there was a tendency of dissipation of excess pore pressure due to

consolidation effect. However, when fill thickness was approaching or more than 3.0 m, even at rest period, there was no reduction or an increase in excess pore pressure at 4.5 m and 7.5 m depths. When the fill thickness approached 4.0 m, there was an obvious increase of excess pore pressure during rest period. It can be explained that due to the progressive development of shear strain in subsoil, the shear induced excess pore pressure increment was larger than partial dissipation effect. Also, when the subsoil approaches failure state, the coefficient of consolidation is reduced due to reduction of soil stiffness, which will reduce the dissipation rate of excess pore pressure. The excess pore pressure versus fill thickness is given in Fig. 7 for 4.5 m depth. The rate of excess pore pressure development is increased with the increase of fill thickness, which can be explained by using the inserted figure in Fig. 7. The shear induced excess pore pressure will increase rapidly with the increase of shear stress level. The continuous development of excess pore pressure under constant surcharge loading can be considered as an index of embankment instability. The tendency shown in Fig. 7 partially supports the proposal made by Tavenas and Leroueil (1980) on excess pore pressure development in soft subsoil under embankment loading.

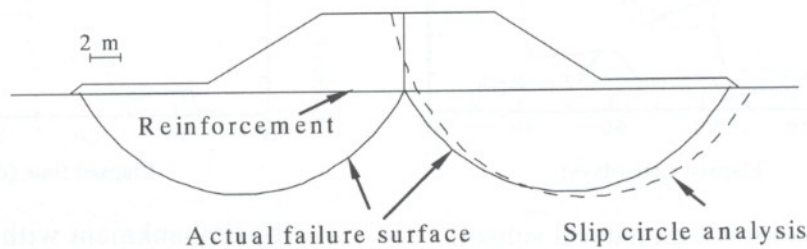
Fig. 8　Failure surfaces

(4) Failure surface: Symmetric failure pattern was observed in the field, i.e. the embankments failed at both sides. The observed failure surfaces are shown in Fig. 8. The estimated depth of failure surface is about 5~6 m. The observed failure surfaces

are not much difference for with and without geotextile reinforcement. It supports the assumption made for conventional stability analysis that the existence of geotextile reinforcement does not change the failure surface much.

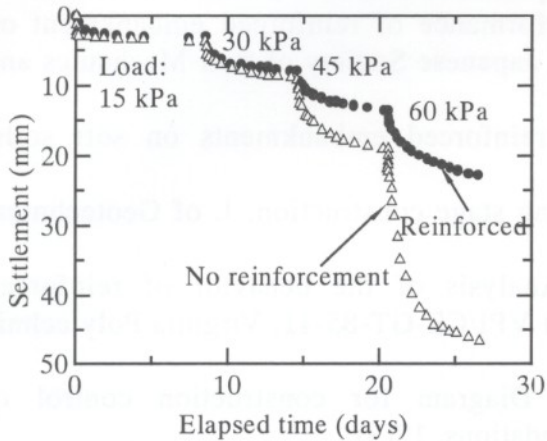
Fig. 11 Settlement versus elapsed time curves of model test

The measured settlement variation and lateral displacement profiles for after applying 60 kPa loading are given in Figs. 11 and 12 respectively. Figure 11 shows that before load increased to 45 kPa, the settlements for both with and without reinforcement are identical. After the load reached 45 kPa, the settlement difference was clearly appeared. At the surface of the model ground, the undrained shear strength was about 5.2 kPa, and the plasticity theory gives an undrained bearing capacity of about 27 kPa. Take the effect of partial consolidation during loading period and the stress spreading effect of model embankment, a bearing capacity of about 40 to 50 kPa can be roughly estimated. When load increased to 45 kPa, for the case without reinforcement, the subsoil was close to failure. For with reinforcement case, due to the restriction effect of geogrid, the surface soil still not failed. Therefore, the settlement difference of two cases appeared. For further increasing the load to 60 kPa, the settlement difference increased rapidly, and which was mainly due to the difference of lateral displacement as indicated in Fig. 12. The model test results clearly illustrated that: (1) when the factor of safety is large, even with very strong reinforcement, there is

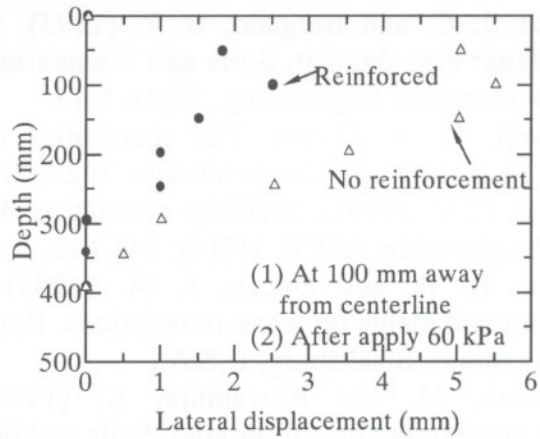
Fig. 12 Lateral displacement profiles of model test

no noticeable effect on subsoil deformation. (2) When the factor of safety is close to 1.0 for unreinforced case, the reinforcement can have considerable benefit on reducing the lateral deformation of subsoil if the reinforcement is strong enough.
