# Earthquake Damages and Disaster Prevention of Aboveground Storage Tanks

Shoichi Yoshida<sup>a,\*</sup>

<sup>a</sup>High Pressure Institute of Japan, Tokyo, Japan. Email:k3syoshidas@tea.odn.ne.jp

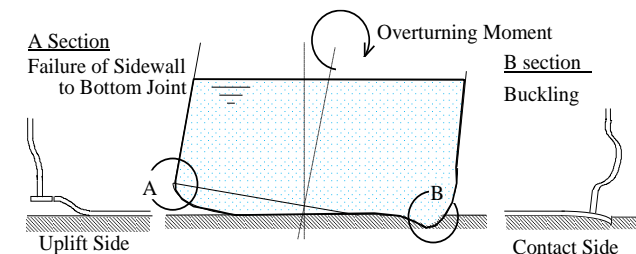
Figure 5. Rocking motion due to high frequency earthquake

Most of the ASTs are unanchored and rest freely on flexible foundations. When an unanchored tank is subjected to lateral load induced by the high frequency earthquake, an overturning moment is developed at a base of the tank sidewall. The tank will rock in response to this overturning moment. As a result, a sidewall-to-bottom joint of the tank contacts and compresses the foundation strongly on one side, and lifts off from the foundation on the other side, as shown in Fig. 5.

On the contact side, buckling of the sidewalls may occur due to excessive vertical compressive force. This buckling is characterized by a "diamond-shape buckle" or an "elephant foot bulge". On the other hand, the uplifting causes large plastic strain at a toe of the sidewall-to-bottom fillet weld, and this leads to a catastrophic failure of ASTs.

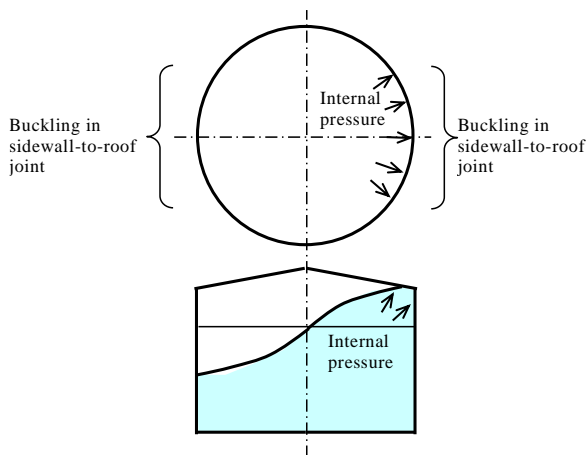
Figure 6. Buckling mechanism of a sidewall-to-roof joint in a fixed roof tank due to low frequency earthquake

The sloshing in an AST may occurs due to the low frequency earthquake. When the sloshing wave reaches to roof plates in the fixed roof tank, the sidewall-to-roof joint is subjected to internal pressure as shown in Fig. 6. This pressure causes circumferential compression force in this joint, and the bifurcation buckling with a high circumferential wave number may occur. The sidewall-to-roof joint is usually designed to be weak from the viewpoint of the frangible roof joint. When an overpressurization occurs due to an ignition of flammable vapors existing inside tank, the sidewall-to-roof joint is expected to fail before failure occurs in the sidewall-to-bottom joint. This is a design concept of the frangible roof joint.

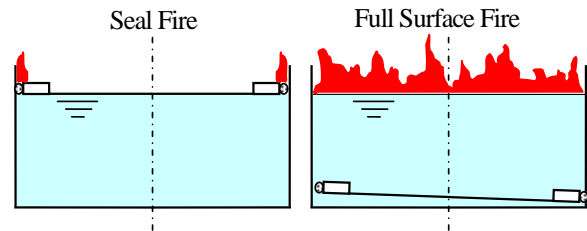
Figure 8. Fire in floating roof tanks

The floating roofs are used in many large ASTs to reduce evaporation. It may deform during the sloshing due to the low frequency earthquake (Fig. 7), and it may cause rupture. When the floating roof loses its buoyancy, it will sink into oil. The floating roof tank was considered to be safer than the fixed roof tank, because only a seal fire might occur and a full surface fire as shown in Fig. 8 could not occur. However, when the floating roof sinks, the full surface fire possibly occurs. The full surface fire will be extinguished when oil burns out in a large AST. It will take several days.
