Research Paper

Uplift of very sensitive soft clay due to pile driving

W. Teeparaksa¹ and J. Teeparaksa²

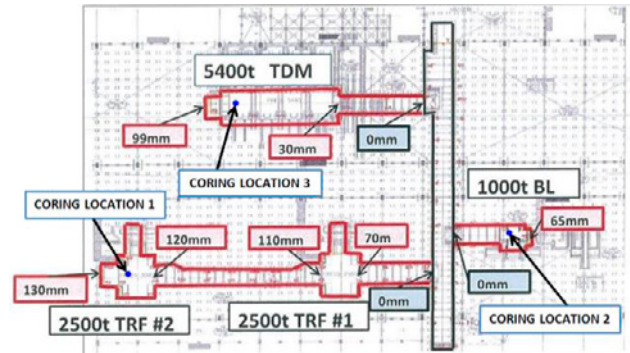
Fig. 1. Locations of four press pit.

The uplift of press pits were observed and measured on 14 December 2014 as presented in **Fig. 1**. as summarized in **Table 2**. After uplift of press pits were observed, concrete coring on base slab of the press pits were carried out at 3 locations as shown in **Fig. 1** as location1 at press pit 2500 tons TRF#2 on 16 December 2014, location2 at press pit 1000 tons BL on 16 December 2014, and location3 at 5400 tons TDM on 19 December 2014.

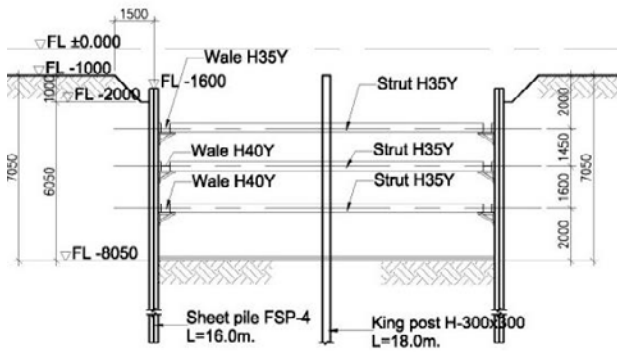
Fig. 3. The detail of sheet pile bracing system.

Steel Sheet pile was 18 m. long with embedded length of 9.95 m. Three bracing layers at -2.0 m., -3.45 m. and -5.05 m. Construction work started by soil excavating to the depth below the first bracing layer and installing the first layer of bracing system at -2.0 m. The process repeated until installation of the third bracing layer at -5.05 m. before excavation up to the final depth of -8.05m. below the ground surface level as shown in **Figs 3** and **Fig 4**. During excavation, there was no groundwater and soil heaving found in the pit as well as pile inside the pit. The sheet pile was removed after the base slab and

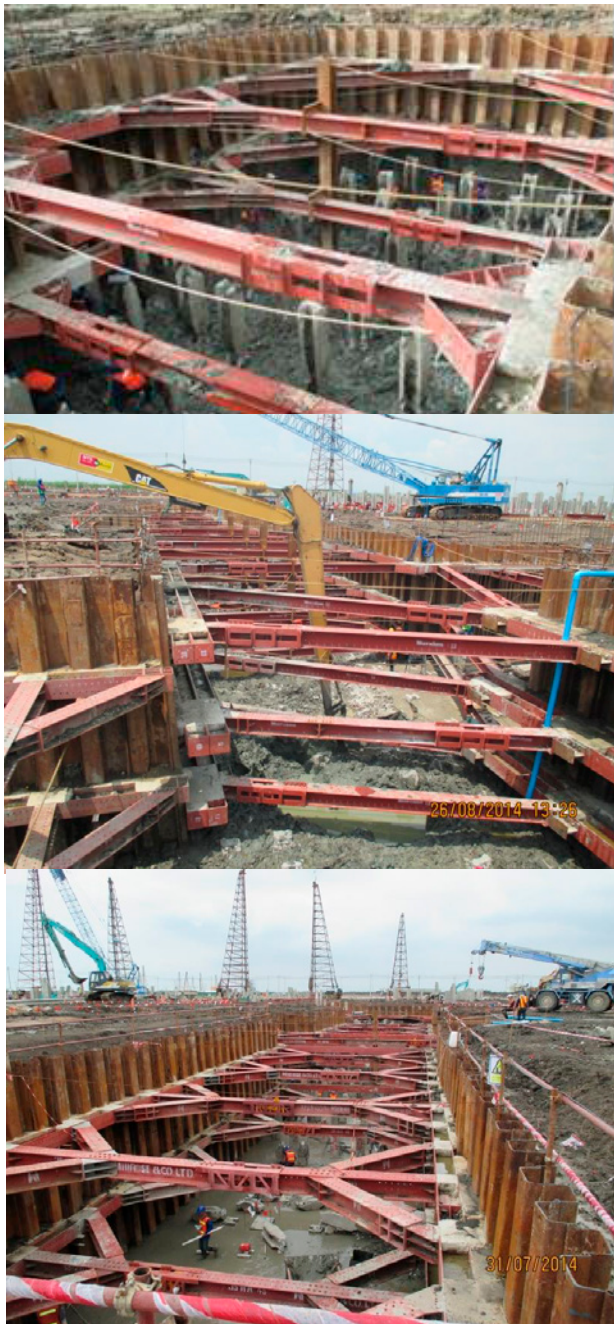
Fig. 4. Sheet pile braced excavation system.

Due to the collapse during open excavation as shown in **Fig. 2**, it can be seen that the trial open excavation was very dangerous to construct the press pit. Therefore, in order to avoid any possible risks, the sheet pile braced excavation method was preferred as a soil protection system instead of open excavation method. Generally, during excavation by sheet pile braced cut system in the very soft sensitive clay, the pile deviation and pile crack normally occur both inside and outside of the pit. Thus, the contractor proposed the excavation method by sheet pile bracing system without pile installation outside of the sheet pile wall as shown in **Fig 3 and 4**. There were, in total three steel bracing layers at the level of -2.0 m., -3.45 m. and -5.05 m. from the ground surface level. Sheet pile was 18 m. long. In addition, the contractor proposed the pile driven sequence into 3 phases as well as construction of press pit as shown in **Fig. 5** with detailed as follows:

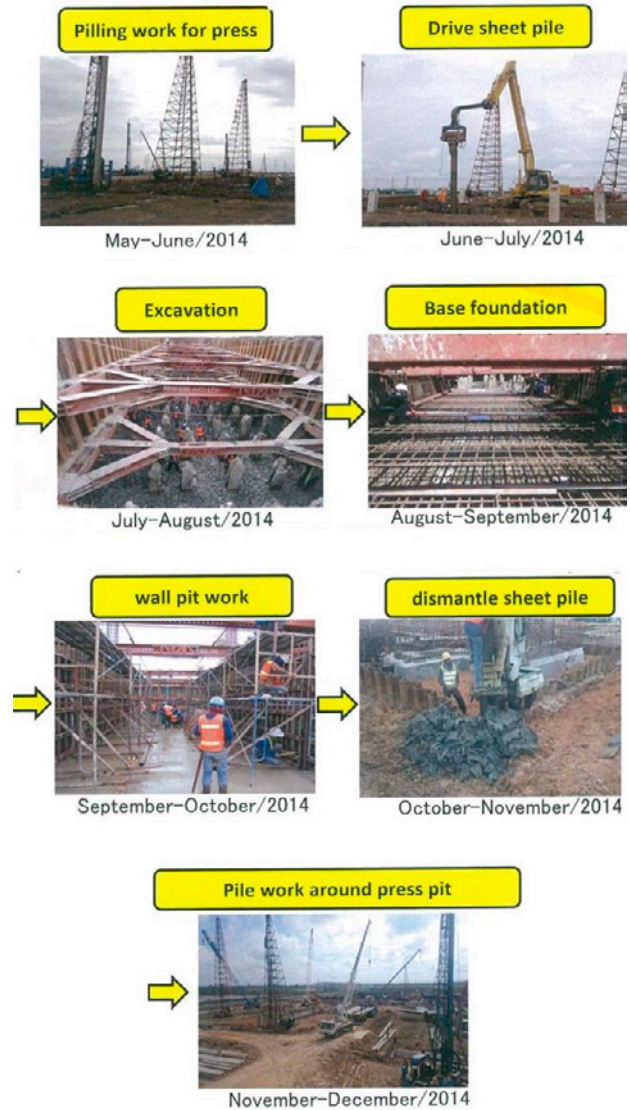
Fig. 5. The schedule of piling pile.

Zone1: Piles driving started on the outside of the areas, that the press pit would be constructed, by waiving the surrounding area of the press pit. The piles surrounding the press pit area were not driven because the piles outside the excavation pit would be normally deviated and cracked during deep excavation in the very soft clay area. Thus, the area of zone1 was far away from press pit areas. Some piles in zone1 were driven at the same time with the excavation of the press pit or the construction of the press pit slab and the retaining wall because zone1 was huge area. In zone1, the piles were used to support the floor slab and column of the factory.
