## GEOTECHNICAL ASPECTS OF THE DESIGN AND BEHAVIOUR OF THE HIGHWAY BRIDGE OVER DRADER RIVER IN MAROCCO

**ABSTRACT:** The motorway bridge on the Drader River suffered from severe floods, which occurred during its construction in 1995-1996. At this site, 8 m thick compressible soft clays layers were found during the site investigations and piled abutments were designed. During the flood, due to erosion of the riverbed under the bridge, the piled abutments were displaced and came in contact with the bridge deck. The access embankments were taken away and a new project was established for the abutments and embankments. L-shaped retaining walls prevent any contact between the fill and the abutments and hollow concrete tubes were placed in the fill in order to reduce the load applied to the ground surface.

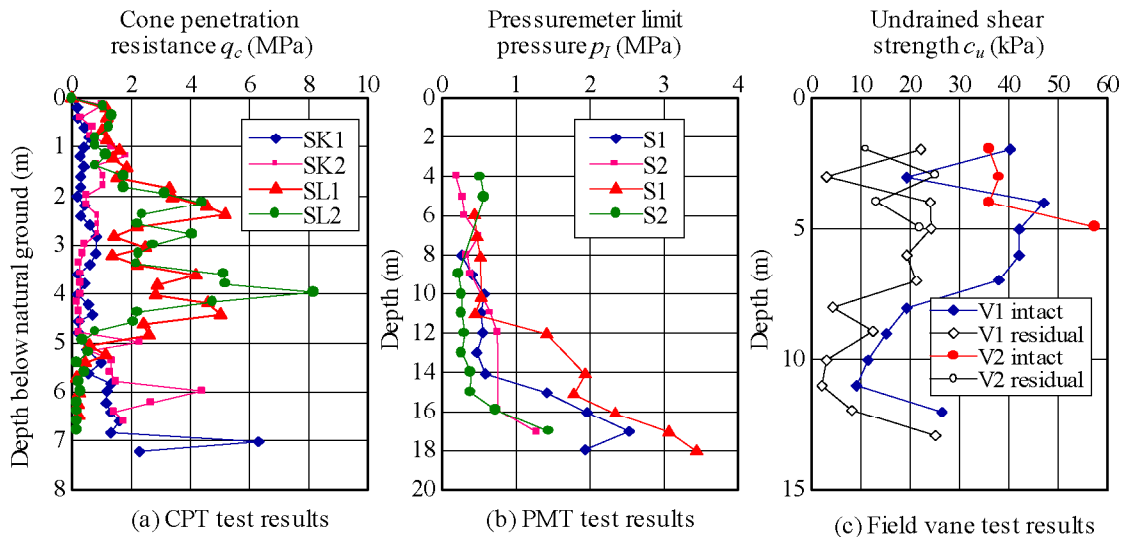
During the floods of January 1996, the access embankments were eroded, a slide occurred in temporary humps of earth located on the left bank of the river, close to the motorway and the abutments moved towards the bridge deck. Additional site investigations were asked for, in order to check the geotechnical assumptions that would be used for the design of the repair works. Ten additional soundings (4 CPT cone penetration tests, 4 PMT Ménard pressuremeter tests and 2 field vane tests) were made in 1996. Besides, the observations made during the installation of the bored piles were analysed. The results of the in-situ investigations are shown in Figs. 4 and 5.

Fig. 4 Geotechnical characteristics of the soils of the Drader valley in the vicinity of the motorway bridge

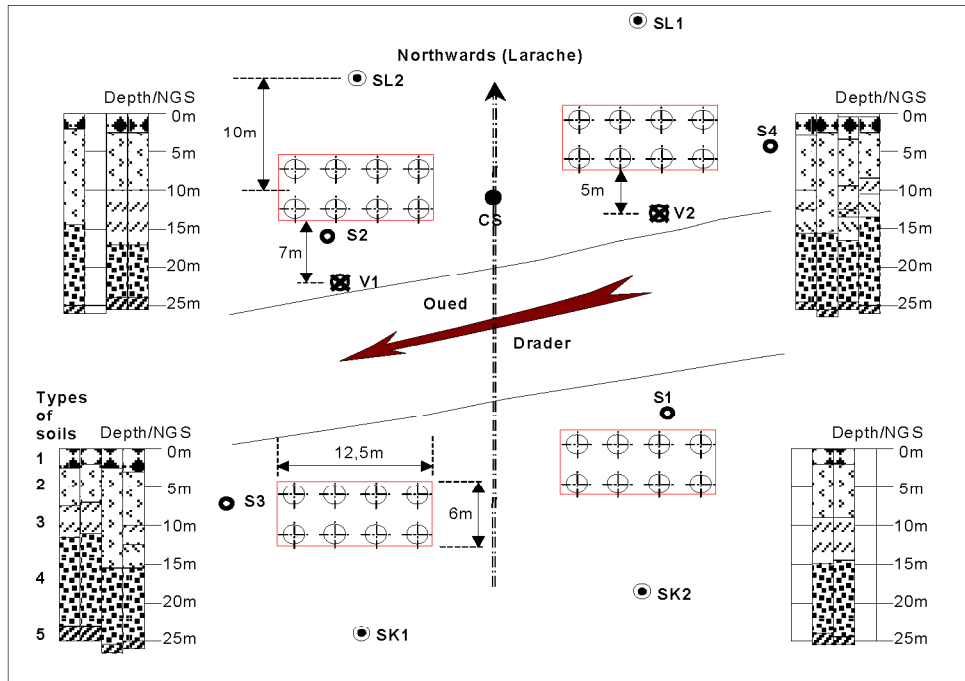
Fig. 5 Layout of the foundations and of the site investigations (Pressuremeter tests S1-S4, vane tests V1-V2, cone penetration tests SL1, SL2, SK1, SK2, core sampling CS, and types of soil found when boring the piles)  
Types of soil: 1-Tirs and sandy silt; 2-Soft clayey mud; 3-Clayey marl; 4. Sandy silt, partly indurated; 5. Stiff marl

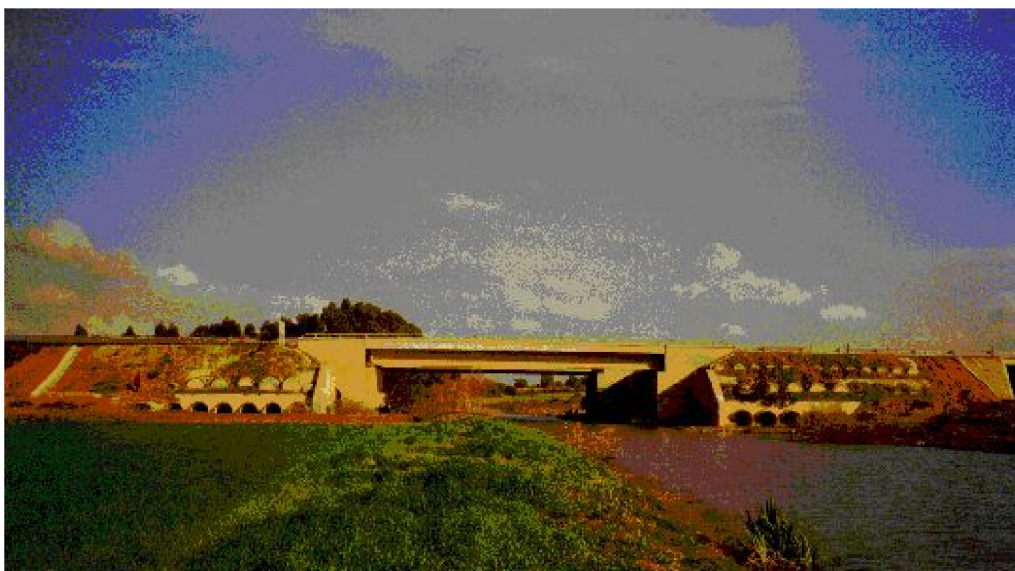
open, in order to facilitate the flow of water during the floods, whereas the pipes of the upper two layers were closed by means of concrete plugs. Two views of the completed embankment are presented in Figs. 8 and 9.

Fig. 8 Side view of the bridge over the Drader river (from the downstream side)

Since the construction works had been interrupted and the completion of the motorway had to be achieved as soon as possible, it was felt that the availability of concrete pipes made this solution the most adequate one. Two types of pipes, 1.6 m and 1.0 m in diameter, were selected and placed in three layers on both sides of each bridge (Fig. 7). The mean weight density of the embankments was thus decreased by 22%. The lower pipes were kept

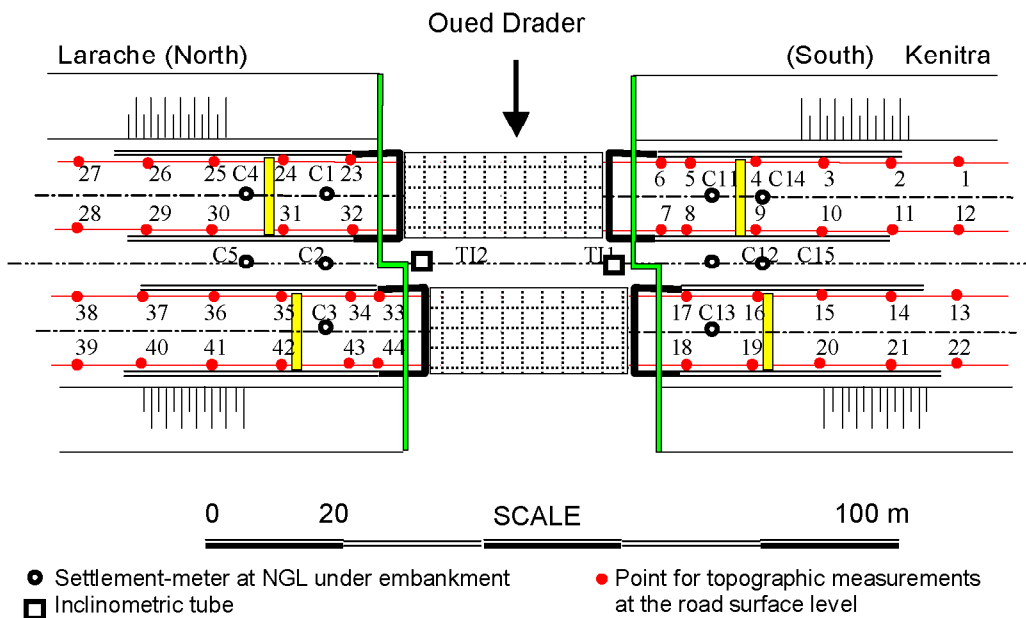
Fig. 10 Location of the instruments used for monitoring the ground movement

The horizontal movements of the ground on both sides of the river, as measured in the two inclinometric tubes TI1 (Left/Southern bank) and TI2 (Right/Northern bank), are shown in Figs. 19 and 20. The movements are not parallel to the bridge but perpendicular to the riverside (Fig. 10). The maximum horizontal movement was observed at a depth of 5.5 m on the right bank (8 cm) and 4 m on the left bank (2.2 cm). Much of the movement occurred during the construction period (3.5 cm and 1.5 cm, respectively). During the next four months, the horizontal displacement amounted to 2.5 cm (0.5 cm), whereas the corresponding settlement of the embankment was in the range 7-10 cm (1-1.5 cm) (Figs. 15 and 14, respectively). The ratio of the horizontal to the vertical displacements was thus close to 30% during that four months period. During the following 21 months (until August 1998),

Since the design of the repair works was mainly based on experience, some importance was given to the monitoring of the vertical and horizontal movements of the foundation soils and embankments. On each side of the river, the instrumentation consisted of (Fig. 10):
