Research Paper

Investigation on the damage to Kumamoto Castle stone wall related to the 2016 Kumamoto Earthquakes

T. Ohsumi

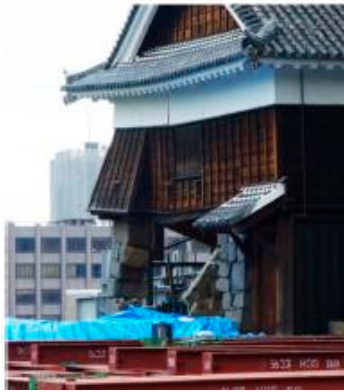
Fig. 6. Photograph of the stone wall of lidamaru Yagura (2004 reconstruction), which was constructed using the Sangi-tsumi method. (courtesy of Prof. K. Meguro, taken Oct. 26, 2016)

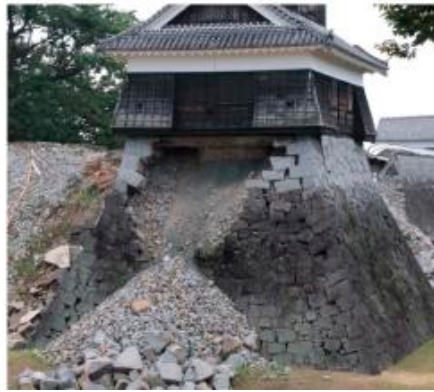
Fig. 7. Photograph of the stone wall of Inui Yagura (2003 reconstruction), constructed using the Sangi-tsumi method. (photo by T. Ohsumi, taken Aug. 11, 2016)

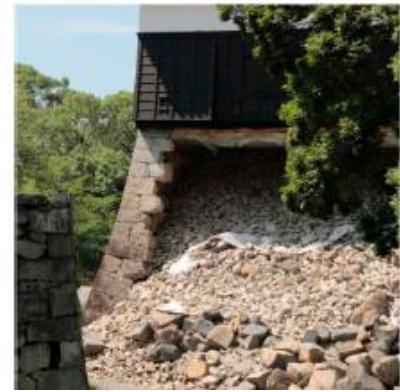
Fig. 8. Photograph of the stone wall of Bagu Yagura (1966 reconstruction), constructed using the Sangi-tsumi method. (photo by T. Ohsumi, taken Aug. 11, 2016)

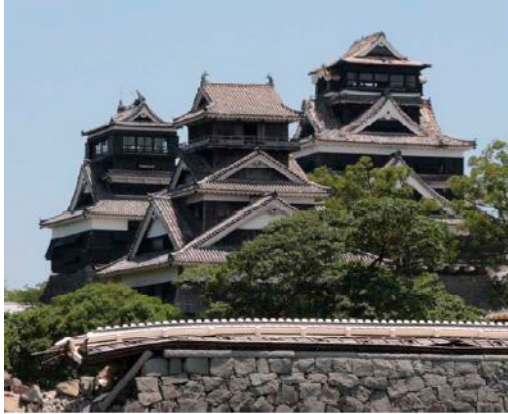
Fig. 10. Photograph of Daitensyu (right: 1960 reconstruction), Uto Yagura (centre) and Shotenshu (left: 1960 reconstruction) from Nino-maru park. (photo by T. Ohsumi, taken Aug. 11, 2016)

Fig. 10 shows a full view of the greater keep (Daitenshu) and Uto Yagura. Only Uto Yagura is the collapse of the tile did not course.

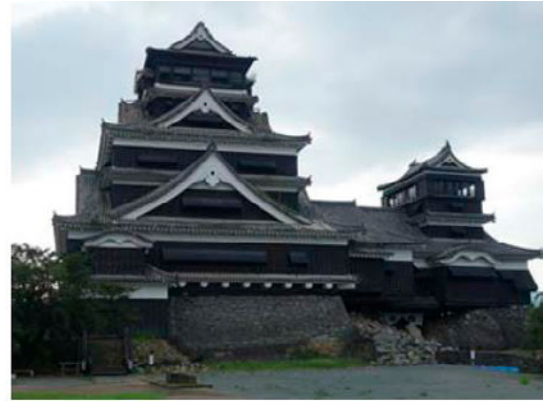
Fig. 11. Photograph of Daitensyu (left) and Shotenshu (right) from Hon-maru side. (courtesy of Prof. K. Meguro, taken Oct. 26, 2016).

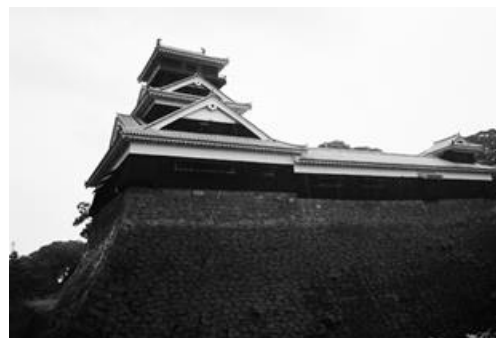
Fig. 15. Photograph of Tsuzuki Yagura and Uto Yagura before the earthquakes (photo by T. Ohsumi, taken in 1989).

height of 20.5 m. The turret has three floors and five stories below the foundation floor is a squirrel that continues from the north side to the west side and a renovation was performed in 1989. It has a corridor on the top floor. A 25-m-long section of Tsuzuki Yagura on the west side collapsed after the earthquakes. Uto Yagura was reinforced by a steel brace installed at the opening. This seismic reinforcement improves strength and stability. However, since it was not similarly reinforced, Tsuzuki Yagura collapsed (**Figs. 14, 15, 16**). **Fig. 17** shows Uto Yagura from Hohoate-gomon, which stone walls were heavily damage.

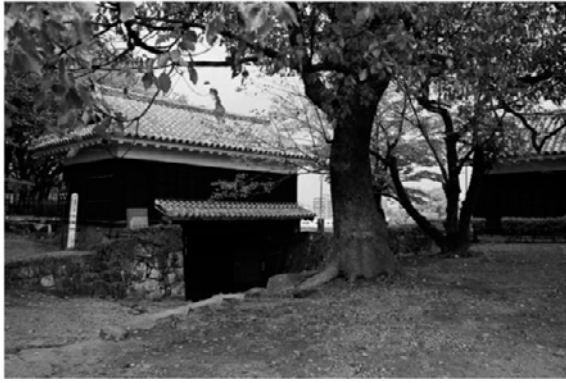
Fig. 22. Photograph of Akazu-no-mon before the earthquakes (photo by T. Ohsumi, taken in 1989)

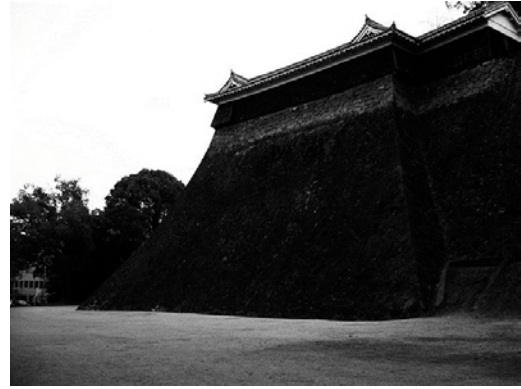
Fig. 23. Photograph of Kita Juhachiken Yagura before the earthquakes (photo by T. Ohsumi, taken in 1989)

Fig. 23 shows before the earthquakes. Kita Juhachiken Yagura, which is located between Kato Shrine and Kumamoto Daijingu shrine, completely collapsed. Behind Kita Juhachiken Yagura, there was a large V-shaped gully erosion at the top of the foundation, which worsened the collapse (Figs. 24, 25).

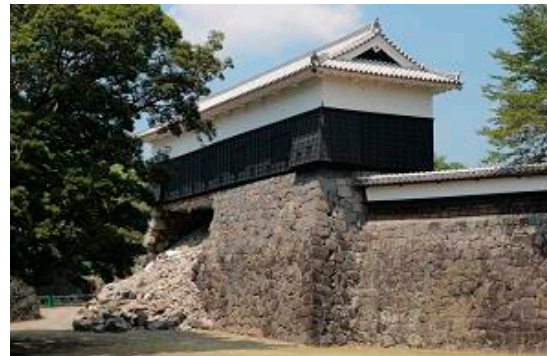
Fig. 28. Photograph of Naga-kabe and Bagu Yagura-dai (1966 reconstruction) (photo by T. Ohsumi, taken August 11, 2016)

Naga-kabe, the longest castle wall, at 242 m, was connected to Hira Yagura from the eastern end of Takeno Maru to the westernmost Bagu Yagura-dai. This long wall (**Fig. 27**) on the south side was built as protection from the Satsuma clan. An 80-m section of Naga-kabe collapsed after the earthquake.
