# Sediment disasters caused by the 2016 Kumamoto Earthquake and regional disaster history

M. Suzuki <sup>1</sup>, K. Kagohara <sup>2</sup>, K. Sakaguchi <sup>3</sup>, H. Matsugi <sup>4</sup> and S. Kataoka <sup>5</sup>

## ABSTRACT

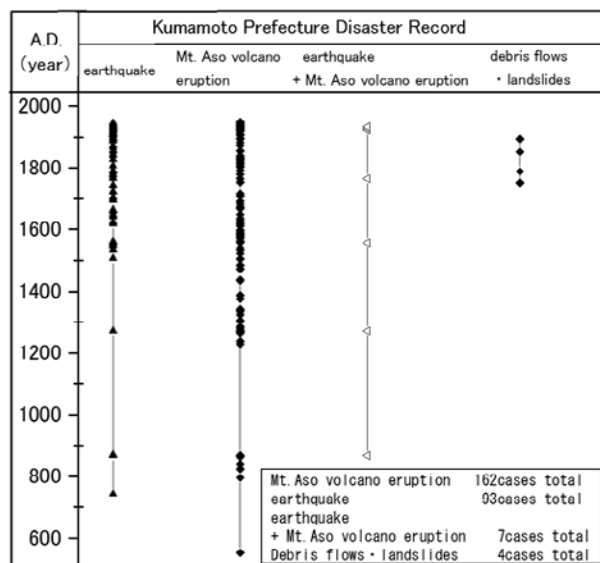
**Figure 12** shows the occurrence years for Mt. Aso eruptions and debris flows from AD 553 to AD 1900 based on descriptions of the "Kumamoto prefectural disaster record" issued by Kumamoto Weather Station (1952). Records of debris flows and landslides were respectively described as mountain tides and landslips in

**Fig. 12.** Records of occurrence for Kumamoto prefecture region earthquakes, Aso volcano eruptions, and debris flows.

the disaster record. We found four sediment disasters and three earthquakes in the record. The occurrence interval for the four debris flows and landslides since AD 1751 is 38, 62, and 43 yr. Earthquakes also occurred three times, with intervals of seven, ten, and six years. There was only one record for Mt. Aso of a landslide associated with an earthquake, in 1854. Thus far, no prior relationships between earthquakes and debris flows have been found.
