Research Paper

Geotechnical damage due to the 2016 Kumamoto Earthquake and future challenges

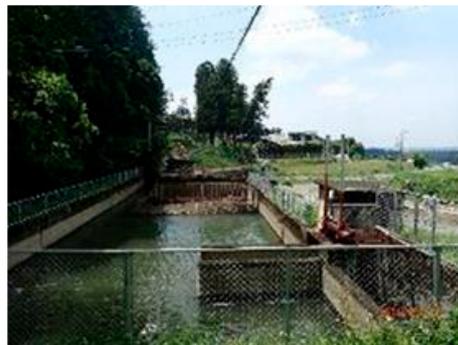
Fig. 36. Regulating pond (no overflow).

The continuous overflow almost emptied the reservoir, which the authors observed in their second survey within four weeks (Fig. 34). We could visually observe the faults that passes through the dam. Therefore, it could be concluded that the major damage was due to these faults. We could also see slope failures at two locations of the dam embankment (Fig. 35). Regulating pond has come to the normal state (Fig. 36), however, the scouring caused

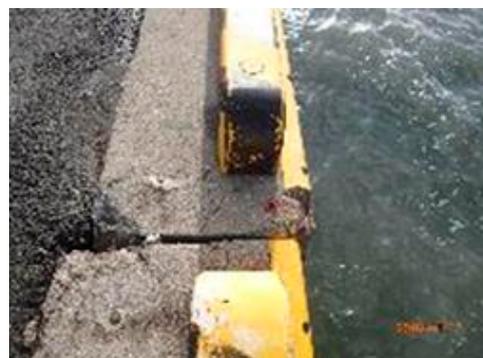
Fig. 59. Quay wall of the port (no damage).

resulting in the maximum settlement of about 30 cm. Liquefaction induced lateral spreading and sinking of the road was also observed (**Fig. 58**). The liquefaction in the areas also led to some minor laterals spreading as seen. No significant damage to the quay wall (**Fig. 59**), however, was observed. The entrance of the ferry terminal was affected by differential settlement (**Fig. 60**) that led to the closer of the terminal for few weeks.
