Research Paper

## Slope Failure Due to Effect of Damrey Typhoon in Penang Island

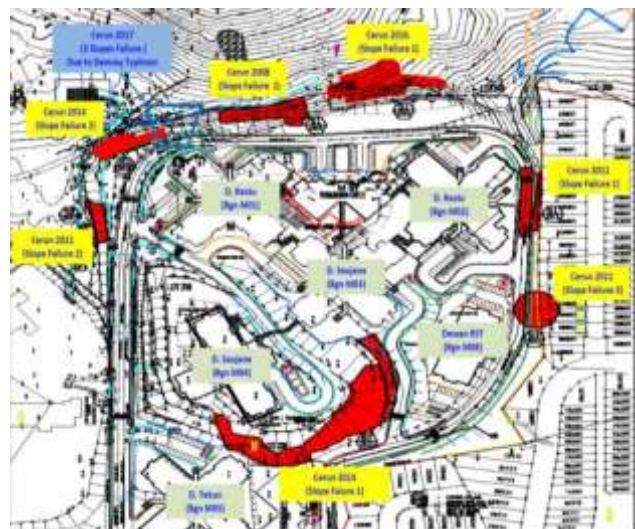
**Fig.2.** Location of the slope failure at USM Hostel

The locations of the site are shown in **Fig. 2**, where the failure has started in earlier years, however it was spread to the new places depending on the influences caused the slope erosion triggered by rainfall. The rainfall recorded over a 24-hour period from from 1st till 4th Nov 2017 was 315 mm, which was 40 mm more than on September 2015.
