Research Paper

Earthquake Resistant Assessment of Building Construction Technique in the Nayagaun Settlement of Kavre before Gorkha Earthquake

R. Pradhan ¹ and P.M. Pradhan ²

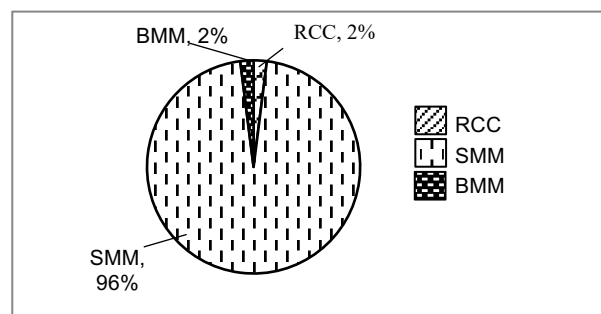
The structures of the buildings in the past were predominantly load bearing type (LBW) with stone walls and mud mortar. Load bearing structures with cement mortar and reinforced concrete frame with masonry infill walls became popular after May 25, 2015 Gorkha earthquake. These are the most popular construction types these days. Before the earthquake, 96% of the buildings in Nayagaun were load bearing wall type construction (Stone mud masonry), 2% were of Brick mud masonry and 2% were Reinforced Concrete type construction. The rest of them were load bearing wall type of construction as shown in **Fig 5**.

Fig. 5 Buildings by Structure Type

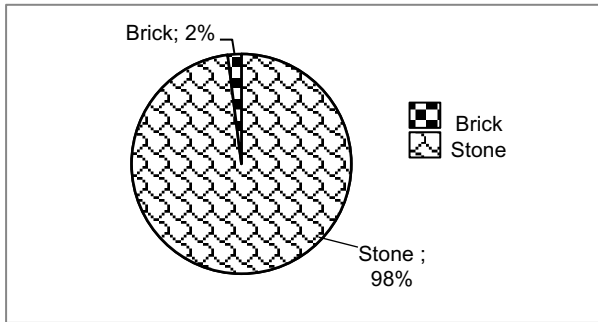
Stones are the predominant wall materials used in the buildings as it is locally available material in the site during construction. Sun dried bricks were also used in few houses as the wall materials in Nayagaun. The floor of the buildings in the past was constructed with mud and wood. 98% houses were constructed with stone and 2% houses were constructed with bricks as shown in Fig 6.

Fig. 6. Types of Wall Materials used in the study area

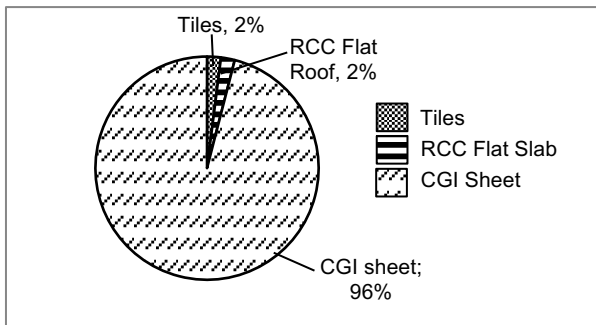
Most of the buildings on the site have corrugated iron sheet (CGI) as a roofing material. Only few buildings have tiles and flat reinforced concrete (RCC) roofs. 96% houses have CGI sheet, 2% houses have tiles and rest 2% houses have RCC Flat roof as roofing materials as shown in Fig 7.

Fig. 7. Types of Roof materials used in buildings in the study area

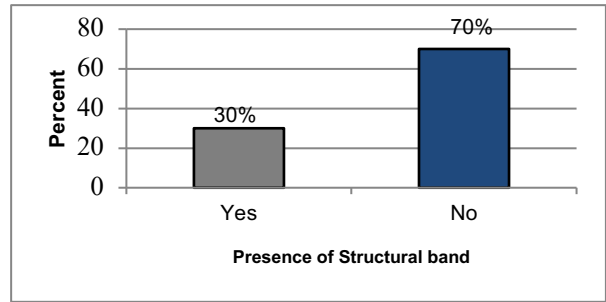
Structural Bands are the most important elements that can greatly contribute to reduce the possibility of different failure mechanisms. The presence of sill bands, lintel bands and roof bands are recorded during field work. The field study revealed that most of the buildings do not have presence of such structural bands. 70% of the buildings have lacked structural bands which are shown in Fig 8. Only 30% of the buildings have used structural bands. Timber and woods were used as structural bands in the buildings.

Fig. 8. Percentage of Presence of sill band, lintel band and roof band

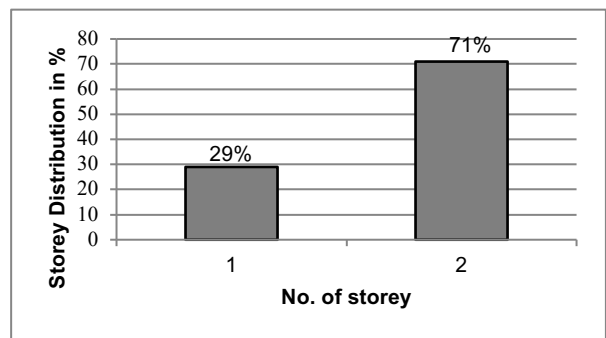
Generally, the buildings on the site were 1 to 3 storeys including attic. More than 70% of the houses were 2 storeys including attic and few of them were 1 storey including attic as shown in Fig 9.

Fig. 9. Storey Distribution in percentage

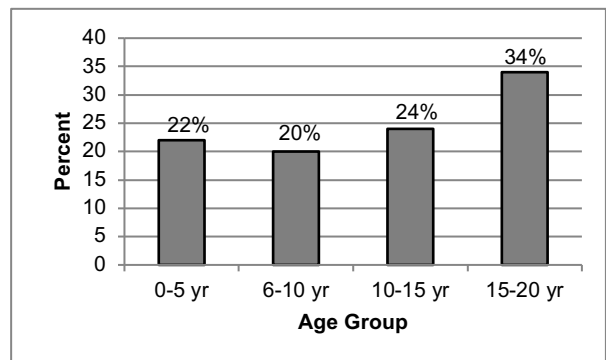
22% of the buildings on the site were of age group 0-5 years, 20% of the buildings were of age group 6-10 years, 24% of the buildings were of age group 10-15 years and 34% of the buildings were of age group 15-20 years as shown in Fig 10.

Fig. 10. Age of building
