# History of Mitigating Rolling Contact Fatigue and Corrugation of Railway Rails in Japan - Review

Makoto Ishida<sup>a,\*</sup>

## Abstract

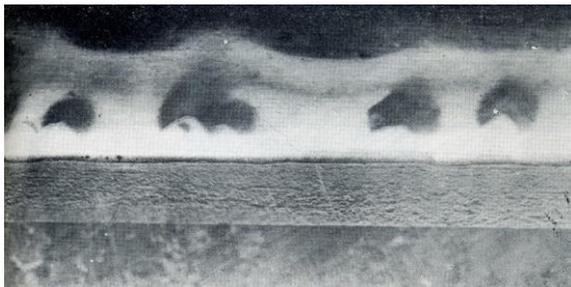
Figure 1. Dark cracks in gentle curves

At first some defects called “dark cracks” shown in Fig. 1 in those days were observed in gentle curves in San-yo line of JNR. Typical cracks were caused together with head checks as shown in Fig. 1. The naming of dark cracks is based on superficial feature that some part surrounding cracks look dark presumably due to slightly indented surface. Then such dark cracks posed so serious problem that a research project was established to study the mechanism of crack initiation following dark cracks. Those cracks were observed not only in curves but also in tangent tracks. Fig. 2 shows dark cracks take place in tangent tracks.

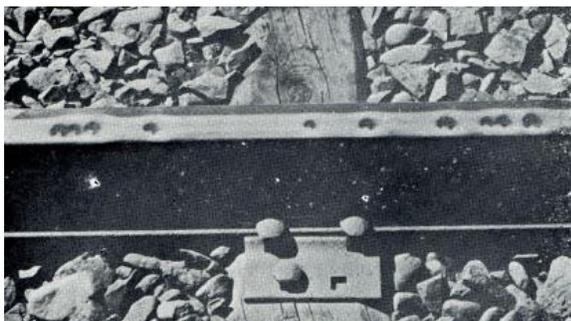
Figure 2. Dark cracks in tangent track

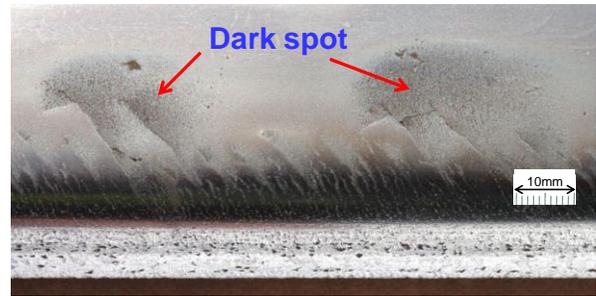
Figure 3. Gauge corner cracks

Shortly afterwards they came to be called shelling and/or rail surface shelling which is named to differentiate gauge corner shelling which is called as one of the typical fatigue defects of rail reported in heavy haul railways [2]. Also, after Hatfield accident [3], gauge corner cracks shown in Fig. 3 were focused on to understand their mechanism and establish some appropriate preventing and/or mitigating measures.

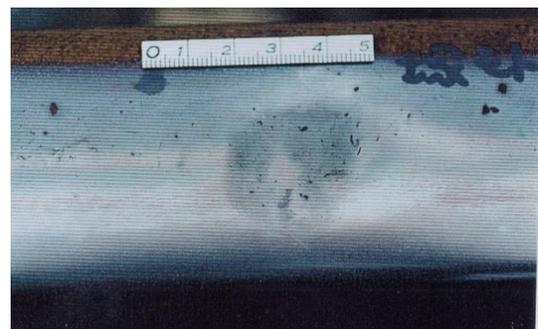
Figure 4. Typical RCF defect “Squat” called in UK and rail surface shelling called in Japan

Considering some features of dark cracks reported in 60 years ago and gauge corner cracks bothering track maintenance engineers nowadays, those cracks look so similar each other not only superficially but also mechanically and metallurgically. Then the mechanism of initiation and propagation of those two cracks may be the same. In addition, gauge corner cracks are classified to rail surface shellings called in Japan or squats called mainly in UK shown in Fig. 4, which is commonly accepted in Japan.

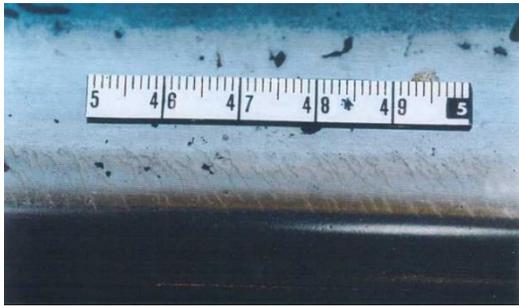
Figure 5. Head checks in as-rolled rail

Also, gauge corner cracks do not necessarily occur at the location where head checks are observed. Head checks shown in Fig. 5 in the case of as-rolled rails and in Fig. 6 in the case of head hardened rails are formed at almost all curves which mean, for example, at transition curves in the case of sharp curves and at circular curves in the case of gentle curves. In these figures, the crack spacing of as-rolled rails is larger than that of head hardened rails, the reason for which is not clearly understood.

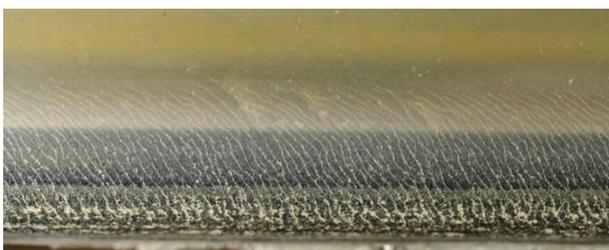
Figure 6. Head checks in head hardened rail

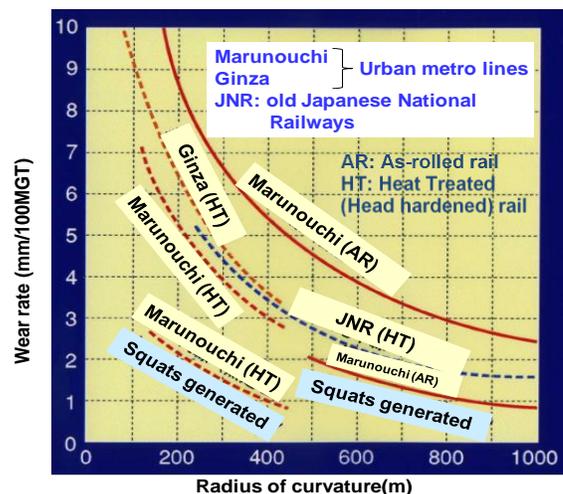
Figure 7. The variation of wear rate with the radius of curvature focusing on rail grade (AR: as-rolled rail, HT: heat treated rail = head hardened rail) and the initiation of RCF defects

Figure 7 shows the variation of wear rate with the radius of curvature focusing on rail grade (AR: as-rolled rail, HT: heat treated rail = head hardened rail) and the initiation of RCF defects. Also, this figure shows the rough tendency of the initiation of RCF defects of both of as-rolled rails and head hardened rails based on wear rate. The both types of rail are suffered from RCF defects, such as squats and/or gauge corner cracks in the case of less wear. It is identified that the larger the radius of curvature is, the less wear rate is, which clearly suggests lateral force and/or steering force causes large wear. For example, considering two sections of Marunouchi line(AR), squats were generated in some sections of Marunouchi line(AR) of less wear rate than the other.

Focusing on Ginza line(HT) and two sections of Marunouchi line(HT), in the least wear rate section of three sections, squats were generated. Less wear is one of key functions for generating squats in both of as-rolled rail and heat treated (head hardened) rail.

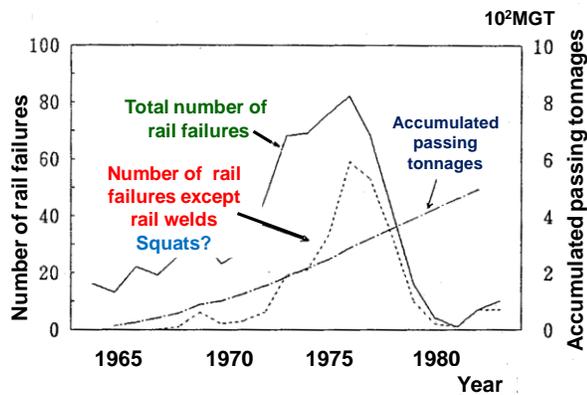
Figure 8. Transition of annual rail failures and accumulated passing tonnages in Tokaido Shinkansen (JIS50T rail)

First stage of rail surface shelling problem in Tokaido Shinkansen which is the first Japanese high speed line opened in 1964 was raised. Since then most of the rail failures were related to rail welds. But the number of rail surface shellings had been increasing after about 10 years passed since starting its operation. Figure 8 shows the history of the number of rail failures in Tokaido Shinkansen.

In this figure, the number of rail failures located not at rail welds was increasing up to 1985. At that time rail surface shellings were not clearly identified by track maintenance people necessarily because the training for the track maintenance people was not enough to check the rail surface shellings, which means obtained data may have included unsuitable ones. But roughly speaking, the trend of changing the main factor of rail failures from rail welds to rail surface shellings can be identified. However fortunately again, the strategy of improving track structure in Shinkansen was implemented since 1977, which was exchanging JIS 50T rail to JIS 60 rail to reduce the damage of ballast track suffered from impact loads. Hence, the damaged rails of JIS 50T rail were naturally changed under such a strategy.

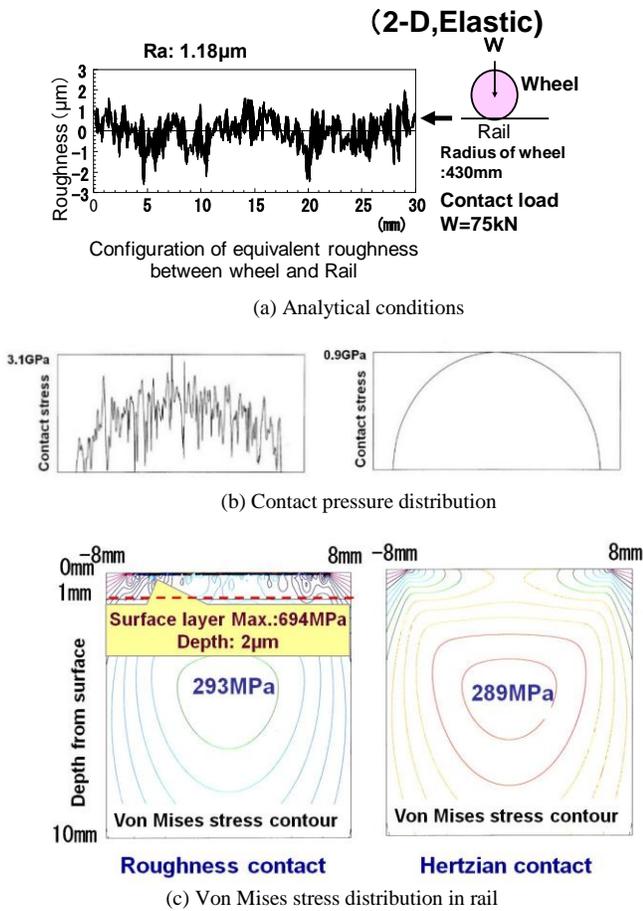
Figure 9. The effect of roughness at wheel/rail contact interface on stress distribution

Figure 9 shows the analytical conditions and its results with 2D roughness contact model constructed by Dr. Franklin and Prof. Kapoor under the collaboration between Sheffield Univ. and RTRI[7, 8]. In this figure, with regard to contact pressure between rail disc and wheel disc, roughness contact pressure is much larger than Hertzian contact pressure. Also, with regard to Von Mises stress distribution, the maximum of Von Mises stress is located at the surface or very thin layer of the surface under roughness contact and no such a high stress takes place under Hertzian contact. Since this 2D analytical model is elastic and two dimensional, the analytical results don't have agreement with actual wheel-rail contact stress condition but suggest some important tendency of stress distribution to roughly understand the damage of rail material. From the analytical results, the damage of rail should be very large at very thin surface layer, which can lead to the effect of preventive grinding.

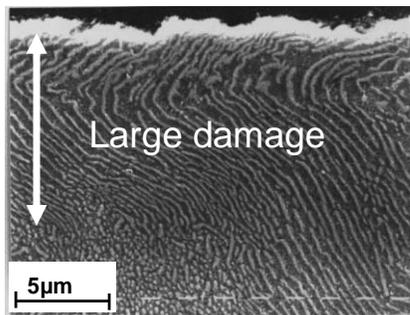
Figure 10. Plastic deformation at the contact surface layer of actual rail material

Figure 10 shows the plastic deformation at the surface of actual rail material. This figure roughly indicates the adequacy of the 2D analytical model and the possibility of RCF crack initiation at the very thin layer. Also, it suggests the possibility that effective grinding thickness should be more than 10 microns and less than 0.1mm of rail subsurface combining with analytical results of 2D roughness model. In addition, focusing on the slip plane of metallic crystal, it is identified that the direction of some specific slip planes is deformed to the same direction plastically under repeated

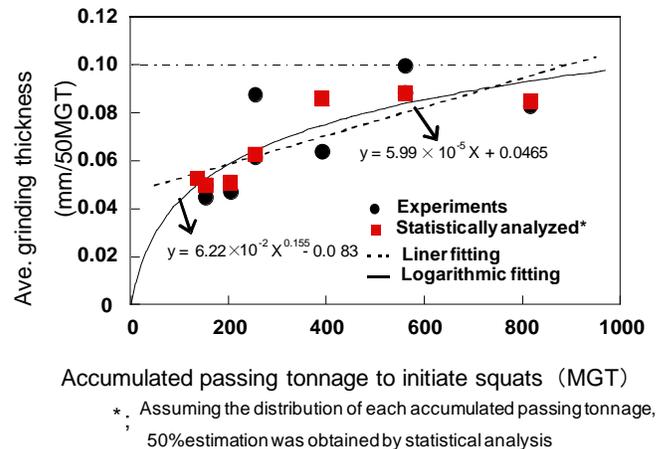
Figure 11. The effect of preventive grinding on accumulated passing tonnages to initiate squats

Figure 11 shows the results of grinding experiments with the large twin disc machine [11]. In this figure, some regression curves were obtained to estimate the effect of grinding on RCF. Roughly speaking, 0.1mm of grinding thickness every 50 MGT has an appropriate effect of grinding to extend the service life of rail up to averagely 800MGT. The adequacy of this preventive grinding method, 0.1mm/every 50MGT was verified in the operation of Tokaido Shinkansen. Roughly speaking, all rails installed in the main line of Tokaido Shinkansen have been ground once a year, about 40 to 50 MGT of annual passing tonnages since 1993. Figure 12 shows the results of detecting rails in the monitoring section of Tokaido Shinkansen [7]. In this figure, the number of defects dramatically decreased since regular preventive grinding started in 1993.

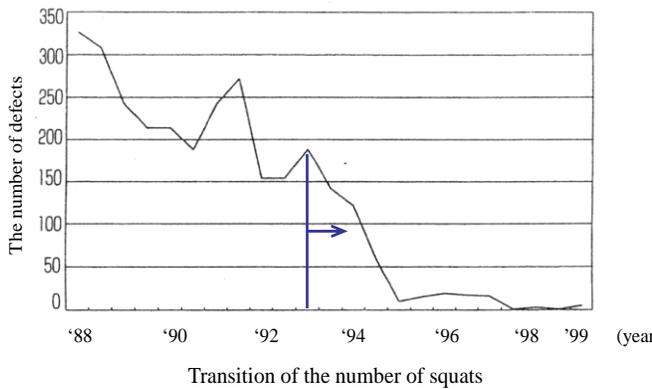
(436 km ~518km) : Kilometer post of Tokaido Shinkansen)

Figure 12. The effect of preventive grinding on mitigating the initiation of RCF defects (after 1993, whole main line of Tokaido was covered with grinding operation)

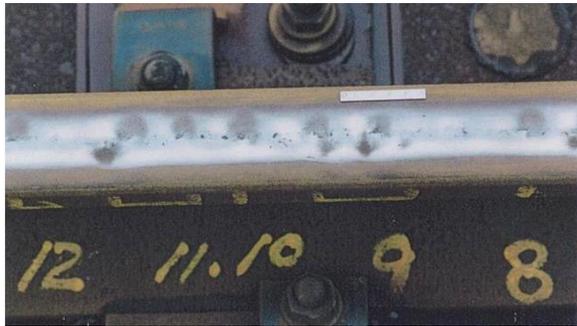
Figure 15. Squat type of RCF defects related to white etching layer

Some reports have been already published in other railways [18, 19]. Figure 15 shows typical squat type RCF defects of white etching layer. Figure 16 shows microstructure of white etching layer.

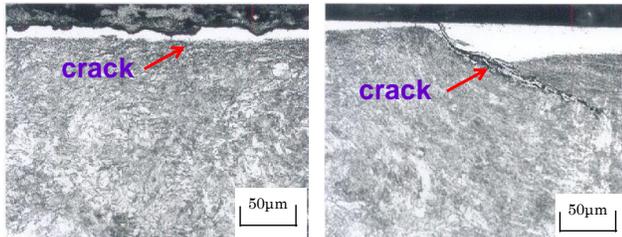
Figure 16. Micro-structure of white etching layer

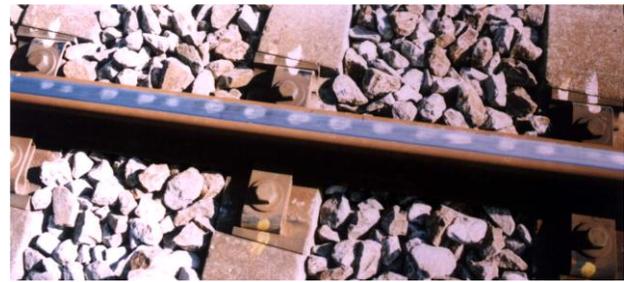
Figure 17. Typical short pitch corrugations formed on low rail surface

Short pitch corrugations on low rails shown in Fig. 17 pose acute problems of noise and track deterioration caused by vibrations excited by interacting between rail and wheel forces.

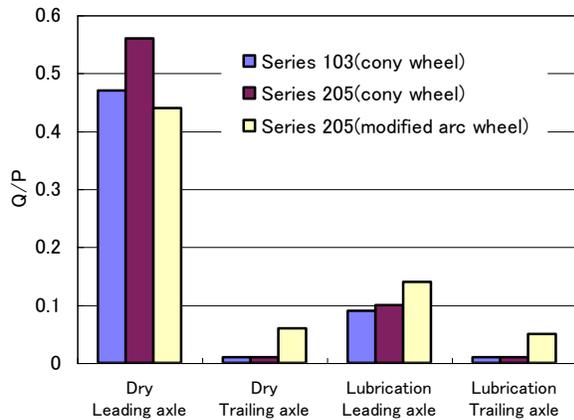
Figure 18. Q/P (lateral force /vertical force) of low rail measured at track site

Also the effect of lubrication on decreasing the lateral force and preventing corrugation formation were studied. Figure 18 shows Q/P (lateral force /vertical force) of low rail measured with strain gauges stuck at rail base flange for lateral force Q and at rail web for vertical force P during the vehicle running tests. In the figure, the Q/P of the leading axle was most significant and the effect of lubrication on reducing lateral forces was also significant. In addition, Figure 19 shows the first formation of corrugations on a new rail, which locates near the second tie from rail joint in the direction of vehicle running. It is not clearly understood that the coupled vibration between rail joint and wheel give rise

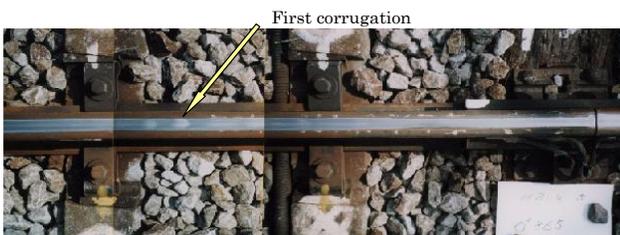
Figure 19. The first low rail corrugations formed on a new rail

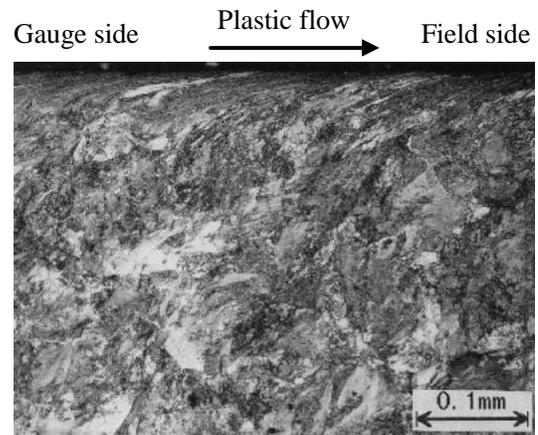
Figure 20. Microstructure of rail surface layer in lateral direction

Considering the above discussions, the investigation of longitudinal and lateral plastic flow on the surface of some corrugations was carried out [22]. There is little evidence of plastic flow in the longitudinal direction. Most of the plastic flow in Fig. 20 is in the lateral direction. Since plastic flow is greatly influenced by the friction force, plastic flow in the lateral direction indicates the importance of lateral creep forces. The direction of plastic flow (from gauge corner to field corner of the rail) corresponds with the direction of the lateral force on the rail applied by the wheel.

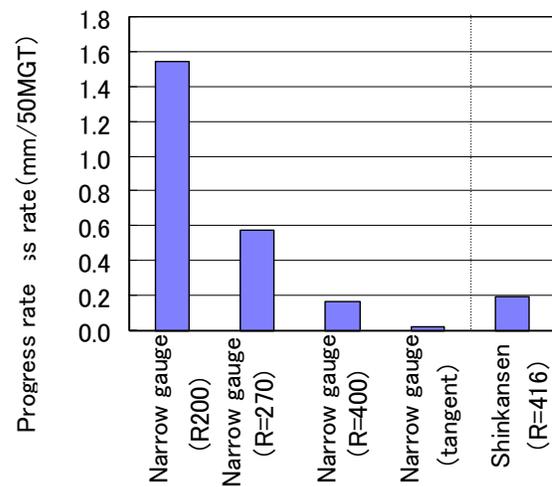
Figure 21. Variation of progress rate of the corrugations with the radius of curvature

Figure 21 shows the variation of progress rate of the corrugations with the radius of curvature. The progress rate is roughly inversely proportional to the radius of curvature. Considering that both lateral creep force caused by a leading axle and longitudinal creep force caused by a trailing axle increase together with the decrease of radius of curvatures, it is not clear which axle has more influence on the formation of corrugations. However, it is not contrary to the possibility of lateral forces influencing the development of corrugation.

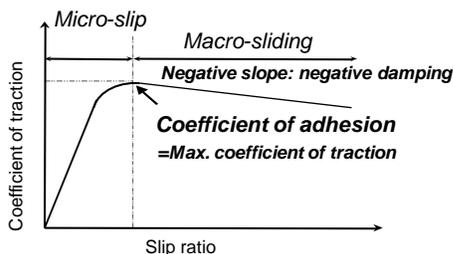
Figure 22. Typical characteristics of traction curve

On the other hand, the mechanism of low rail corrugations is almost understood but its prediction model has not been established yet. Also, one of most effective solutions to prevent low rail corrugation in sharp curves is considered “friction modifier” which was developed focusing on preventing negative damping phenomenon in traction curve shown in Figure 22 and obtaining positive slope in sliding region of slip ratio [24].

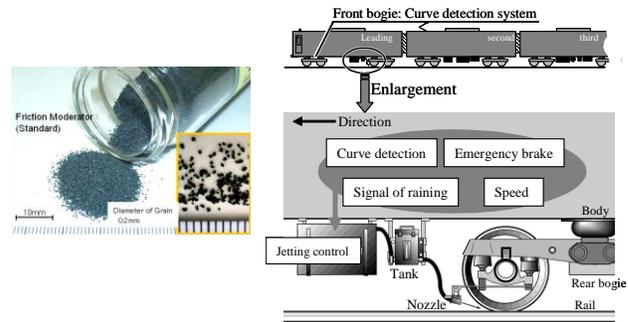
Figure 23. Friction Moderator and Friction Moderating System (on-board system)

A solid-type lubricant which was named as “friction moderator” to reduce lateral force and squealing noise excited by vehicle negotiating sharp curves was developed. Friction moderator consists of grains of coke whose raw material is artificial graphite crushed to a diameter of 0.2 mm and appropriately arranged about its graphitization, and

phenol resin which is adopted as coating for the grains of coke from the aspect of preventing them from catching fire and to aid braking (because phenol resin is used for composite brake shoes). Also, the jetting device was developed with a focus on the arrangement of the nozzle size and air pressure. Figure 23 shows friction moderator and its jetting system on board, which is called as Friction Moderating System (FRIMOS).

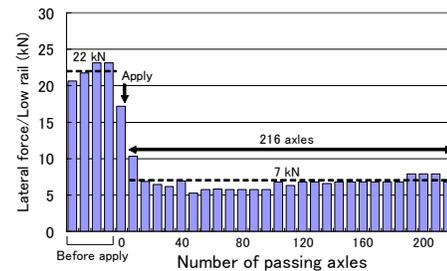
Figure 24. Effect of Friction Moderator (Lubricant) on decreasing lateral force

Figure 24 shows the lateral forces of the low-rail and high-rail as measured at the track site. In the figure, approximately 22 kN of lateral force on the low-rail before application of the friction moderator decreased to approximately 7 kN after application to the wheel/rail interface on the low-rail side using the jetting device of the FRIMOS that was installed on the test vehicle [25].

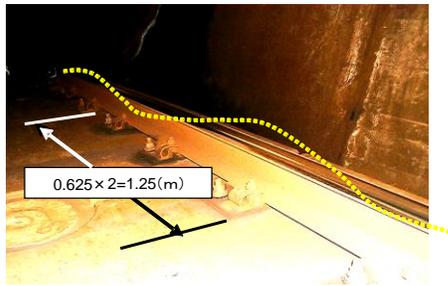
Figure 25. Rail corrugations formed in the ascending slope of Shin-Kammon Channel tunnel (salt water environmental tunnel)

Figure 25 shows rail corrugations formed on slab track in the ascending slope of salty environmental tunnel, called Shin-Kammon Channel tunnel, of San-yo Shinkansen line [26]. Since they are causing noise and large interacting forces between wheels and rails, a lot of maintenance work such as frequent rail renewal and rail grinding have been spent to cope with those problems.

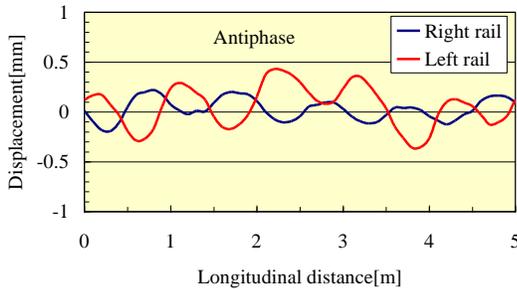
Figure 26. Typical example of the waveforms and its phase lag of rail corrugations

Figure 26 shows a typical photo of the waveforms and its phase lag of corrugations between left and right rails. In this figure, the wavelength is about 1.2m whose frequency calculated by running speed is about 70Hz which is almost the same as the resonance frequency of unsprung mass of vehicle supported by track stiffness. Also, there are two

cases about the phase lag between the right rail and left rail corrugations. One is the same phase of both rails and the other is the phase lag of 180 degree between right rail and left rail. Considering those facts, the resonance of unsprung mass of vehicle and the rolling frictional vibration of wheelset may have great influence on the mechanism of rail corrugations.

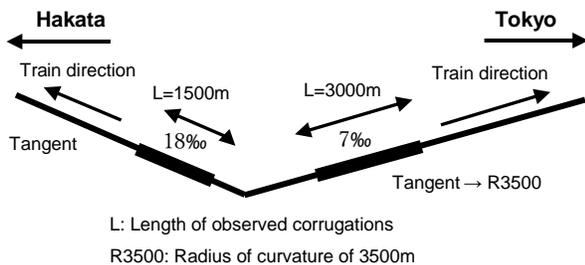
Figure 27. Location of rail corrugations observed in ascending slopes of Shin-Kammon Channel tunnel (upward-slop)

Figure 27 shows the location of rail corrugations observed in ascending slopes of the tunnel. In this figure, corrugations are generated only in ascending slopes not in descending slopes, and in almost tangent track, which suggests the corrugations may be caused by driving wheels not following wheels. According to the findings obtained from the Figs. 26 and 27, the possibility of the following mechanism of the corrugations can be considered.

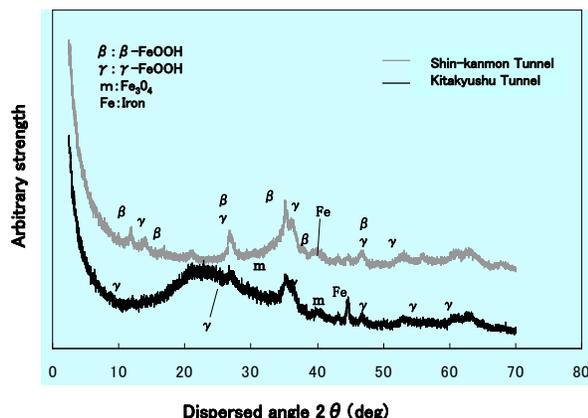
Figure 30. Results of X-ray diffraction analysis

At first Fourier transform infrared absorption spectroscopy was revised to analyse the surface of rail installed in track in situ but the analytical results were not clearly achieved. Then sample rails were put aside track in a salty environmental tunnel and a dry mountain tunnel which was selected as no corrugation condition to compare with the salty environmental tunnel. The sample rails were exposed in those two tunnels for 6 months to get rust enough for analysis. X-ray diffraction analysis was carried out to investigate the surface substances of sample rails.

Figure 30 shows the analytical results in comparison with the two tunnels. In this figure, some iron oxides and oxyhydroxides were identified, but  $\beta$ -FeOOH was found out only in the case of salty environmental tunnel. Since  $\beta$ -FeOOH is the material of low COF, the possibility of roll-slip phenomenon can be expected only in salty environmental tunnel. In this study, in situ analysis has not been successful yet, but laboratory analysis, particularly X-ray diffraction analysis, played a very important role to recognize the possibility of roll-slip phenomenon leading to the formation of corrugation.
