## MEASURED BEHAVIOR OF A TRIAL EMBANKMENT ON FLOATING COLUMN IMPROVED SOFT ARIAKE CLAY DEPOSIT

**ABSTRACT:** A 6.5m height trial embankment was constructed on soft Ariake clay deposit improved by the floating soil-cement columns. At the test site, the thickness of the soft soil was about 10 m, and the length of the column was 8.5 m and the area improvement ratio was about 31%. To check both the mechanical and geoenvironmental performance, the embankment was monitored for more than 2 years. The measured results indicate that the behavior of the trial embankment satisfies the performance requirements for constructing a highway around Ariake Sea, in Kyushu, Japan, i.e. settlement and lateral displacement at the toe of the embankment are less than 50 mm, and residual settlement is less than 0.3 m. The observed results also show that the column improvement not only reduced the settlement but also accelerated the consolidation rate of the deposit. The results of groundwater monitoring indicate that at the test site, in terms of groundwater level, flow velocity, pH value and the concentrations of some key ions, there was no effect on the groundwater quality due to the installation of so

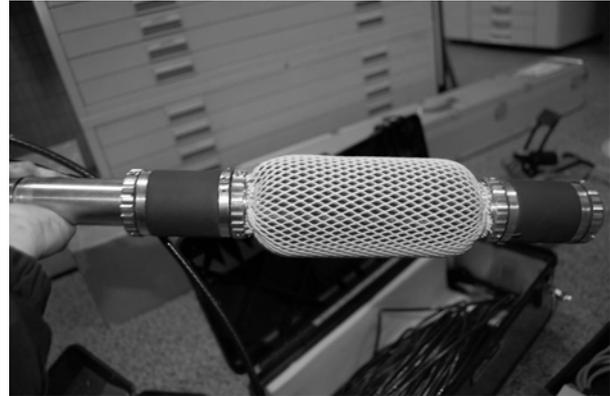
Fig. 13 Heat-capacity groundwater flow direction/velocity meter

finished in December 2009. Therefore some of the results given below include the effect of constructing the road. The structure of the groundwater monitoring well is shown in Fig. 12. The heat-capacity groundwater flow direction/velocity meter used is shown in Fig. 13 (Hayami et al. 2009). The observations were made before (October 2007), during (August, December 2008) and after (December 2009) the embankment construction. Tables 1 and 2 show the results of monitored temperature, elevation (level), flow velocity and direction of the groundwater. The results in Tables 1 and 2 show that the groundwater temperature level and flow velocity were not affected by the embankment construction. Table 3 shows the results of groundwater quality monitoring. When the mixing cement into the ground, there is a concern that the cement may affect the groundwater quality. Both before and after the embankment/road construction, the level of hexavalent chromium ( $Cr^{6+}$ ) was “not detected” (ND) or under the minimum limit of the measurement method used, and no obvious changes were observed with regard to calcium ion ( $Ca^{2+}$ ), magnesium ion ( $Mg^{2+}$ ) concentration and pH values.
