Research Paper

An early warning monitoring of Earthquake-induced slope failures by monitoring inclination changes in multi-point tilt sensors

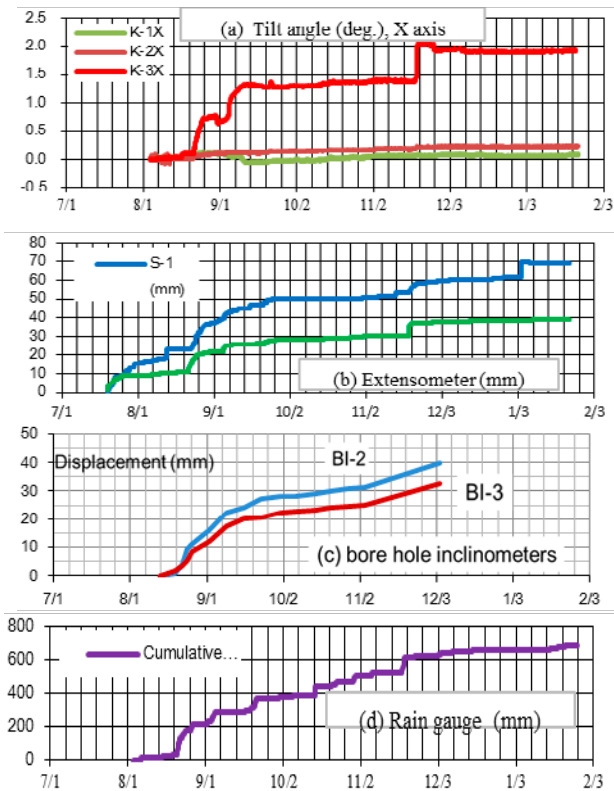
Fig. 4. The time histories of field evaluation results recorded by the rain gauge.

A field evaluation of the new tilt sensor method and a comparison with traditional extensometers and borehole inclinometers was undertaken in Japan. A set of field measurements is shown in **Figure 3**. These concern a period of heavy rainfall in July 2011 that caused slope failure along a local highway in Kyushu, Japan. During road construction on that involved substantial earthworks, an emergency monitoring system using multiple borehole inclinometers, extensometers, tilt sensors, and rain gauges was established at the slope failure site. To validate the newly developed tilt sensor with field extensometer data, three tilt sensors were collocated near the fixed poles of the extensometers, as shown in **Figure 3**. At this field location, four additional boring surveys have been undertaken and multiple borehole inclinometers have been installed. Two of the tilt sensors (K-2, K-3) were deployed near survey holes BI-2 and BI-3. **Figure 4** shows the temporal histories of the tilt sensor inclination in the direction of the extensometer wire (tilt sensor X-axis), movement of the extensometer (S-1, S-2), and displacement of the borehole inclinometers (BI-2, BI-3). **Figure 4d** shows the cumulative rainfall values

Normally, the fixed pole of a tilt sensor is inserted into a slope surface to a depth of 1.0 m, such that the inclination of the tilt sensor corresponds to the average movement of the slope surface. The results show that the inclinations of the tilt sensors (especially K-3) and the movement of the extensometers increased with rainfall, and they showed strong correlation (Fig. 4a–d). Almost the same amount of movement was found between the extensometers, tilt sensors, and borehole inclinometers.

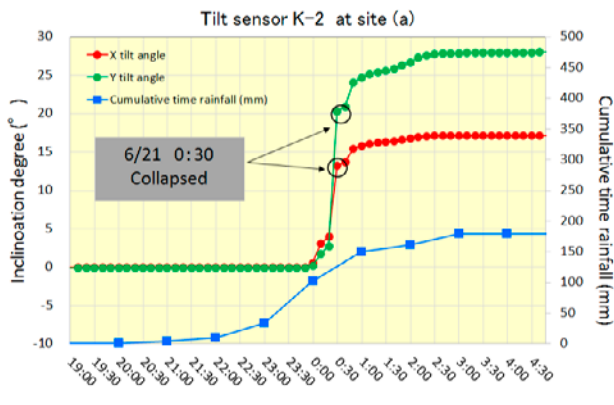
Fig. 6. Tilting and rainfall results of monitoring in site (a)

The equipment arrangements of each site are shown in Fig. 5. Two slope failures occurred in the early morning of June 20-21, 2016, triggered by ten hours of precipitation totaling 200 mm. Small-scale slope failure in site (a) occurred at the position of wireless sensor unit K-2 (Fig. 6) on June 21, 2016, with an accompanying increase in rainfall. Another two wireless sensor units maintained normal operations. The monitoring system perceived the abnormal behavior from the wireless sensor, and the caution notice and warning were issued automatically.

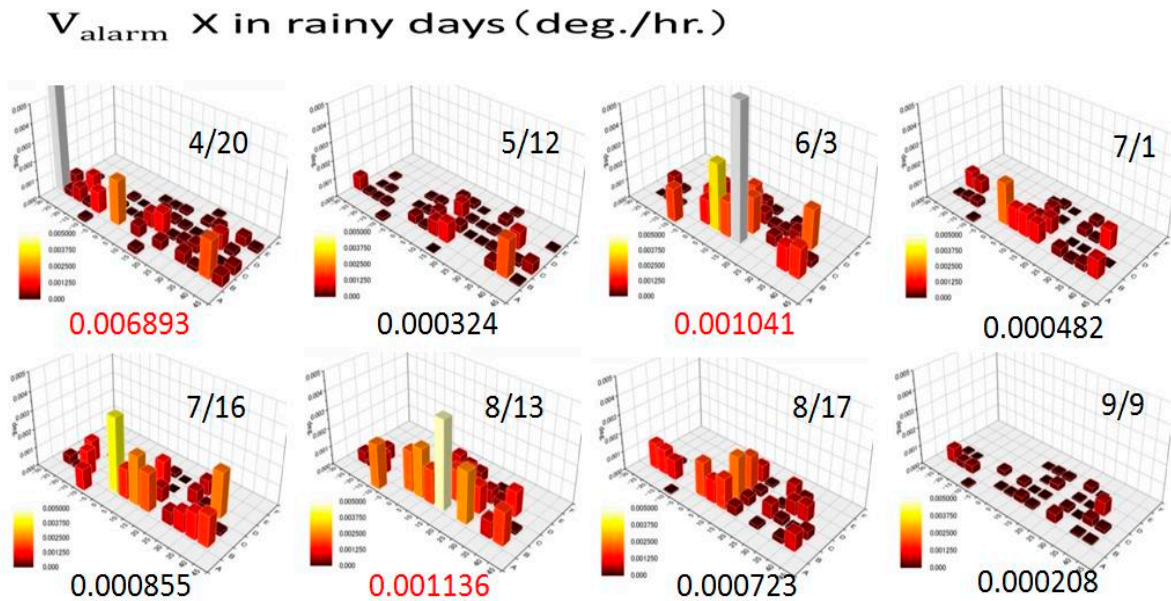
Fig. 11. Distribution of tilting rates during each rain day (>50mm/hr)

The 66 sensor units were divided into 3 groups (left, middle, and right zones), and 1 data receiver unit and 1 logger/gateway unit for Internet connectivity collected all the data from their respective groups, as shown in Fig. 9. There were eight heavy rainfall events during summer 2015, and the accumulated distribution of tilt angles is summarized in the 3D graph in Fig. 10. The tilting rate averaged during each rainfall event, when the rainfall was >50 mm/h, is shown in Fig. 11. The distribution of tilting behaviors is determined based on multipoint monitoring.
