Empirical Quality Control Analysis on Manufacture Industry Process: A Case Study in Development Country

Abstract

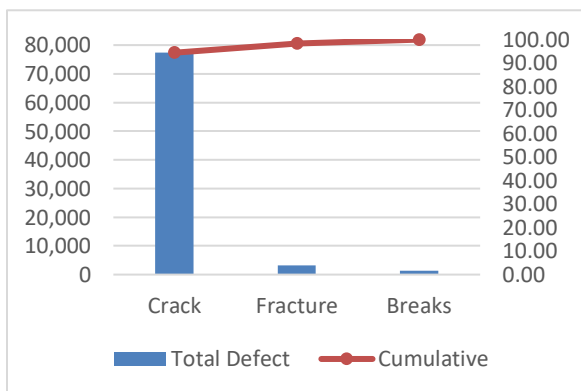
The cumulative percentage of sequence CTQ (Critical to Quality) in the production process of paving blocks for more details presented in the following Pareto diagram.

Figure 2. Pareto diagram of paving block total defect in 2013-2015

Based on the Pareto diagram, it is known that the type of defects generated in the production of paving blocks in a row is cracked by 94.43%, fracture 3.91%, and breaks, 1.67%.

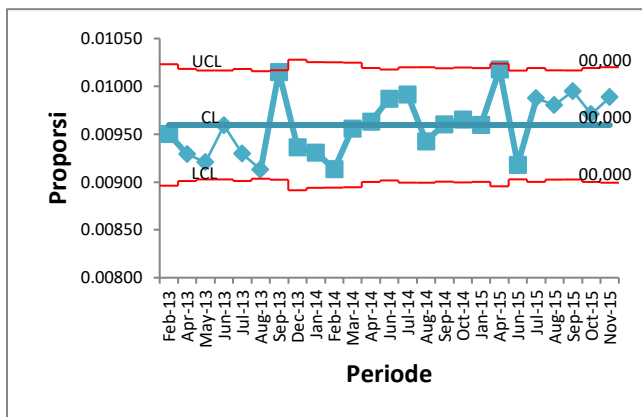
The results of calculation of the percentage defect product (proportion), CL, UCL and LCL after the elimination of data that are beyond the control limit.

Figure 4. Control chart of Paving Block after revised

Figure 4. above can be seen that the process is already in a stable state because all processes are under control.

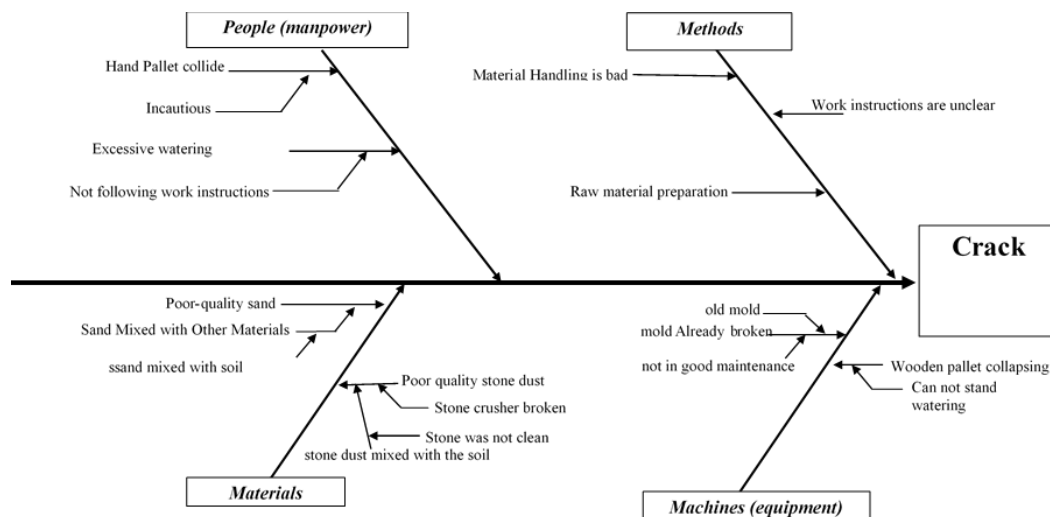
Figure 5. Fishbone diagram for cracks

Diagram analysis describes that the main factor is the cause of the defect are machines and material factors. At machines factor, wood pallets which collapsed due to watering process that continues resulted in many product experience of defect and mold that worn that resulted in the overflow of the material to be printed. At the material factors, the quality of sand and stone dust that bad, affect quality of paving blocks, sand and stone dust mixed with other material will degrade the quality of the
